# Site Investigation Report

| Job Information | |
|---|---|
| Client | Crawford & Co |
| Visit date | 18/03/2022 |

| Overview | |
|---|---|
| Brief | Auger were commissioned by Crawford & Co to undertake a site investigation and CCTV inspection of the underground drainage within the area of concern (AOC) at the property. |

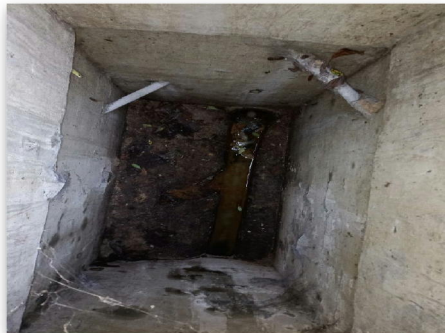
Fig 3.1: MH1

| Overview | |
|---|---|
| Visual Inspection | <p>A visual inspection of MH1 revealed the outlet of this run is an interceptor trap, this was partially blocked and causing the channel of the manhole to retain water. In addition the chamber walls appear to be falling in and the pointing between the bricks are non-existent. We believe a section of the chamber wall has broken off, fell in the channel and caused the blocking of the trap.</p> <p>Furthermore RWG1 was seen to be a back inlet gully whereby the inlet was a 50mm plastic pipe serving the rainwater downpipe and the outlet was also a 50mm plastic pipe leading into (we assume) MH1. However the outlet of this gully was blocked and due to the diameter of the pipe we were unable to cleanse and survey this run. We would inform the client that 50mm pipework should not be used as a substitute to 100mm below ground pipework. Therefore we recommend the downstream pipework serving this gully is renewed in 100mm pipework. This action should however be completed on a private basis as this is classed as poor workmanship.</p> |

| Recommendations | |
|---|---|
| Refer Back to Client | <p>It is recommended that the following repairs are carried out to prevent an escape of water from the system:</p> <p><b>Line 1</b><br/>Install a 100mm patch liner 6m upstream of MH1 to cover the displacement.</p> <p><b>Manhole 1</b><br/>Excavate and replace the interceptor trap with 100mm straight pipework. This will involve removing the chamber wall and installing a 100mm patch liner after completion in order to connect the new to existing pipework.</p> <p>Re-bench and re-channel MH1. Also the top of the chamber the bricks are loose, please replace the defective bricks and reform the upper level of the chamber, this may involve lifting/ breaking the paving slabs to facilitate this work. Should this happen then this will prolong the claim and incur further costs.</p> <p>Due to the depth of the chamber special health and safety measures must be undertook.</p> <p>Interceptor traps were originally designed to keep foul smells from entering the property. It is now generally accepted that they should be removed as they are a major cause of blockages within a drainage system. Auger like most drainage contractors and Water and Sewerage Companies replace these traps with a straight section of pipe to prevent blockages. In some circumstances this does result in smells becoming apparent in the property as it occasionally highlights existing defects with internal traps and seals. Auger is unable to take responsibility if this happens after work is completed. Smells in the house will not be covered under policy terms and if this occurs customers will need to employ their own plumber to resolve the issue. If this is of concern please discuss the matter with your account manager before repairs commence.</p> <p><b>We will now refer back to the client in order to progress the claim.</b></p> |

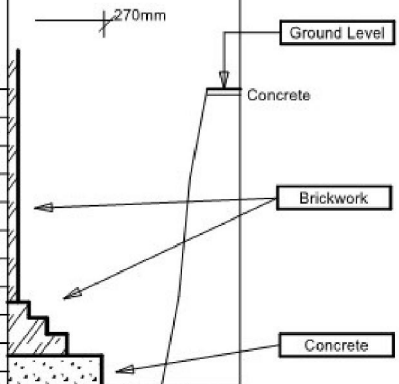
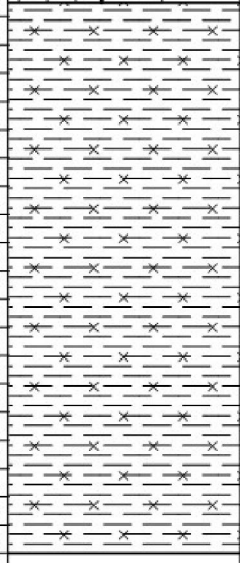
## Trial Hole Log No.1

Location: Front right corner of three storey property

| Depth<br>(m) | Symbolic Log | Strata Description | Insitu Tests | | Soil<br>Sample | Root<br>Sample |
|---|---|---|---|--|---|---|
| 2.0 | | Dry very stiff Brown fine to medium gravelly<br>silty CLAY | 108kpa | | Soil<br>@ 2.05m | Root<br>@ 2.05m |

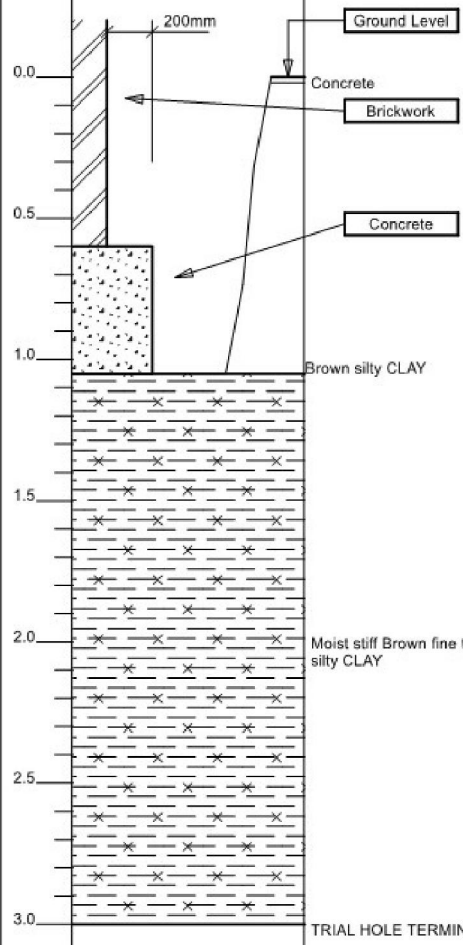
## Trial Hole Log No.2

Location: Rear right corner of rear extension

| Depth<br>(m) | Symbolic Log | Strata Description | Insitu Tests | | Soil<br>Sample | Root<br>Sample |
|---|---|---|---|--|---|---|
| 2.0 | | Moist stiff Brown fine to medium gravelly silty CLAY | 104kpa | | Soil @ 2.05m | |
