## Arboricultural Appraisal Report

### Subsidence Damage Investigation at:

170 Maygrove Road  
London  
NW6 2EP

| REPORT DATE: | 25/07/2022 |

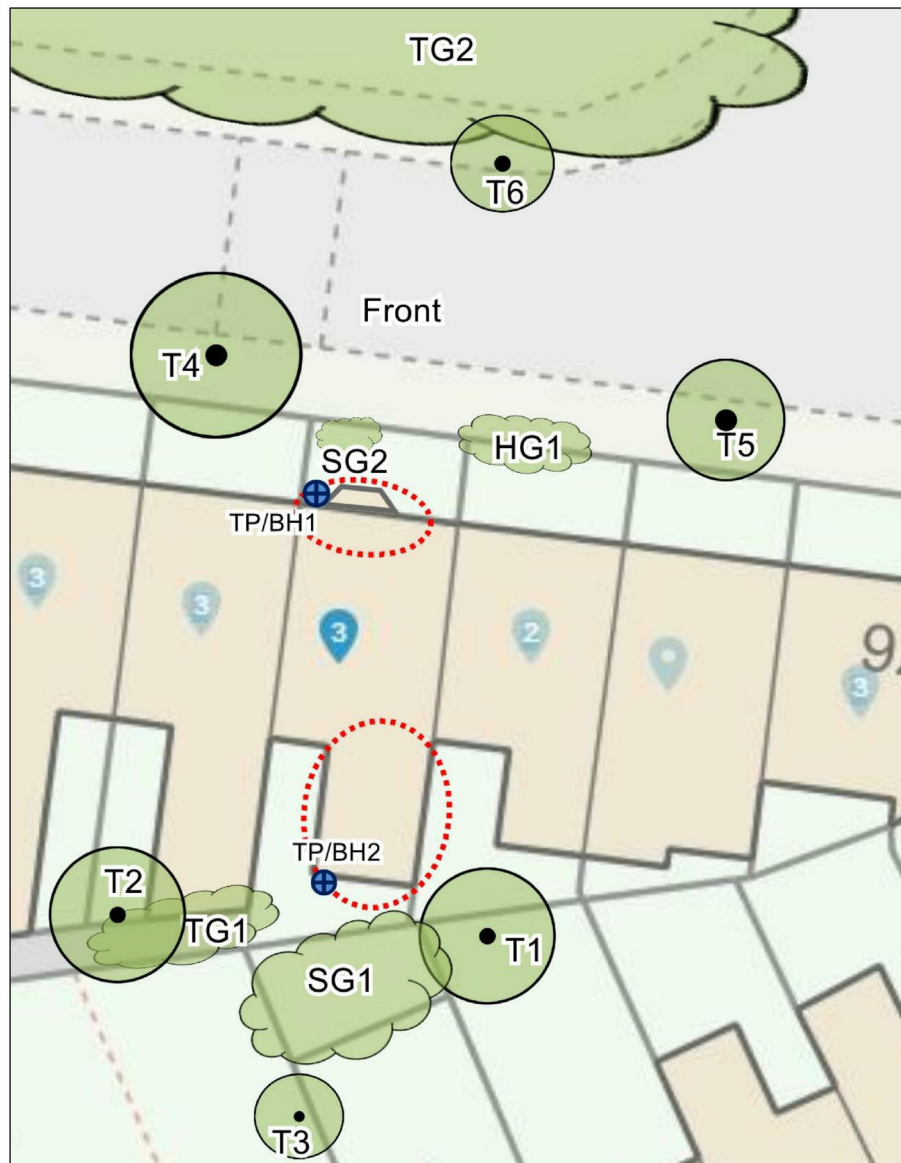
Site Plan

Approximate areas of damage

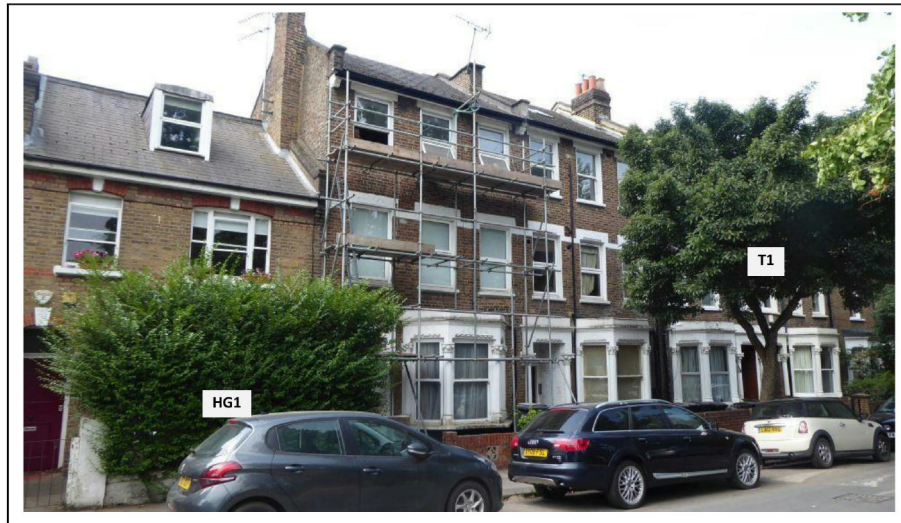
Roots were observed to a depth of 2.55m bgl in TP/BH1 and recovered samples have been positively identified (using anatomical analysis) as Pomoideae gp. and Salicaceae spp.; the origins of which will be T4 Cockspur thorn and the nearby stems of TG2 Poplar group, confirming their influence on the soils below the foundations.

Irrespective of the identification of recovered root samples, the roots of the nearby HG1 Privet hedgerow will also likely be present below foundation level in proximity to the area of movement/damage and contributing to the influence of soil moisture and volumes.

View of T1 Crataegus and HG1 Privet hedgerow

| Tree No. | Species | Ht (m) | Dia (mm) | Crown Spread (m) | Dist. to building (m) | Age Classification | Ownership |
|---|---|---|---|---|---|---|---|
| Recommendation | | Remove (fell) to near ground level and treat stump to inhibit regrowth. | | | | | |
| Recommendation | | Reduce height to 1.5 and cut back sides to leave hedge no wider than 0.5m. Trim on an annual cycle thereafter to maintain at broadly reduced dimensions. | | | | | |

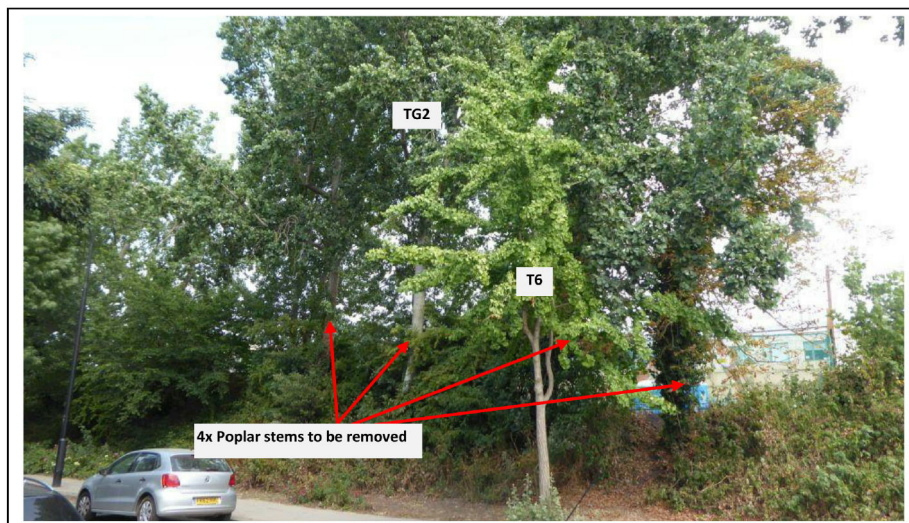
View of T6 Ginkgo tree with TG2 Poplar group visible beyond

| Tree No. | Species | Ht (m) | Dia (mm) | Crown Spread (m) | Dist. to building (m) | Age Classification | Ownership |
|---|---|---|---|---|---|---|---|
| Recommendation | | Remove (fell) eastern-most 4x stems to near ground level and treat stumps to inhibit regrowth. | | | | | |

| Tree No. | Species | Ht (m) | Dia (mm) | Crown Spread (m) | Dist. to building (m) | Age Classification | Ownership |
|---|---|---|---|---|---|---|---|
| Recommendation | | Maintain broadly at no more than current dimensions by periodic pruning. | | | | | |

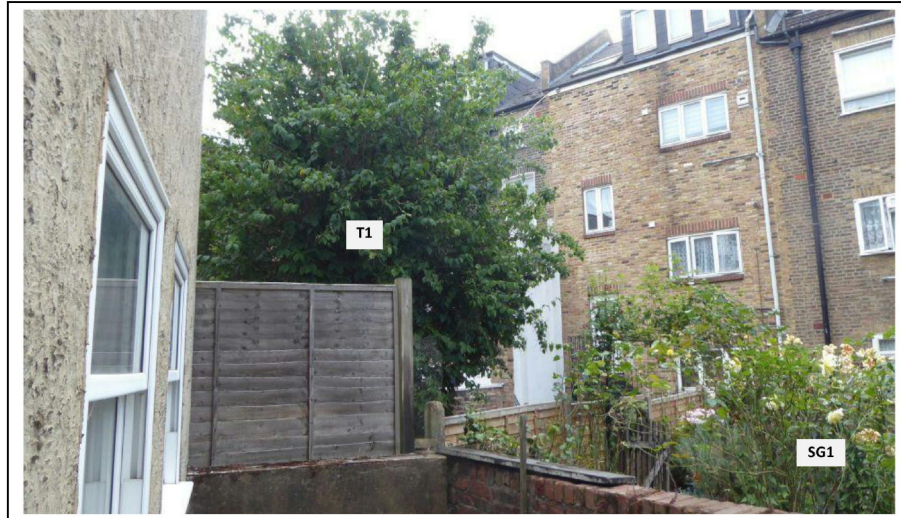
View of T1 Philadelphus with SG1 shrub group visible to right

| Tree No. | Species | Ht (m) | Dia (mm) | Crown Spread (m) | Dist. to building (m) | Age Classification | Ownership |
|---|---|---|---|---|---|---|---|
| Recommendation | | Reduce height to 1.0m and thereafter re-prune on an annual cycle to maintain at broadly reduced dimensions. | | | | | |

| Tree No. | Species | Ht (m) | Dia (mm) | Crown Spread (m) | Dist. to building (m) | Age Classification | Ownership |
|---|---|---|---|---|---|---|---|
| Recommendation | | Maintain broadly at no more than current dimensions by periodic pruning. | | | | | |

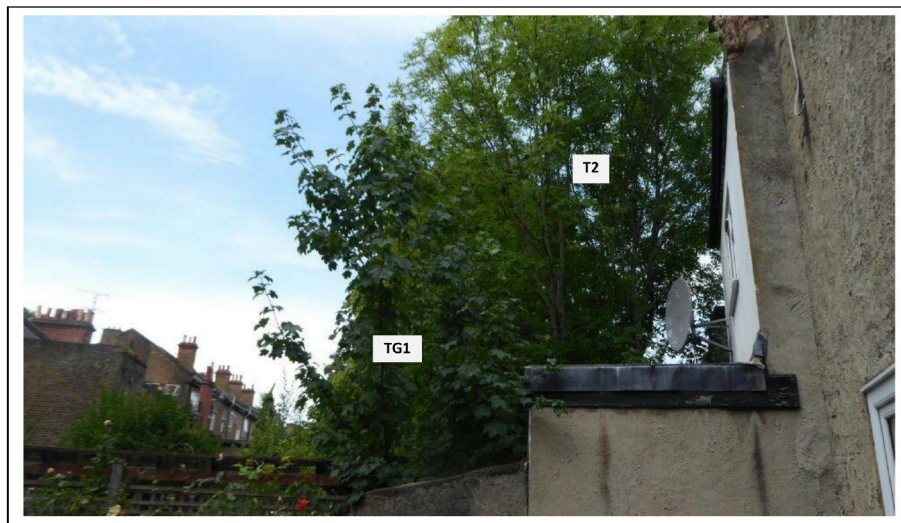
View of T2 Ash and TG1 Sycamore group

| Tree No. | Species | Ht (m) | Dia (mm) | Crown Spread (m) | Dist. to building (m) | Age Classification | Ownership |
|---|---|---|---|---|---|---|---|
| Recommendation | | Remove (fell) to near ground level and treat stump to inhibit regrowth. | | | | | |

| Tree No. | Species | Ht (m) | Dia (mm) | Crown Spread (m) | Dist. to building (m) | Age Classification | Ownership |
|---|---|---|---|---|---|---|---|
| Recommendation | | Remove (fell) to near ground level and treat stumps to inhibit regrowth. | | | | | |
