ARBORICULTURAL ASSESSMENT REPORT

30 Eton Avenue, London, NW3 3HL

**Survey Date:** 06/07/2023

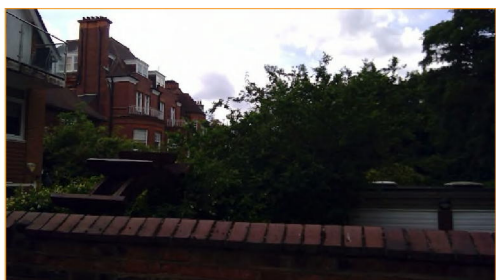
SG4 - Mixed species shrubs
