Simon Pryce Arboriculture

Report

Site: 58 Belsize Park Gardens, London, NW3 4ND

Subject: Decay and safety assessment of ash tree in the back garden

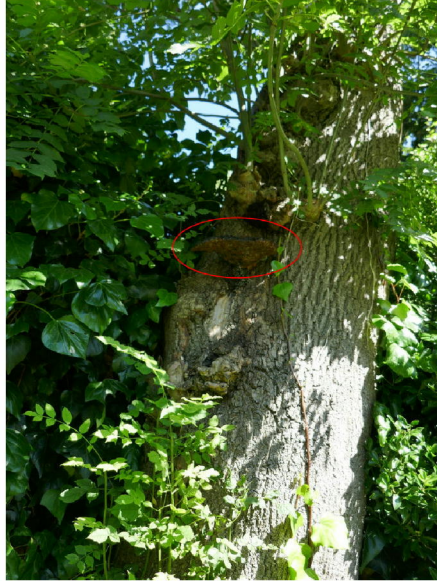
- 3.5 However this summer a bracket of *I.hispidus* appeared near the top of a wound on the lower trunk. The wound is relatively shallow, possibly caused by some kind of impact and has concentric bands of callus round the edges, which is common in trees affected by this fungus.

Inonotus hispidus bracket circled, near the top of the old wound.

- 5.4 Access with the drill was restricted, but the readings show that the decay has spread in from the wound, rather than hollowing the centre of the trunk like some other fungi. Owing to the lean the wound is on the tension side of the tree, but as the fungus reduces tensile and compressive strength that makes little difference.

- 5.5 Trees do not have immune systems so they cannot fight fungal infections, but they can compartmentalise timber in order to contain decay. However ash timber is not naturally durable and they do not have a strong ability to do this, as shown by the gradual transitions between sound wood and advancing decay. *I.hispidus* is known for weakening trees rapidly before the timber shows visible signs of decay. ⁽¹⁾

- 5.6 Given the tree's size and location any failure in the lower trunk would cause considerable damage. The crown reduction was done to a good standard and will have reduced weight and wind loads on the tree, but it would need to be recut regularly in order to maintain the benefit. That would give some safety margin, but the decay would continue to spread and the tree would grow back, so it would need intensive monitoring and management as long as it was retained. Camden's approval would be needed each time it was worked on.
- 5.7 Felling the tree or reducing it to a high stump would eliminate any risk and avoid the need for ongoing management. There would be some loss of amenity, but that would be mitigated by the much larger London plane at the end of the garden and the other trees in the wider area. For the longer term there would also be space to plant a new tree nearby.

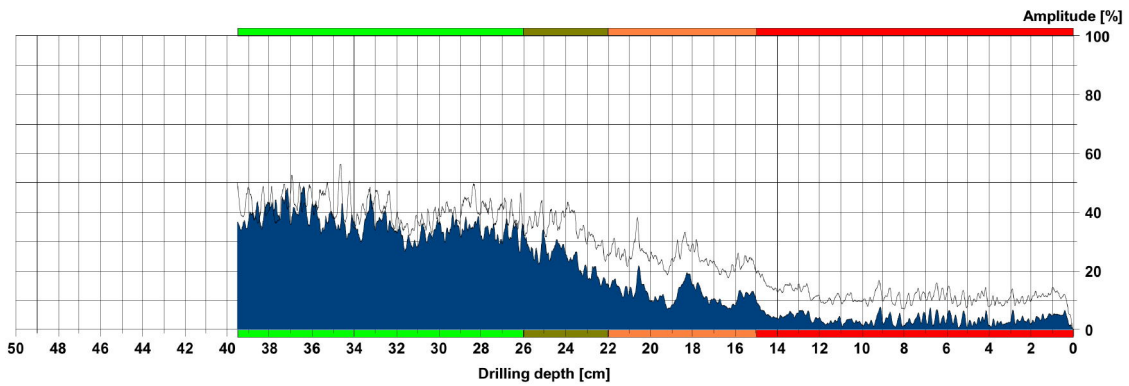
Red	From 0,0 cm to 15,0 cm : Decay
Orange	From 15,0 cm to 22,0 cm : Early decay
Green	From 22,0 cm to 26,0 cm : Suspected decay
Light Green	From 26,0 cm to 39,5 cm : Sound wood
White	From 0,0 cm to 0,0 cm :
White	From 0,0 cm to 0,0 cm :

SW side just below bracket. Significant decay grading into sound wood, which has higher resistance. Gradual transition indicates that the tree is not resisting the spread of decay at this point.

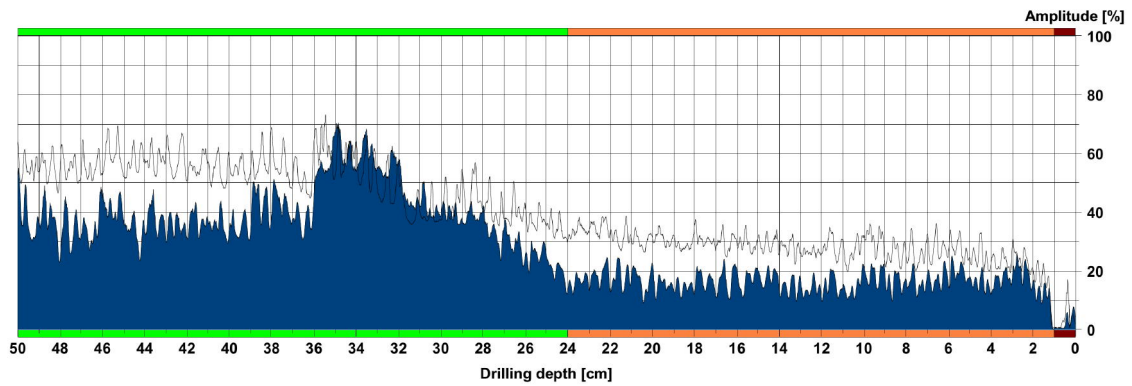
■	From	0,0 cm	to	1,0 cm	: Bark
■	From	1,0 cm	to	24,0 cm	: Early decay
■	From	24,0 cm	to	50,0 cm	: Sound wood
■	From	0,0 cm	to	0,0 cm	:
■	From	0,0 cm	to	0,0 cm	:
■	From	0,0 cm	to	0,0 cm	:

South at 2m. Grain texture is well defined to about 24cm but resistance is low. Higher resistance at 30 - 36cm is possible reaction to an old injury.

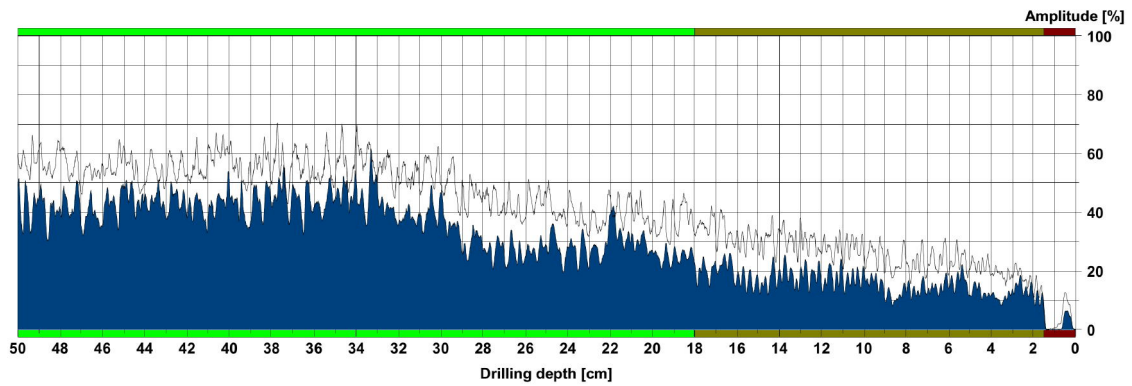
■	From	0,0 cm	to	1,5 cm	:	Bark
■	From	1,5 cm	to	18,0 cm	:	Suspected decay
■	From	18,0 cm	to	50,0 cm	:	Sound wood
■	From	0,0 cm	to	0,0 cm	:	
■	From	0,0 cm	to	0,0 cm	:	
■	From	0,0 cm	to	0,0 cm	:

Similar to reading 2, initial resistance is low, but transition to sound looking wood is less well defined.

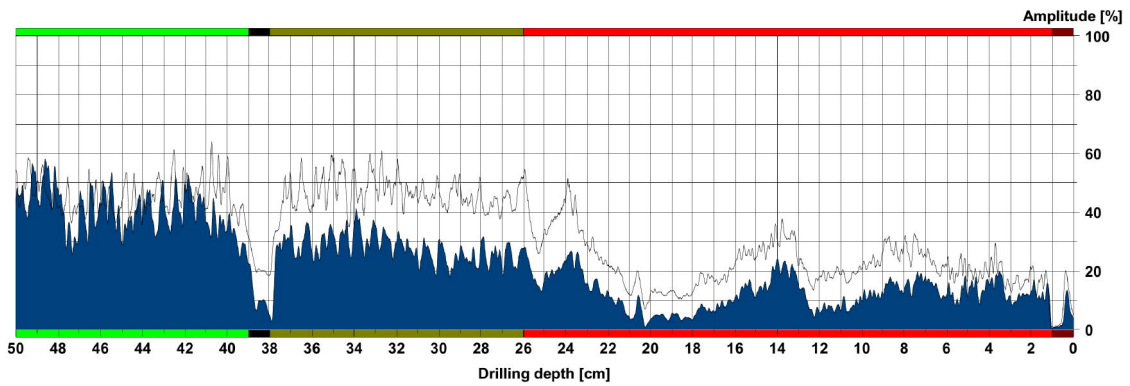
■	From	0,0 cm	to	1,0 cm	:	Bark
■	From	1,0 cm	to	26,0 cm	:	Decay
■	From	26,0 cm	to	38,0 cm	:	Suspected decay
■	From	38,0 cm	to	39,0 cm	:	Cavity
■	From	39,0 cm	to	50,0 cm	:	Sound wood
□	From	0,0 cm	to	0,0 cm	:

SW level with bracket. Decay in to at least 26cm and decay pocket or possible crack at 38cm.

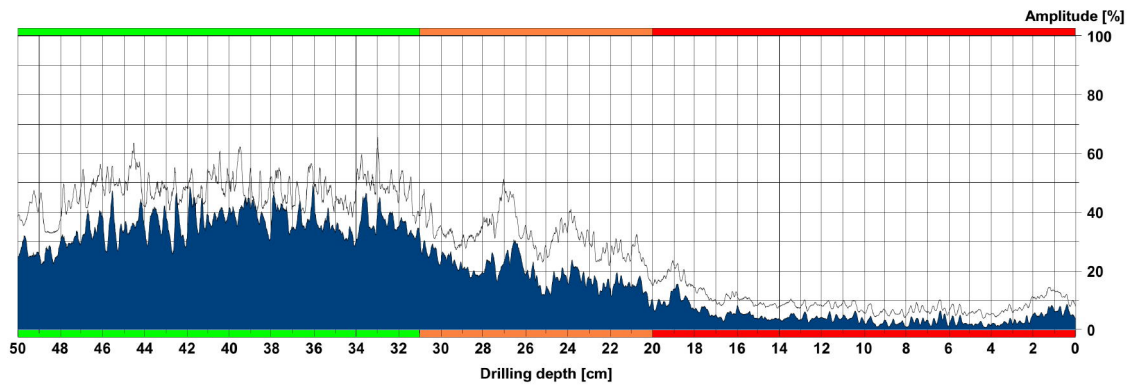
■	From 0,0 cm to 20,0 cm : Decay
■	From 20,0 cm to 31,0 cm : Early decay
■	From 31,0 cm to 50,0 cm : Sound wood
■	From 0,0 cm to 0,0 cm :
■	From 0,0 cm to 0,0 cm :
■	From 0,0 cm to 0,0 cm :

1.8m at base of the wound below the bracket.
Decay extensive and no clear transition to sound wood.

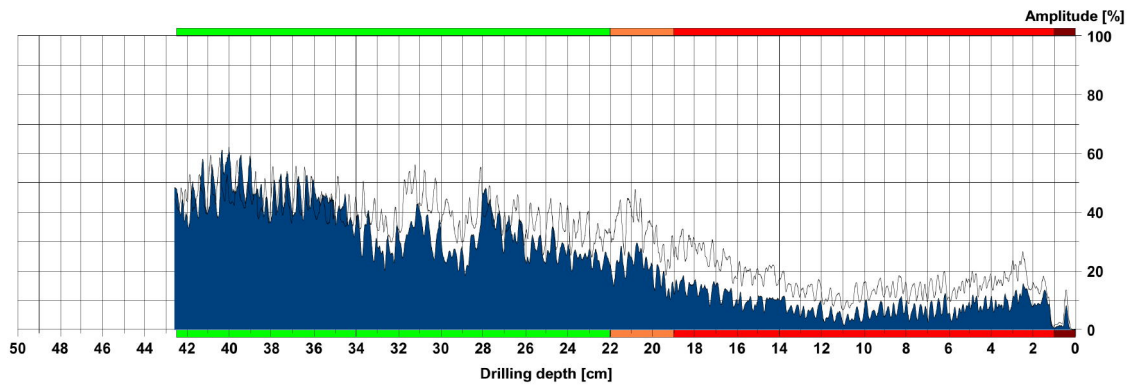
■	From	0,0 cm	to	1,0 cm	:	Bark
■	From	1,0 cm	to	19,0 cm	:	Decay
■	From	19,0 cm	to	22,0 cm	:	Early decay
■	From	22,0 cm	to	42,5 cm	:	Sound wood
□	From	0,0 cm	to	0,0 cm	:	
□	From	0,0 cm	to	0,0 cm	:

SW below the wound. Low resistance consistent with decay but some grain texture still evident.

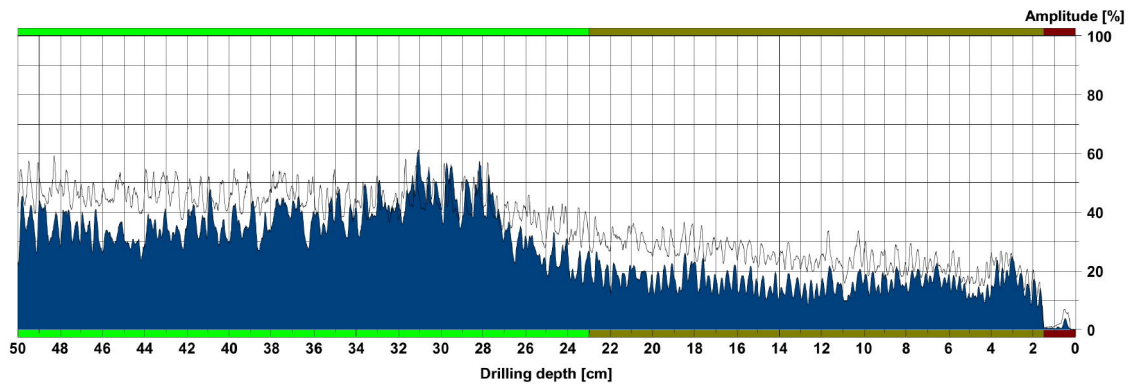
■	From 0,0 cm to 1,5 cm : Bark
■	From 1,5 cm to 23,0 cm : Suspected decay
■	From 23,0 cm to 50,0 cm : Sound wood
■	From 0,0 cm to 0,0 cm :
■	From 0,0 cm to 0,0 cm :
■	From 0,0 cm to 0,0 cm :

E level with bracket. Similar to 2 and 3. Grain texture present but resistance low with no clear transition to sound wood

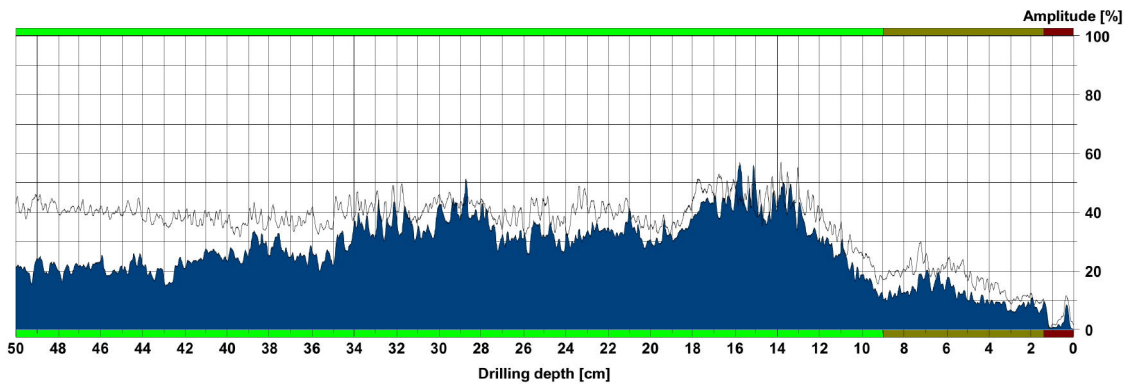
■	From 0,0 cm to 1,4 cm :	Bark
■	From 1,4 cm to 9,0 cm :	Suspected decay
■	From 9,0 cm to 50,0 cm :	Sound wood
■	From 0,0 cm to 0,0 cm :	
■	From 0,0 cm to 0,0 cm :	
■	From 0,0 cm to 0,0 cm :

SW, control drill well below the wound.
Resistance more variable than in the readings higher up the trunk and grain texture not as well defined after about 34cm, but no obvious signs of decay
