# ARBORICULTURAL ASSESSMENT REPORT

50 Priory Road, London, NW6 3RE

Survey Date: 19/12/2022

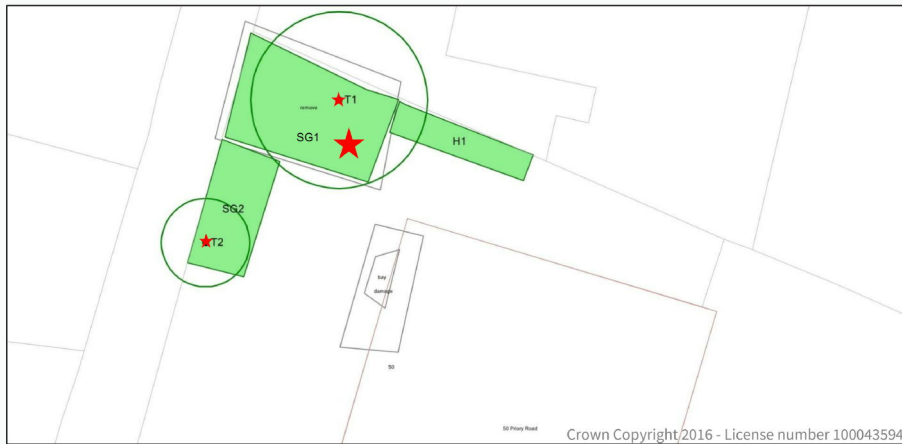
## 7.0 APPENDIX 2: SITE PLAN

Tree No:	Species	Works Required
SG1	Mixed species shrubs	Fell and treat stump with eco plugs (broadleaved).
T1	Apple (Sweet Crab)	Fell and treat stump with eco plugs (broadleaved).
T2	Cabbage Tree	Fell and treat stump with eco plugs.
