Structural Report 2023_04_21 Page 1 2457_Report 02_A

1.0 Introduction

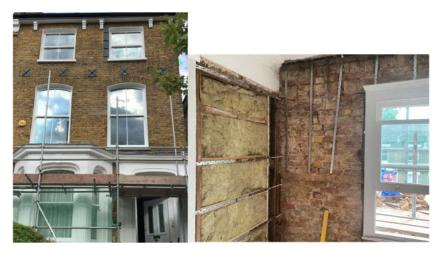
- Steel patress plates were installed at second floor level externally.Studding drilled through the wall and welded ot a MS bat strap screwed to joists.
- 2.2 Steel patress plate was installed vertically to align with the internal non-loadbearing strud partion and fixed back to the studs.

3.1 The installation of external pattress plates was the only option to effectively retrain the front façade as the condition of the bricks would have not allowed the padstone detailed in P01 to work effectively.
