## **Report Contents**

### **1.0 Introduction**

- 1.1 This report has been completed by John Harrison MStructE, CEng) for Harrison Shortt Structural Engineers Ltd.
- 1.2 Harrison Shortt Structural Engineers Ltd. have been appointed by the leaseholders of flat C to review the condition of the building on their behalf to submit a report to the Freeholder
- 1.3 Access has been gained to the leasehold demise of this apartment on 3<sup>rd</sup> August 2021, site notes are shown on plans E12 and E13
- 1.4 The building is occupied and therefore opening up works have not been completed.
- 1.5 Harrison Shortt worked for the leaseholder in in the structural design of the alterations to the basement flat.

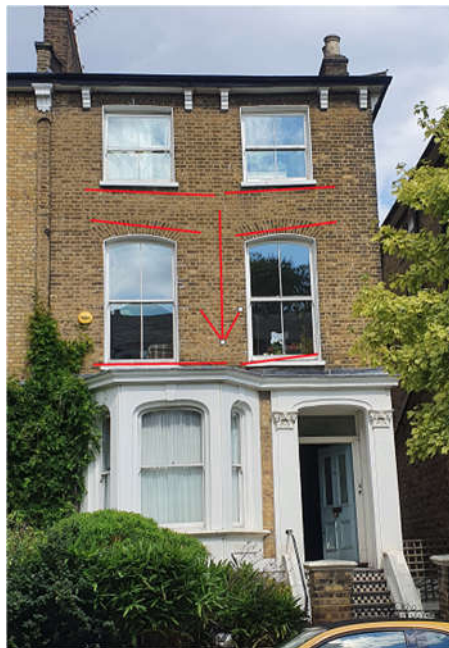
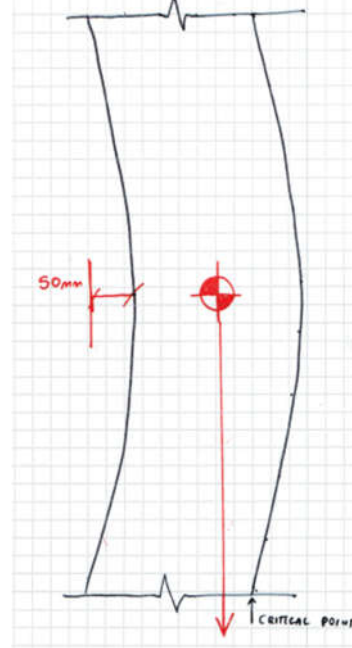
4.3

The bowing within the front façade appears to be worse at the second floor level as the tying at both eaves and roof level appear adequate as there is limited bowing at this level. When the center of mass of the wall moves beyond the face of the wall then it becomes unstable, this has not happened yet. The reason for the movement is likely to be as a result of central heating skrinkking the joists reducing the fricking into the wall at that level. It would be advisable to install strapping as shown on P01.

- 5.1 The bowing in the front elevation is a result of the loss of tie at second floor level that should be reinstated with the installation of BAT straps
- 5.2 The sag left to right at second floor level could be improved by the removal of the partition and replacement with a lightweight wall but this is not critical.
- 5.3 The vertical sag in the front façade on the balance of probability is historic however if the movement is ongoing a new bressmer beam (152 UC 37 with steel cap-plate to suit wall thickness) will be required. It would be advisable to confirm with the leaseholder at ground floor to confirm if the beam has already been replaced and lift a floor board at first floor level to determine construction and delay any works to see if the sagging worsens.
