Site Investigation Report

Job Information	
Client	Crawford & Co
Client ref	[Redacted]
Visit date	28/10/2022
Report date	07/11/2022

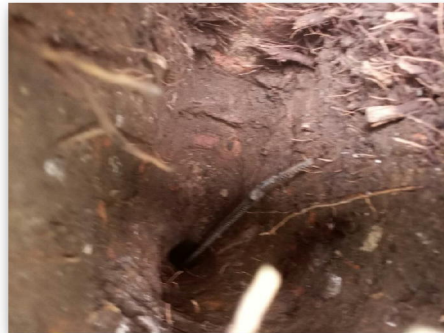
Fig 1.2: Trial Hole 1 Footing

Depth (m)	Symbolic Log	Strata Description	Insitu Tests		Soil Sample	Root Sample
			SV(19)			
0.0		Ground Level				
		Grass				
		Brickwork				
		Concrete				
1.5		Brown silty fine to medium gravelly CLAY	140kpa		Soil @ 1.4m	Root @ 1.4m
2.0			140kpa		Soil @ 1.9m	Root @ 1.9m
2.5		Brown silty CLAY	140kpa		Soil @ 2.4m	Root @ 2.4m
3.0		TRIAL HOLE TERMINATED	140kpa		Soil @ 2.9m	Root @ 2.9m

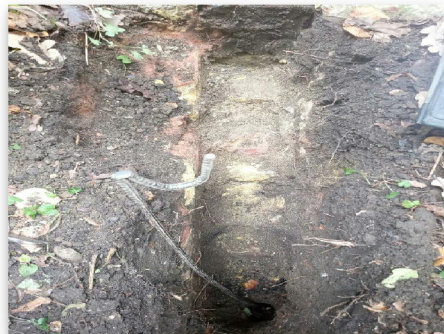
Fig 2.2: Trial Hole 2 Footing

Overview	
Brief	Auger were commissioned by Crawford & Co to undertake a site investigation and CCTV inspection of the underground drainage within the area of concern (AOC) at the property.
Findings	
Trial Hole Findings	<p>We were unable to reach the required depth in TH2 because we encountered impenetrable gravelly clay which our engineer could not auger through.</p> <p>The footing exposed during TH2 was seen to be a brick step on top of sloped concrete.</p>
Visual Inspection	<p>We carried out a water mains listening test whilst on site which revealed that there was no evidence of a leak on the incoming water supply serving the property.</p> <p>The structure/ brick chamber of both manholes (MH1 and MH2) were seen to be damaged, and as such require replacing. Refer to the images below which shows the damage to the chamber/ benching.</p>
Drain Survey	<p>Within the area of concern there were multiple drains, some of which solely belonged to our customer, the neighbour and also some were shared. The drainage has been categorised into three groups (as seen below), we would advise the client refers back the Shared Drainage and the Neighbours Drainage to the LWA and neighbour respectively.</p> <p>Neighbours Drainage</p> <p>Line 1- MH1 upstream to WG1 Our CCTV survey did not reveal any defects which could be allowing an escape of water.</p> <p>Line 2- MH1 upstream to SVP Our CCTV survey revealed a joint displacement. The cast iron section of this run was seen to be furred.</p> <p>Line 3- MH1 upstream to WG2 Our CCTV survey revealed a hole within the pipework. The cast iron section of this run like line 2 was furred in sections.</p> <p>Line 12- MH1 upstream to outside AOC Our CCTV survey did not reveal any defects which could be allowing an escape of water. However similar to the above lines this cast iron run was furred.</p> <p>Shared Drainage</p> <p>Line 4- MH1 downstream to MH2 Our CCTV survey revealed root ingress and a hole in the chamber just prior the trap outlet.</p> <p>Line 8- MH2 downstream to main run Our CCTV survey revealed a hole, root ingress and joint displacements</p> <p>Customers Drainage</p> <p>Line 5- MH2 upstream to WC Our CCTV survey revealed a joint displacement</p> <p>Line 6- MH2 upstream to WG3 Our CCTV survey revealed cracking and joint displacements</p> <p>Line 7- MH2 upstream to Rodding eye Our CCTV survey did not reveal any defects which could be allowing an escape of water, although our survey did reveal the cast iron pipe is furred.</p> <p>Line 9- MH3 upstream to Unknown Our CCTV survey revealed fracturing and mass debris. Due to the debris within the run and also the bend in the pipe we were unable to continue the survey as such this was abandoned. The end destination of the upstream pipe is currently unknown and the only way to actually confirm this is via an excavation.</p> <p>Line 10- MH3 downstream to outside AOC Our CCTV survey revealed root ingress, fracturing and joint displacements.</p> <p>Line 11- MH4 downstream to Line 7 Our CCTV survey did not reveal any defects which could be allowing an escape of water.</p> <p>The above mentioned defects to the below ground drainage system have been caused by ground movement.</p>

Ground Level Soil (Border) Brickwork Concrete				
0.5						
1.0		Brown silty fine to medium gravelly CLAY TRIAL HOLE TERMINATED	140kpa		Soil Sample @ 0.85m	Root Sample @ 0.85m
1.5						
2.0						
2.5						
3.0

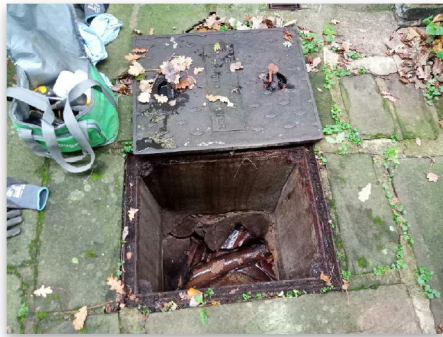
Fig 3.1: Defective manhole

In terms of the shared drains and also the defective manholes, these defects need to be referred to the LWA. These defects could be leading to an escape of water into the surrounding ground. If the Loss Adjuster/Engineer is of the opinion that these defects are an influence in the cause of subsidence to the building structures, we recommend you inform the LWA of the problem and request that they (the LWA) inspect and repair their asset. We cannot undertake any further inspection or repair of LWA assets without the express approval of the LWA.

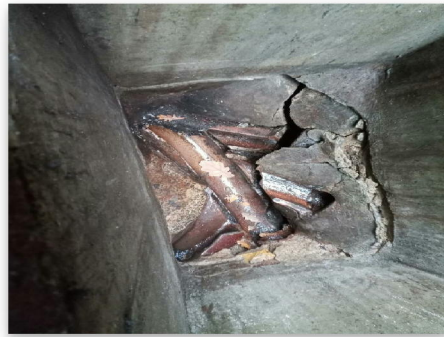
Fig 3.2: Defective manhole channel/ benching

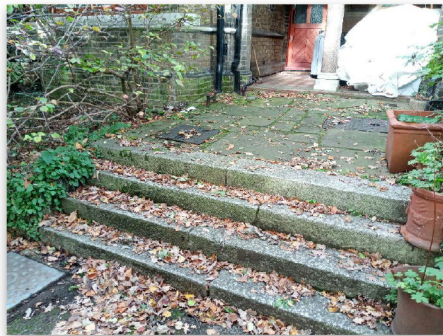
Fig 3.3: Location of manholes (on the raised patio area).
