Arboricultural Appraisal Report

Subsidence Damage Investigation at:

7 Holly Village
London
N6 6QJ

CLIENT:	Crawford & Company
CLIENT REF:	[REDACTED]
MWA REF:	[REDACTED]
MWA CONSULTANT:	Andy Clark
REPORT DATE:	30/06/2023

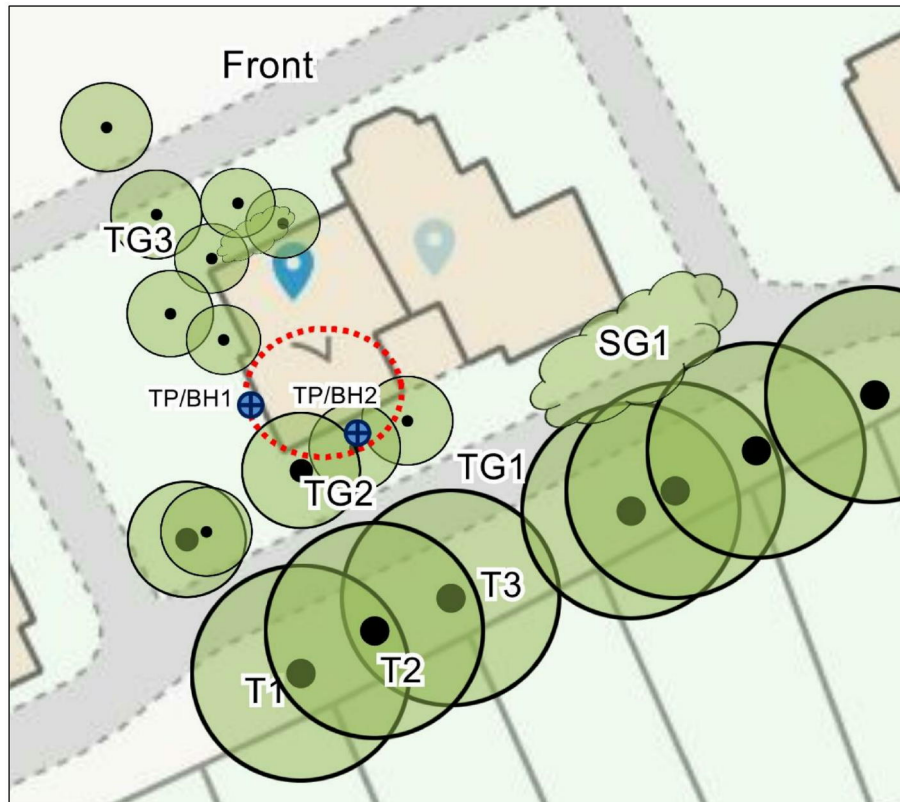
Site Plan

Approximate areas of damage

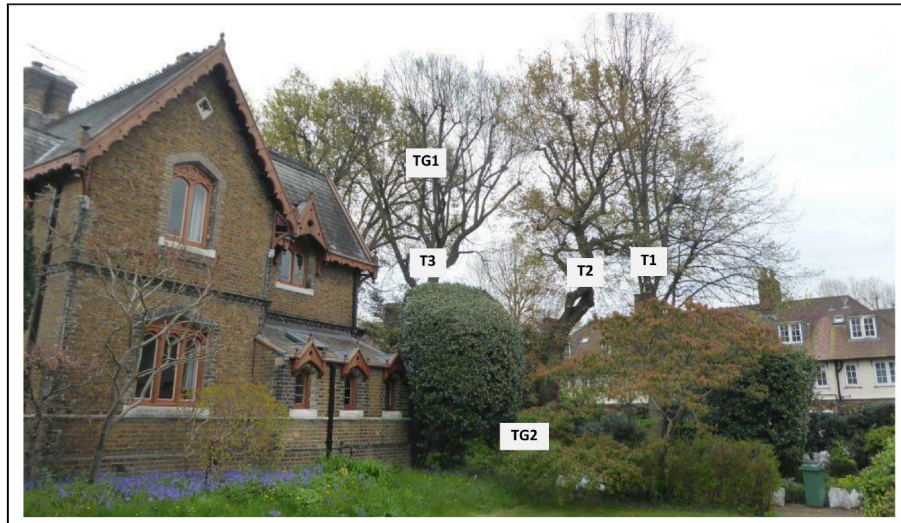
Irrespective of the identification of retrieved root samples, the T1 Lime of TG1 group will also have roots below the property foundations and will be influencing soil moisture and volumes.

View of TG1 group with TG2 to foreground

If an arboricultural solution is to be implemented to mitigate the influence of the implicated trees/vegetation we recommend that the Bay of TG2 group is removed in the first instance, combined with hard pruning of the remaining woody shrubs of TG2 and significant crown reduction of the T1, T2 and T3 stems of TG1 group.

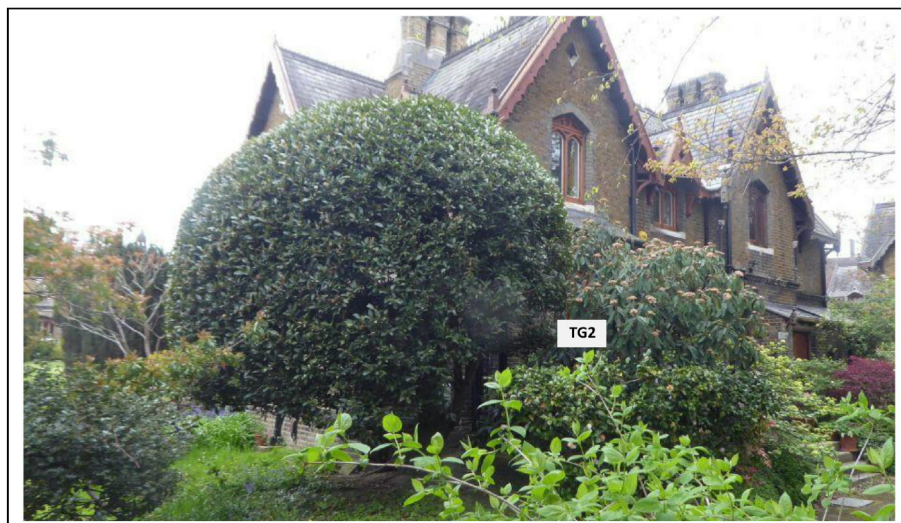
Roots were observed to a depth of 2.9m bgl in TP/BH1 and to 0.85m bgl in TP/BH2, and recovered samples have been positively identified (using anatomical analysis) as either *Laurus* spp., *Camelia* spp. or *Rhododendron* spp., *Quercus* spp. and *Pomoideae* gp.; the origins of which will be the related shrubs of TG2 group [contains Bay, *Rhododendron*, *Camelia* and *Amelanchier* elements] and the Oaks [*Quercus* spp.] of TG1 group, with stems T2 and T3 being the closest. The retrieval of roots from below foundation depth confirms the influence of the related vegetation on the soils below the property foundations.

View of TG2 group

Recommendation		<p>Remove (fell) Bay to near ground level and treat stump to inhibit regrowth. Hard prune remainder back to individual elements no larger than 1.0m high by 1.0m spread. Re-prune thereafter on an annual cycle to maintain at broadly reduced dimensions.</p>

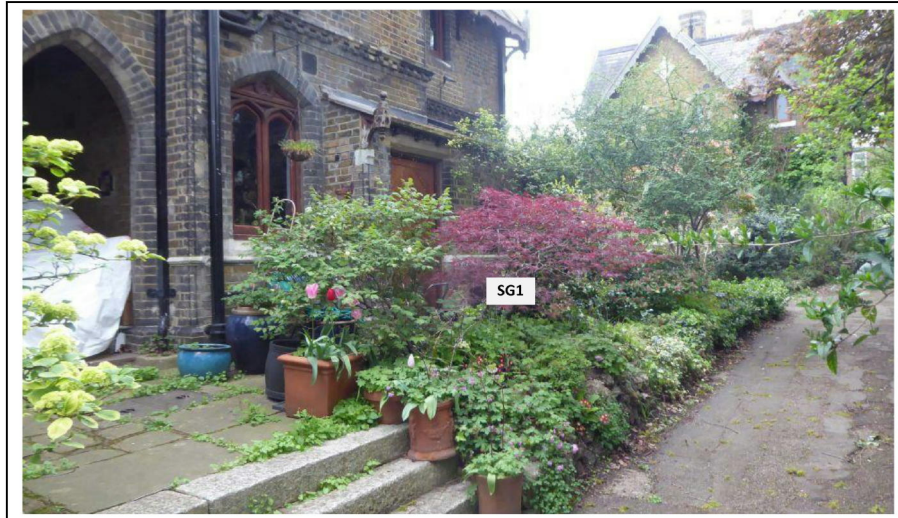
View of SG1 group

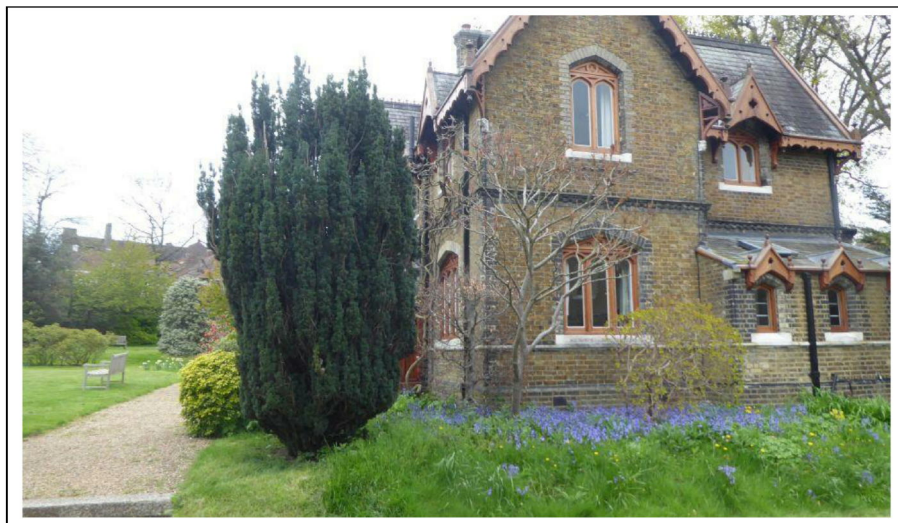
Tree No.	Species	Ht (m)	Dia (mm)	Crown Spread (m)	Dist. to building (m)	Age Classification	Ownership
TG3	Mixed spp. group of mostly Yew, Amelanchier, Choisya, Beech, Lonicera, Sumac and Wisteria	5.0	110 Ms	4.5	0.3	Younger than Property	Policy Holder
Management history		Subject to past management/pruning - appears regularly pruned.					
Recommendation		Maintain broadly at no more than current dimensions by periodic pruning.					
SG1	Mixed spp. group of mostly Japanese Maple, Camelia and Cotoneaster	3.5	40 Ms *	4.0	4.0	Younger than Property	Third Party 8 Holly Village N6 6QJ
Management history		No significant recent management noted.					
Recommendation		Maintain broadly at no more than current dimensions by periodic pruning.

View of TG3 group
