## SITE INVESTIGATION FACTUAL REPORT

Report No: [REDACTED]  
Client: Sedgwick International UK - Maidstone  
Site: 69 Canfield Gardens  
Camden  
Client Ref: [REDACTED]  
Date of Visit: 28/02/2023

Site: 69 Canfield Gardens, NW6

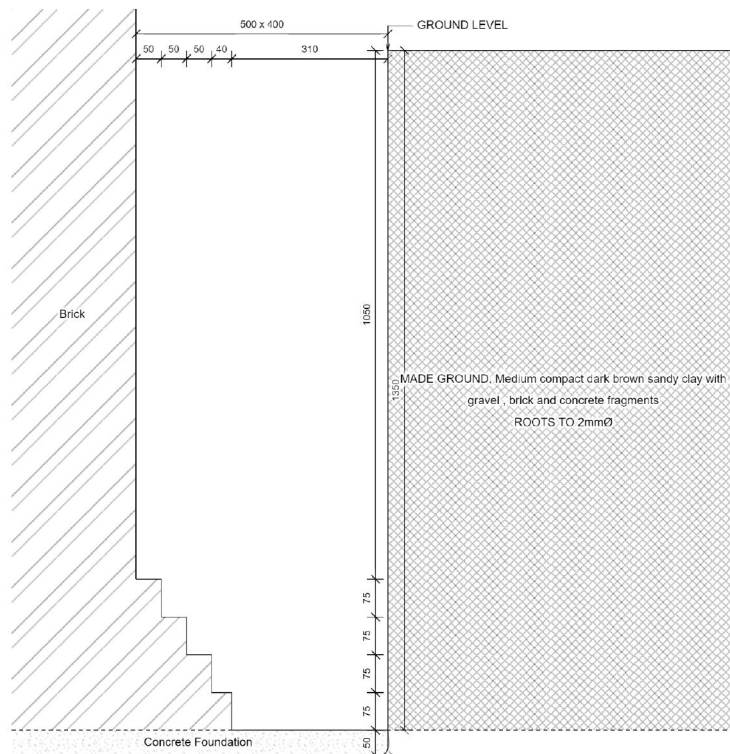
TRIAL PIT REF: TP1

Trial pit abandoned at 1350mm

TP Abandoned at 1350mm, due to depth unable to find edge of projection. U/S of foundation not found, no soil sample taken.

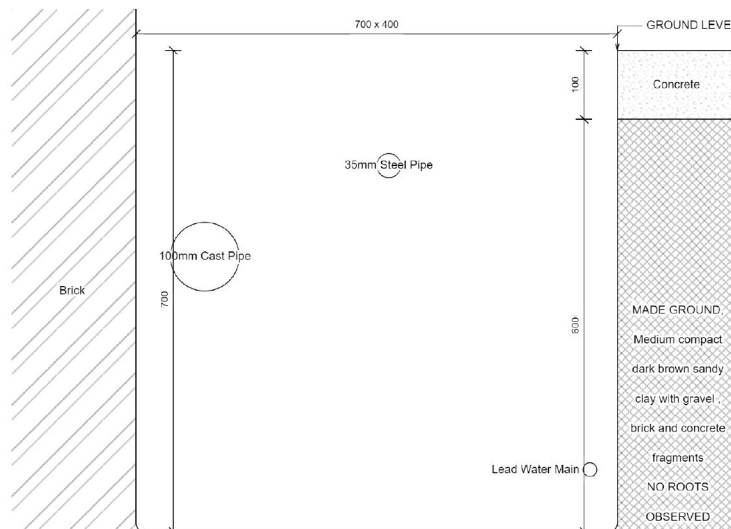
TRIAL PIT REF: TP2

Trial pit abandoned at 700mm

U/S of Foundation not found, no soil sample taken. Abandoned due to services and concrete obstruction. Unable to carry out BH
