Observations

Flat 3, 56 Lisburne Road, London, NW3 2NR
Photograph Schedule

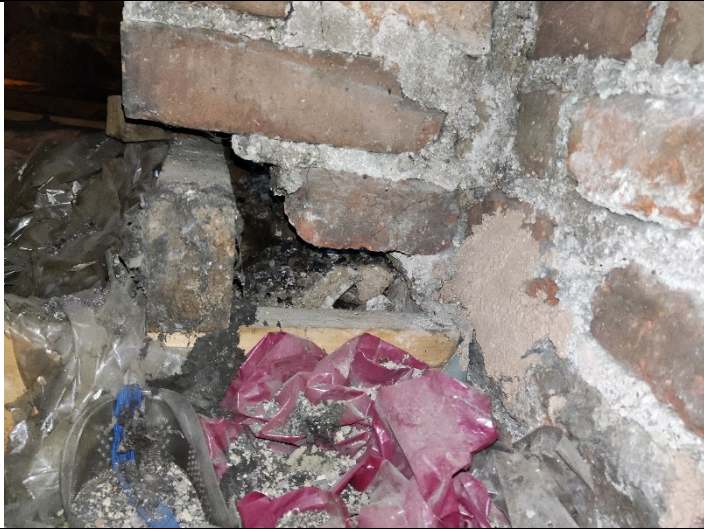
Internally, the chimney is visible within the loft accessed through Flat 3 where it is formed in brickwork built into the party wall. Historically, the chimney breast has been removed at ceiling level where part of the stack is now supported partially on a section of timber run between the ceiling joists. This is not considered a suitable method of support and would likely explain the leaning of the stack seen externally.

1. Unsupported Chimney

1. As the chimney is no longer in use the external stack could be removed in its entirety. The roof and parapet will require making good once the chimney is removed. Note-planning may be required.
2. Repairs should be undertaken to the roof to avoid deterioration.
3. In its current state the chimney is considered dangerous and the flat below should be decanted for works to be undertaken.

No.	Location	Defect / Issue	Comment / Causation	Work required	Budget Cost (£)
Option					
1.01	Chimney	The rear chimney is unsupported.	Removal of chimney it its entirety	Demolish chimney stack complete including within loftspace, make good brickwork, extend roof covering to match existing, remove waste and debris. Planning may be required.

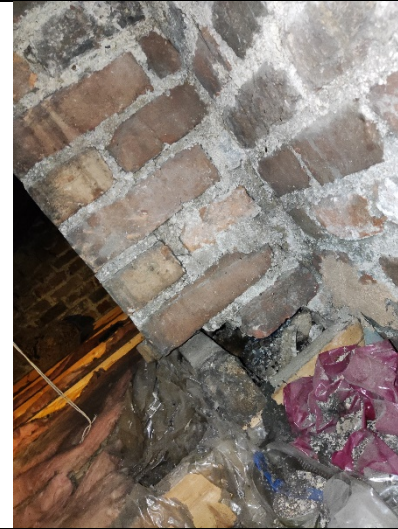
2. Unsupported Chimney

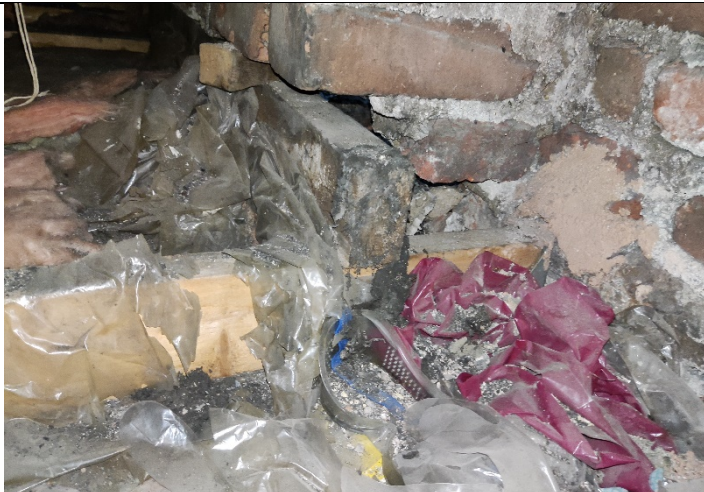
3. Unsupported Chimney

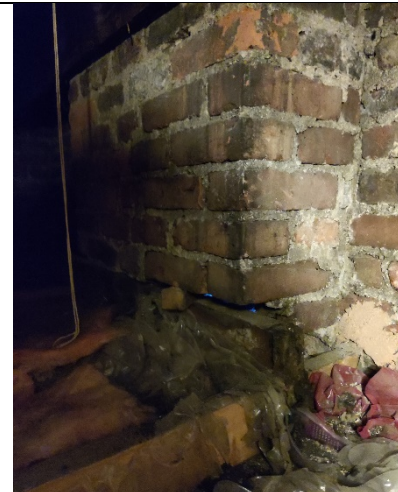
4. Unsupported Chimney

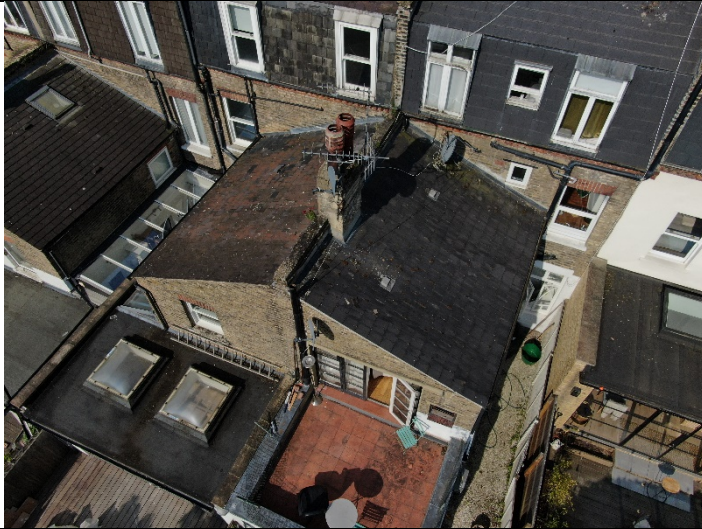
The chimney is relatively tall and thin. The chimney is generally deteriorating with cracking seen to the rendered surfaces and a section spalling to the rear side of the chimney exposing the brickwork, there is also a growth of moss to the flaunching.

5. External View of Chimney

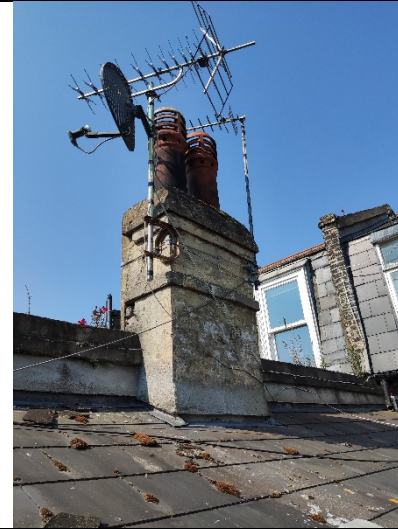
6. External View of Chimney

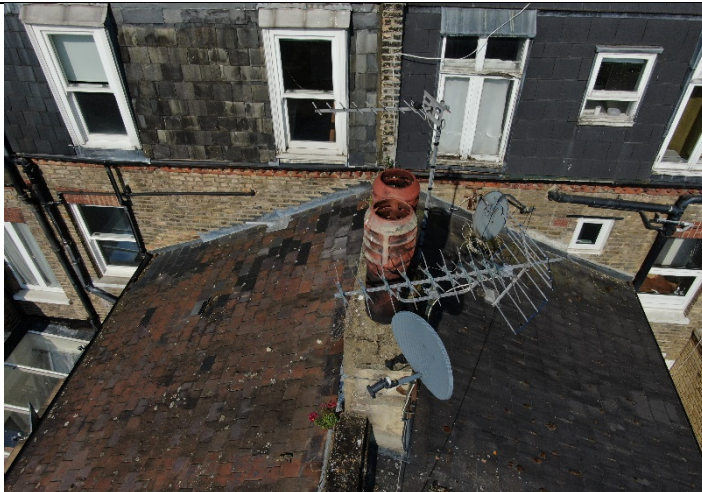
7. External View of Chimney

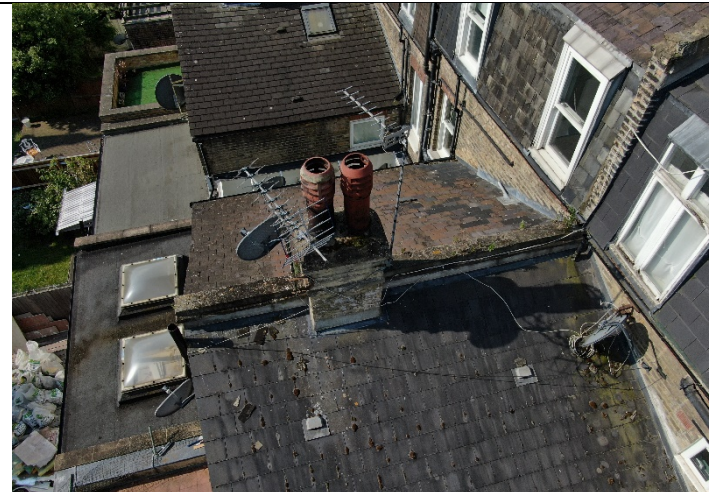
8. External View of Chimney
