1.1 BUILDING AND USE: THE BRITISH MUSEUM

The British Museum are proposing to carry out urgent repair, conservation and maintenance works to nine external staircases at the West and East Residences. All of the staircases are in view of the public from within the entrance court to the Museum.

Eight of the nine staircases (Stairs 01, 02, 04, 05, 06, 07, 08, 09) have been referred to in a recent Listed Building Application 2023/0680/L. This report has been written in relation to staircase 3 only.

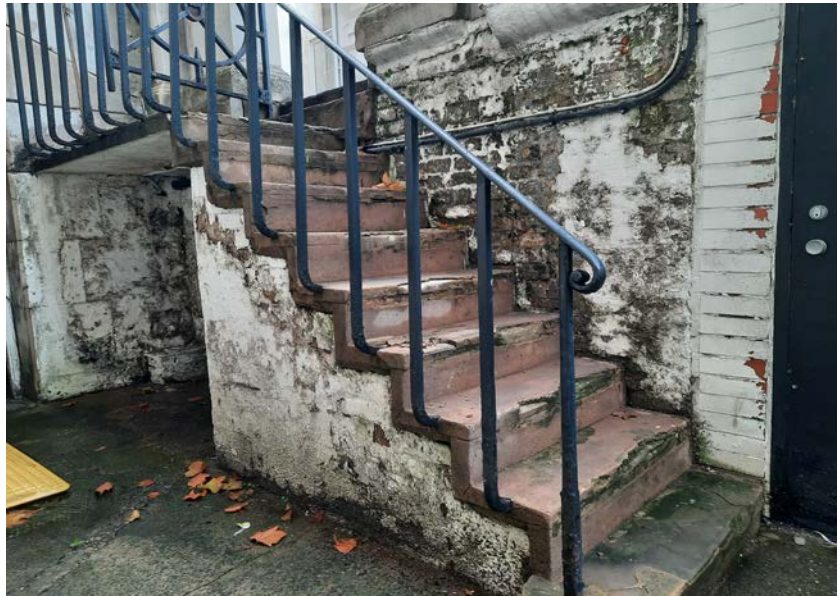
The wrought iron handrail is becoming detached from the stone landing and treads and the feet of several of the railings are proud of the surface and severely corroded, leaving it unsafe. There are also concerns about the safety of the cantilevered stone landing which has degraded, cracked and is in poor condition. Conservation repair work is being planned for this stair in order to conserve and retain as much of the original stone material as possible.

Stair 03: Original stone stair faced with failing cementitious render, very thin original cantilevered landing

It is proposed that the existing York stone treads and landings are kept, with new York stone veneers tiled to the top and bedded on a lime mortar base. In order to regularise the different risk heights. The stone tile thicknesses will vary between 30mm and 40mm. The treads will be completed in a single unit while the landing, due to its size, will be tied in 4 rows.

Additional support will be provided to the landing stone by three precast concrete lintels supported on brick piers built up under the landing slab either side of the existing doorway. Alan Baxter Associates have provided proposals to the structural integrity of the stair, attached to this report.

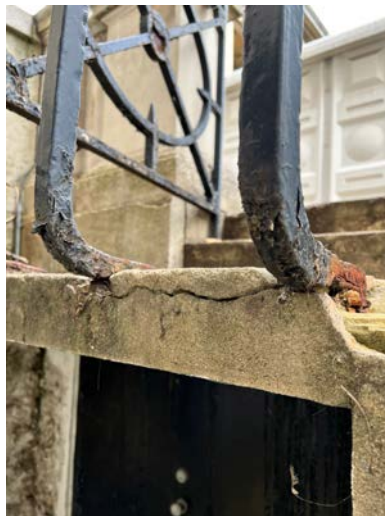
Stair 03: Railing uprights corroded and standing proud of landing slab surface (Left); Failing topping to landing slab and corroding handrail bases (Top). Failing topping to stair treads and corroding railings (Below).

The wrought iron handrail will be carefully removed and caulking drilled out carefully in order to minimise damage to both the balustrade and stone pockets into which it is set. The balustrade will be taken away as a single unit, cleaned and repaired. The swan neck bases to the balustrade will be repaired or replaced with new sections to the same profile. The end of each balustrade will be extended with new rods between 10mm and 15mm to ensure its bedding into the original stones will be the same as the original and allow for the losses of stone surface. The original pockets in the stone landing and treads will be deepened to accommodate the handrail, which once treated with a rust inhibitor and decorated, will be resin fixed back into place.
