Arboricultural Consultant: Kim Gifford

Tree Survey Grays Inn Gardens 2023.

1.1 Inspection date: 3rd, 4th, 5th April 2023 by Mr. Kim Gifford, undertaken in the area of test and at the time of inspection.

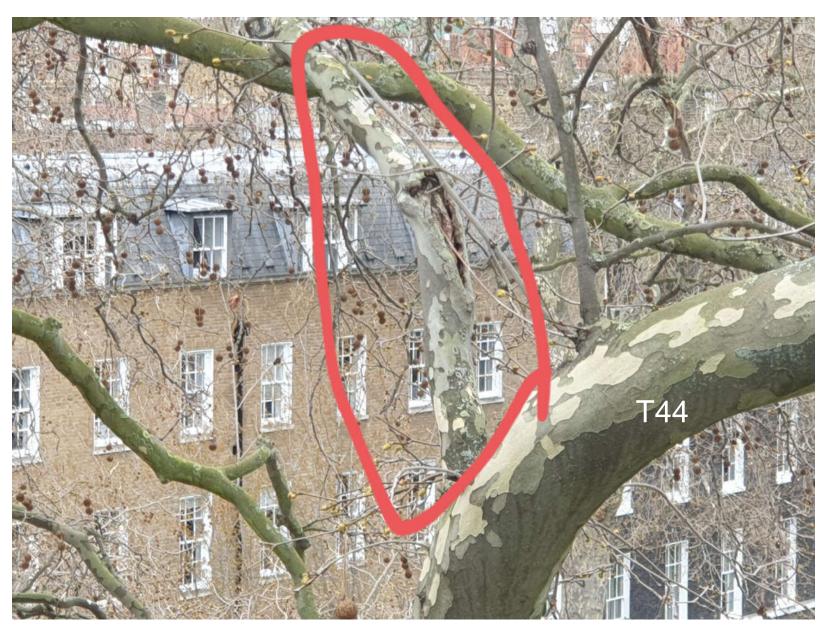
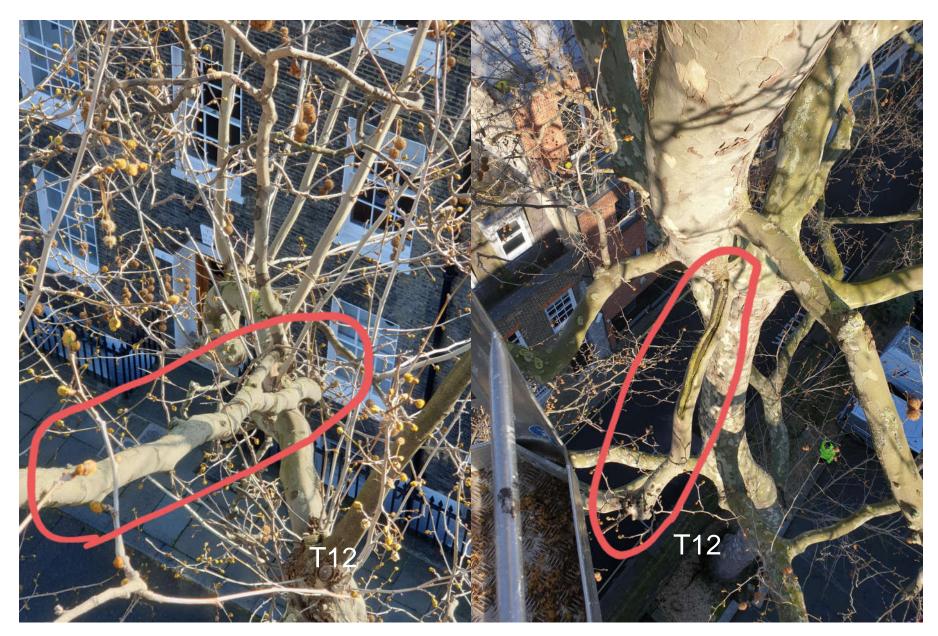
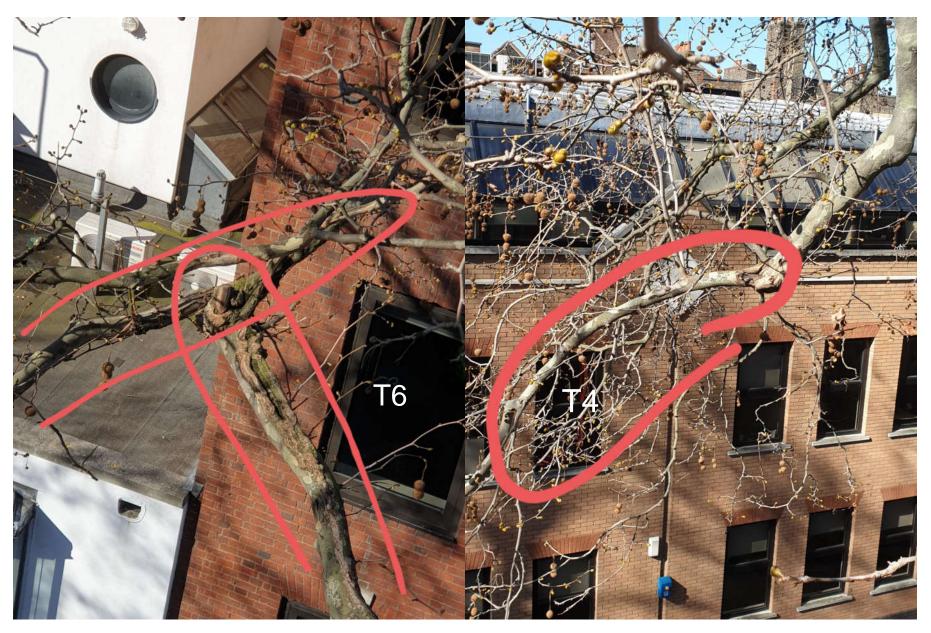
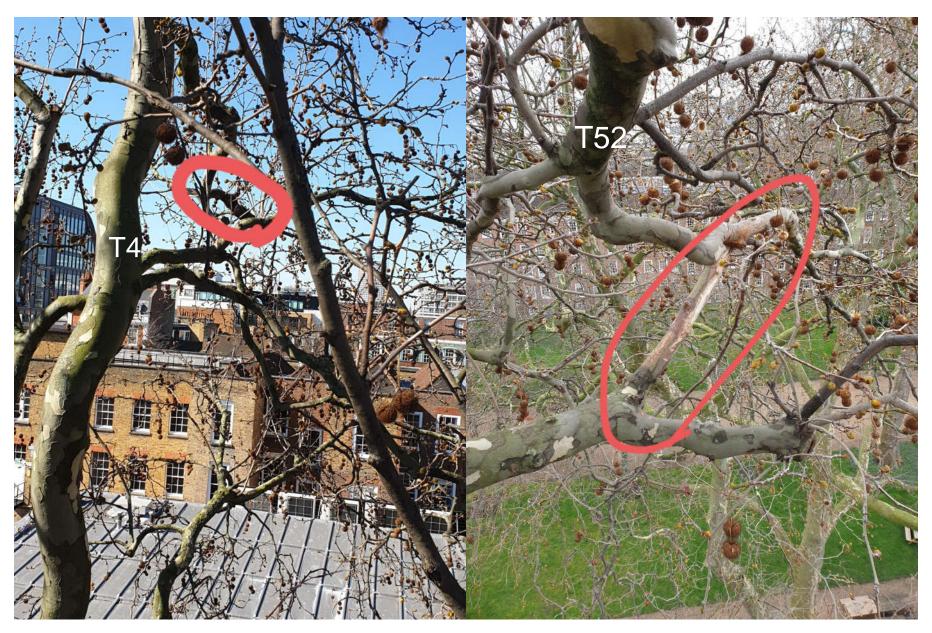
Field Court Pollards: Cavities and Decay

The survey also identified an historic issue with the pollarded London Plane trees in Field Court. Most of these 8no specimen are in a decaying condition, with hazardous decayed pollard points, and cavities throughout: see photographs on pages 38/39. It is now appropriate to recommend that a major replanting project is initiated. To include the staged removal and replanting, with semi mature Acer campestre (Field Maples) subsequent to Local Authority consent and structural engineer consultations.

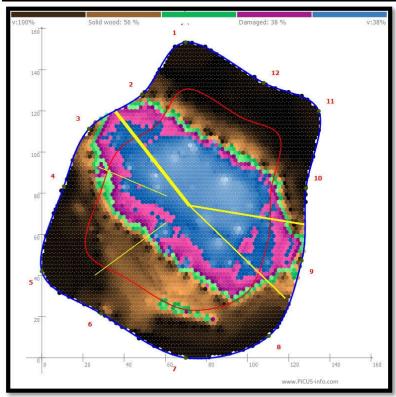
Figure 2 P1

1.6 Test T55 London Plane @ level: 40cms ground level approximately from ground level. Test point 1 at north orientation.

<u>Picus Analysis: Low readings decayed central column. Conclusion: Specimen recently major reduction. Recommendation: Continue to monitor.</u>

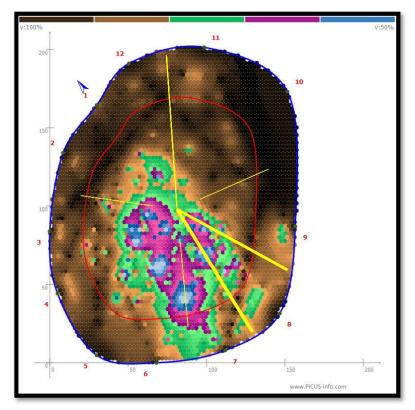
Figure 3 P2

Test T58 London Plane @ level: 40cms ground level approximately from ground level. Test point 1 at north orientation.

<u>Picus Analysis: Low readings decayed central column. Conclusion: Specimen recently major reduction further remedial treatment recommended in the survey. Recommendation: Continue to monitor.</u>

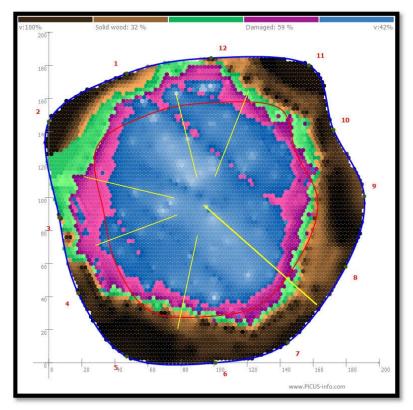
Figure 4 P3

Test T59 London Plane @ level: 100cms ground level approximately from ground level. Test point 1 at north orientation.

<u>Picus Analysis: Low readings decayed central column. Conclusion: Specimen recently major reduction further remedial treatment recommended in the survey. Recommendation: Continue to monitor.</u>

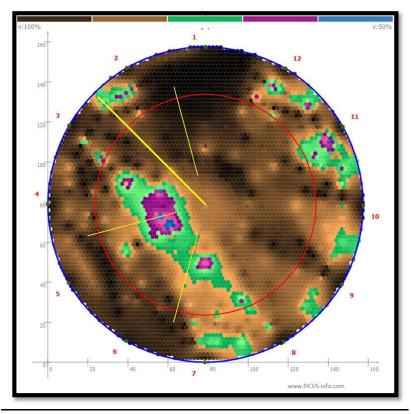
Figure 5 P4

Test T91 London Plane @ level: 40cms ground level approximately from ground level. Test point 1 at north orientation.

<u>Picus Analysis: high readings indicating sound timber. Conclusion: Specimen has remedial treatment recommended in the survey.</u>
<u>Recommendation: Continue to monitor.</u>

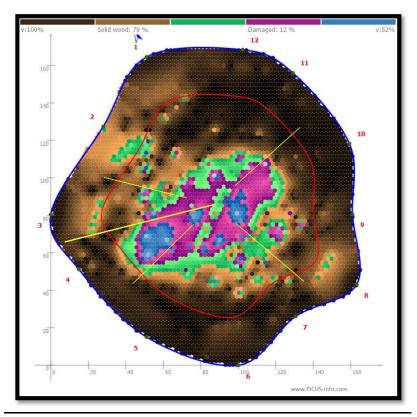
Figure 6 P5

Test T119 London Plane @ level: 60cms ground level approximately from ground level. Test point 1 at north orientation.

<u>Picus Analysis: Low readings decayed central column. Conclusion: Specimen has recently major reduction further remedial treatment recommended in the survey. Recommendation: Continue to monitor.</u>

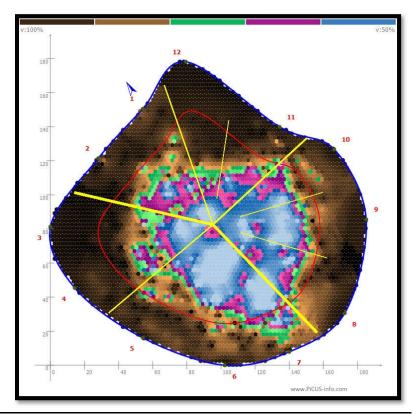
Figure 7 P6

Test T125 London Plane @ level: 40cms ground level approximately from ground level. Test point 1 at north orientation.

<u>Picus Analysis: Low readings decayed central column. Conclusion: Specimen has recently major reduction further remedial treatment recommended in the survey. Recommendation: Continue to monitor.</u>

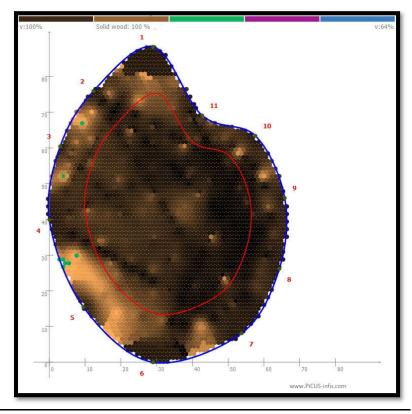
Figure 8 P7

Test T20 Red Oak @ level: 40cms ground level approximately from ground level. Test point 1 at north orientation.

<u>Picus Analysis: high readings indicating sound timber. Conclusion: Specimen requires further remedial treatment recommended in the survey. Recommendation: Continue to monitor fungal bracket at base.</u>
