WORKS TO EXISTING ROOF - MAIN HOUSE

Project : 28 Albert Street

Drawing No. 22019_Schedule Of Works

Drawing Title: Schedule Of Works

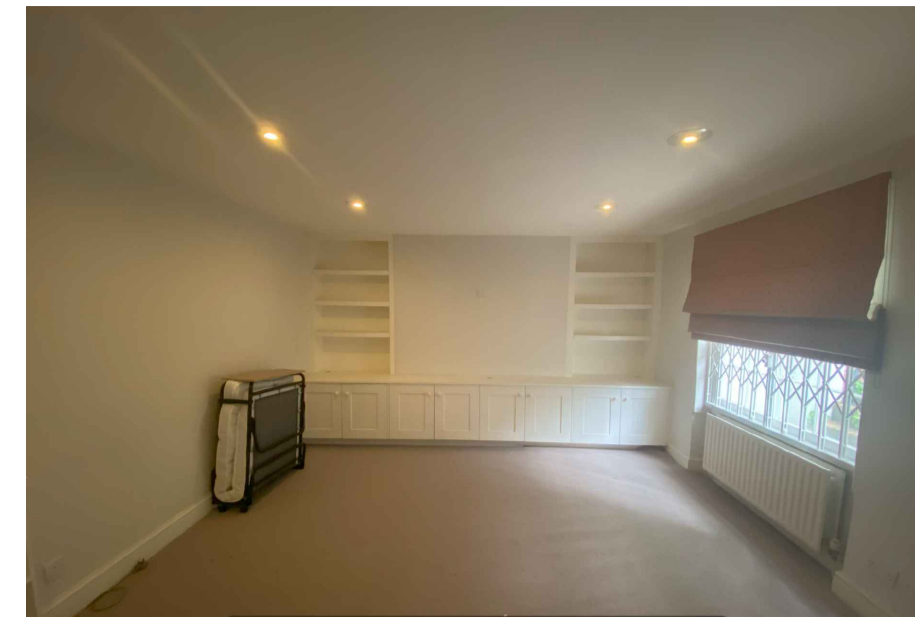
Water damage along the front wall of the house and bowing in the central portion of the existing plasterboard ceiling in the lower ground front room required this plasterboard ceiling to be removed and replaced with a new suspended plasterboard ceiling which will have a 3mm skim coat with a painted emulsion finish. No existing cornices present on this level of the house.

1 Lower Ground Front Room - Ceiling To Be Replaced
image SCALE 1: na

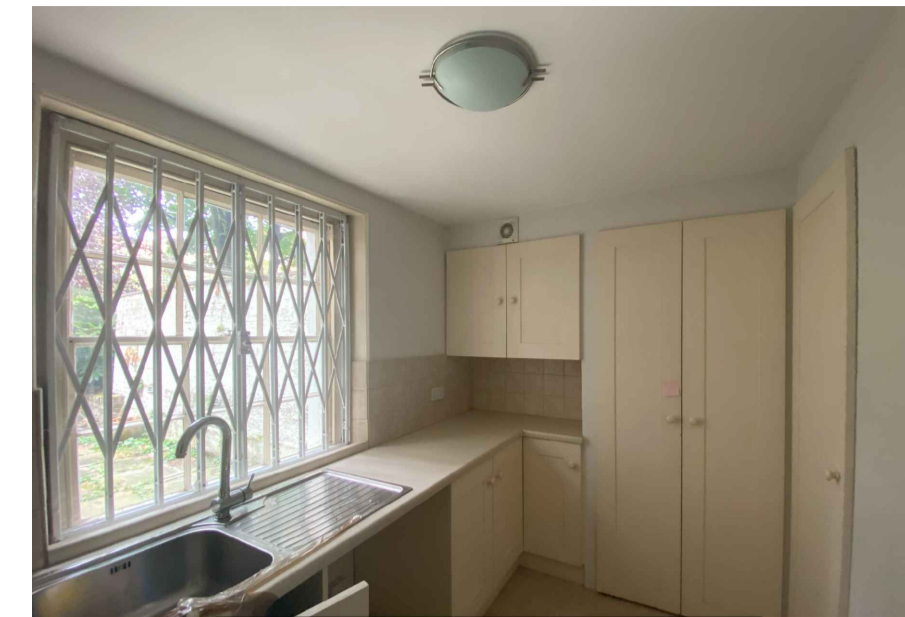
Non original modern utility storage units and stainless steel sink to be stripped out of Lower Ground Floor Utility room. Flooring to be removed to expose original timber floors which will require sanding, cleaning and re stained. Existing lighting fixture to be removed.

2 Lower Ground Utility - Joinery To Be Stripped
image SCALE 1: na

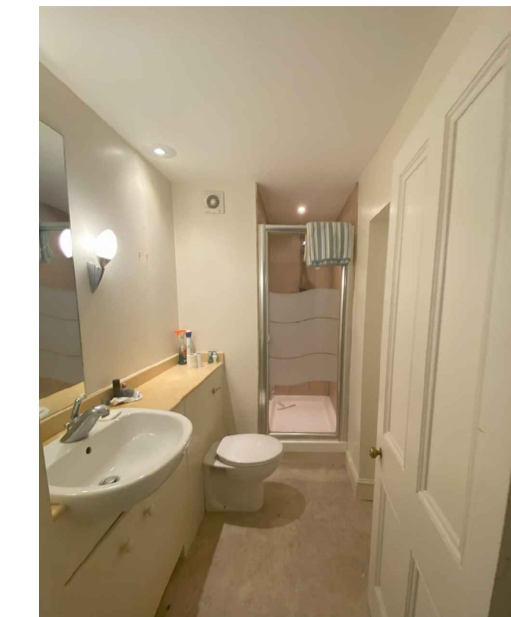
All non original fittings, fixtures and finishes to be stripped out of existing lower ground floor bathroom.

3 Lower Ground Bathroom
image SCALE 1: na

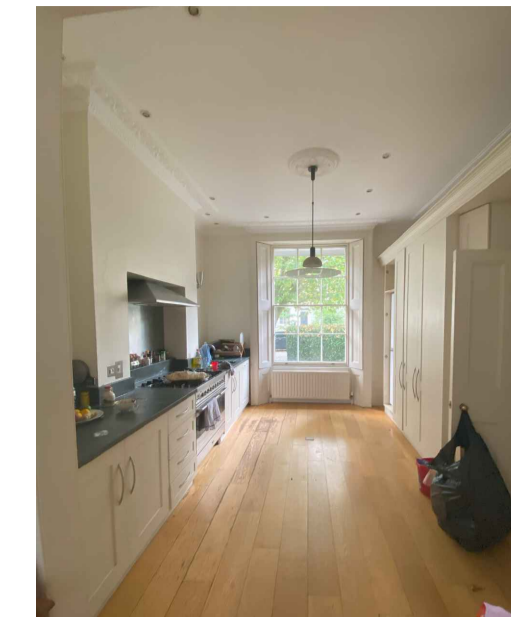
Existing low level kitchen units to be stripped out and replaced. Proposed new joinery to finish below cornices. Refer to kitchen joinery drawings. Existing ceiling cornices, floors, skirting to be retained.

4 Kitchen - Left Kitchen Run To Be Stripped
image SCALE 1: na

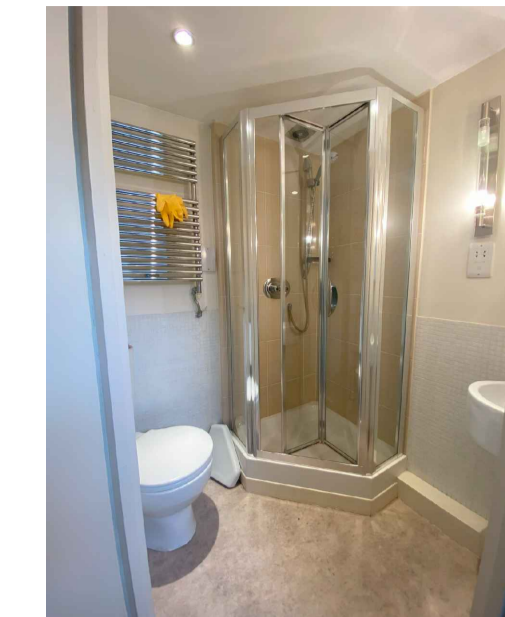
Existing wc fittings, fixtures and finishes to be stripped out. Bathroom to receive new tiled floors and replacement sanitaryware.

5 Landing WC - Finishes & Fittings To Be Stripped
image SCALE 1: na

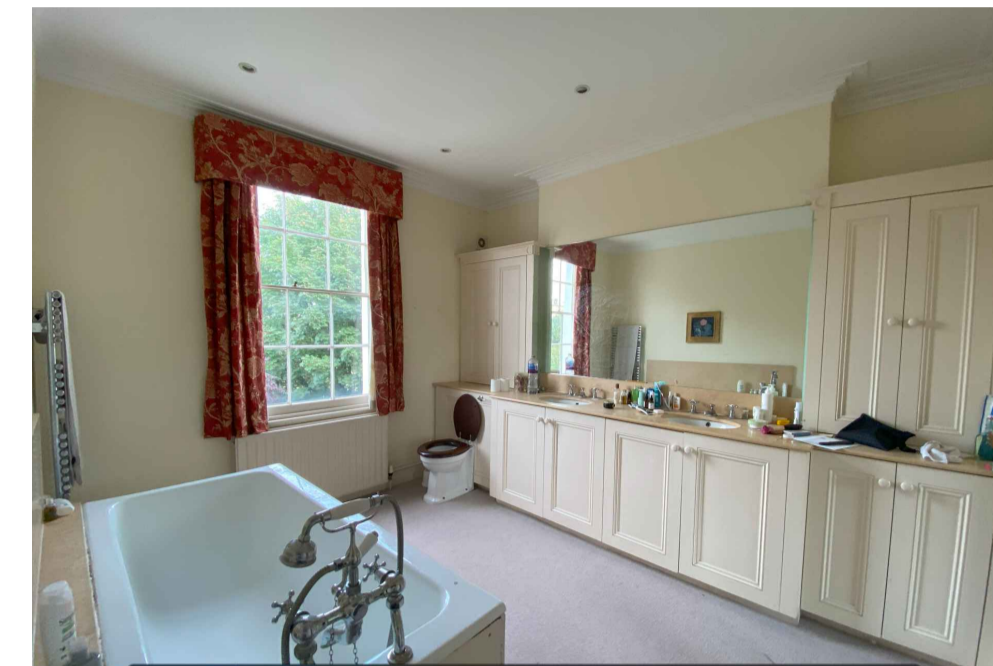
7 Master Bedroom Ensuite - Furniture, Fixtures, Finishes To Be Stripped
image SCALE 1: na

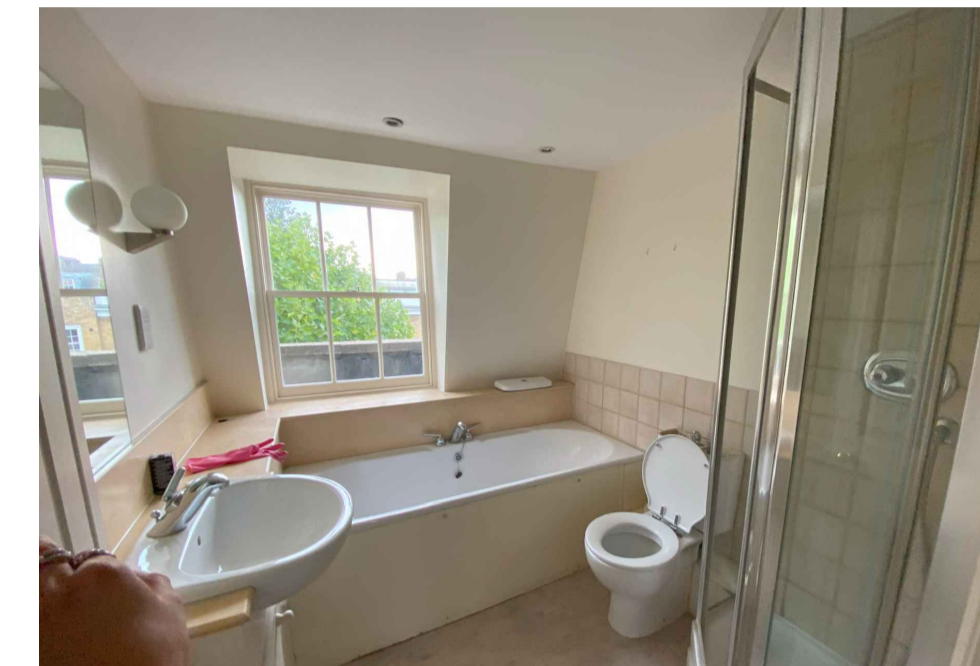
8 Third Floor Bathroom - Fittings, Finishes, Fixtures To Be Stripped
image SCALE 1: na

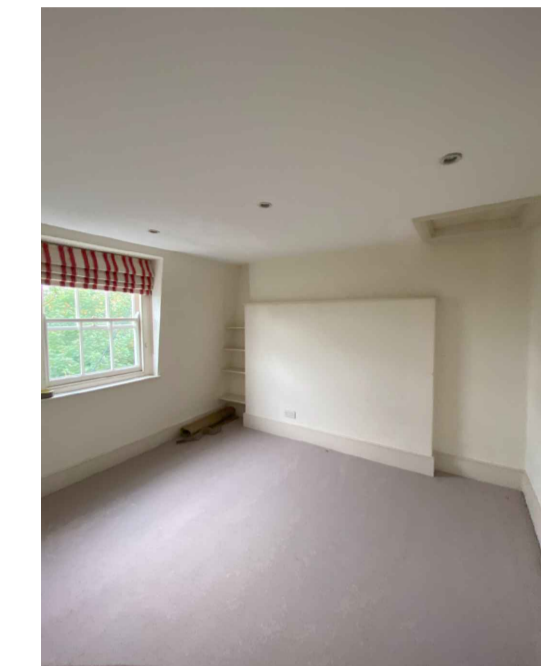
9 Third Floor Rear Bedroom - Damage To Ceiling
image SCALE 1: na
