Project : 28 Albert Street

Drawing No. 22019\_Schedule Of Works

Drawing Title: Schedule Of Works

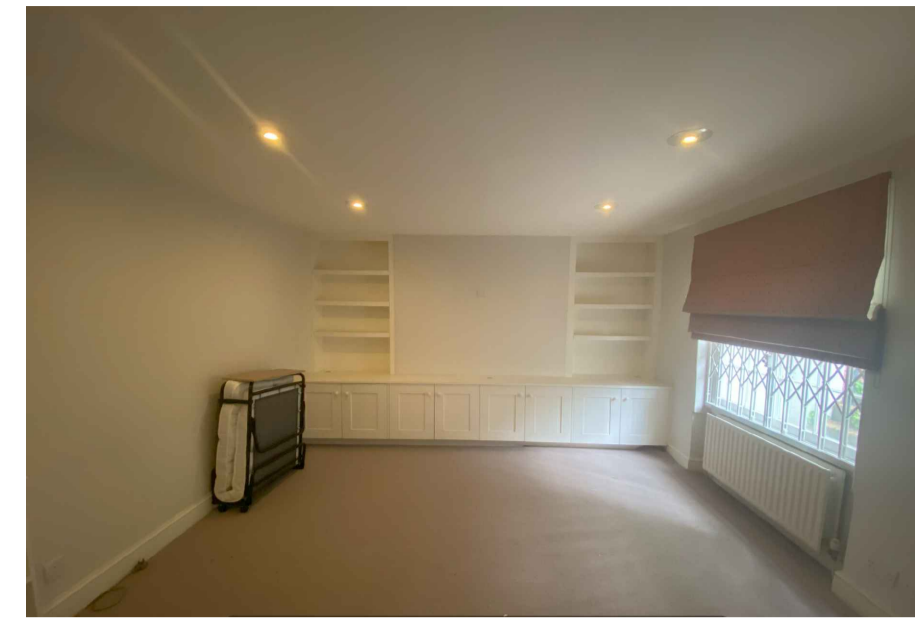
1 Lower Ground Front Room - Ceiling To Be Replaced  
image SCALE 1: na

Water damage along the front wall of the house and bowing in the central portion of the existing plasterboard ceiling in the lower ground front room required this plasterboard ceiling to be removed and replaced with a new suspended plasterboard ceiling which will have a 3mm skim coat with a painted emulsion finish. No existing cornices present on this level of the house.

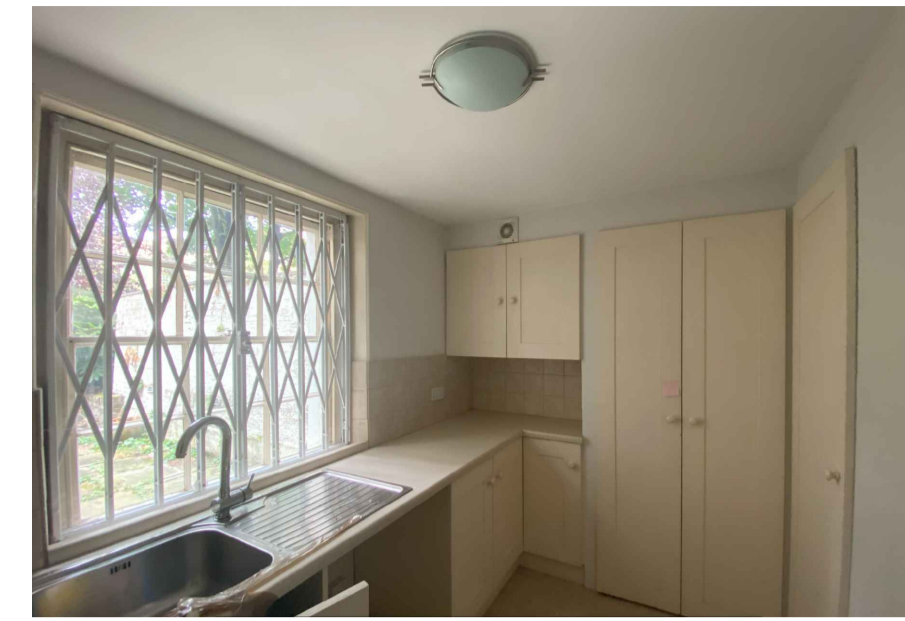
2 Lower Ground Utility - Joinery To Be Stripped  
image SCALE 1: na

Non original modern utility storage units and stainless steel sink to be stripped out of Lower Ground Floor Utility room. Flooring to be removed to expose original timber floors which will require sanding, cleaning and re stained. Existing lighting fixture to be removed.

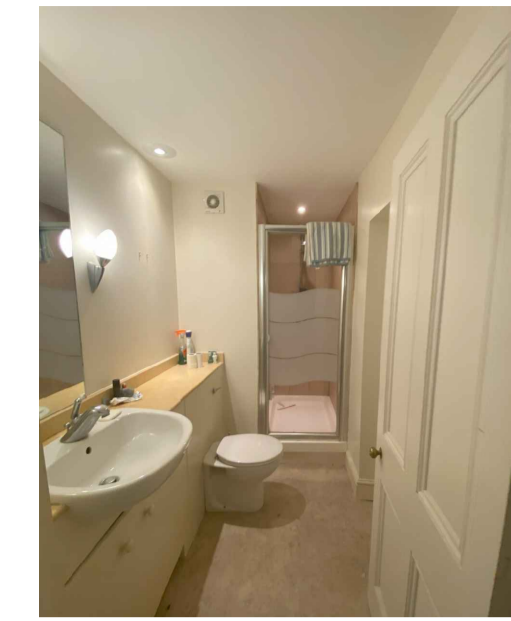
3 Lower Ground Bathroom  
image SCALE 1: na

All non original fittings, fixtures and finishes to be stripped out of existing lower ground floor bathroom.

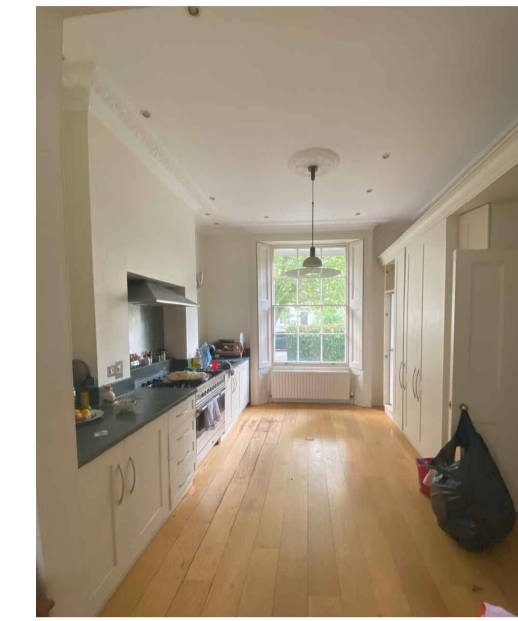
4 Kitchen - Left Kitchen Run To Be Stripped  
image SCALE 1: na

Existing low level kitchen units to be stripped out and replaced. Proposed new joinery to finish below cornices. Refer to kitchen joinery drawings. Existing ceiling cornices, floors, skirting to be retained.

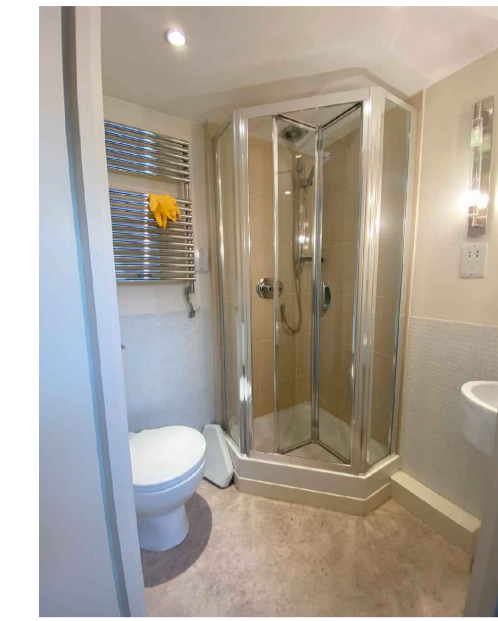
5 Landing WC - Finishes & Fittings To Be Stripped  
image SCALE 1: na

Existing wc fittings, fixtures and finishes to be stripped out. Bathroom to receive new tiled floors and replacement sanitaryware.

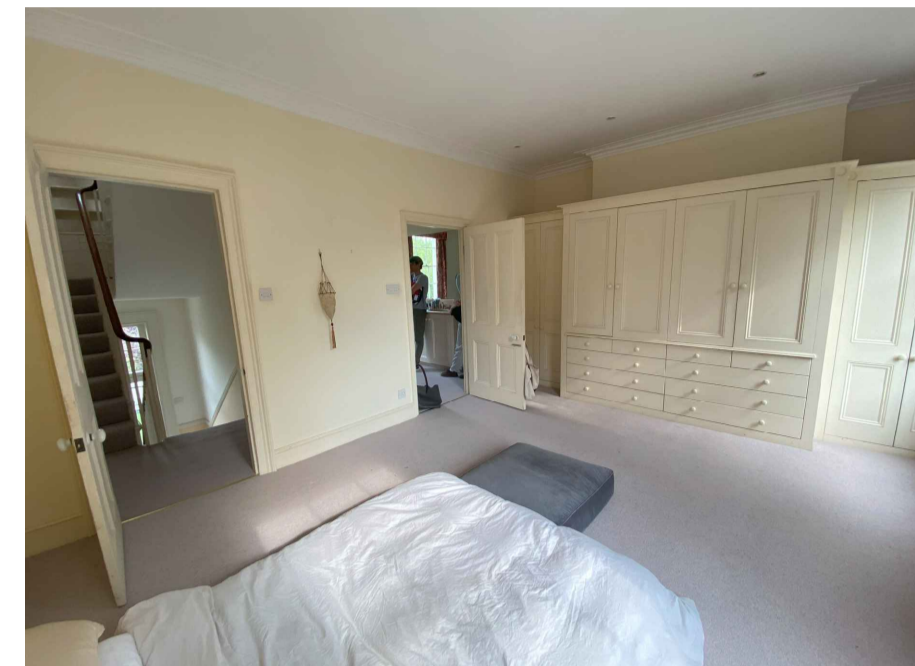
6 Master Bedroom - Joinery To Be Stripped  
image SCALE 1: na

Existing non original wardrobes to be carefully removed in Master bedroom. Original fireplace to be re installed. Specialist chimneysweep required to survey existing chimney flues and comment on remedial works.

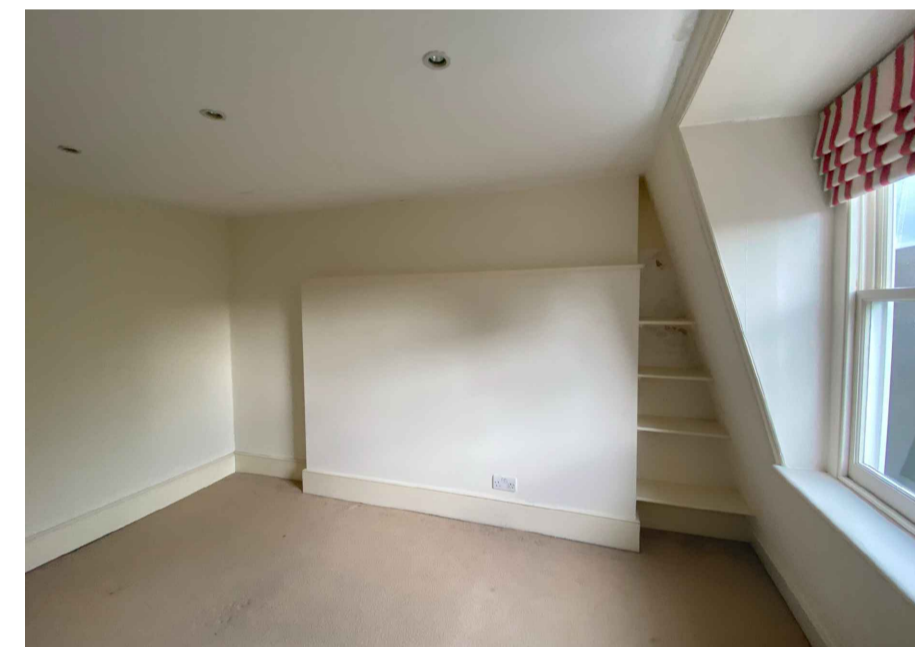
10 Third Floor Front Bedroom - Downlights To Be Removed  
image SCALE 1: na

Modern recess downlights were added to the building at some point in its recent history. In the primary room and main bedroom it is proposed to remove these fittings and make good cut outs.

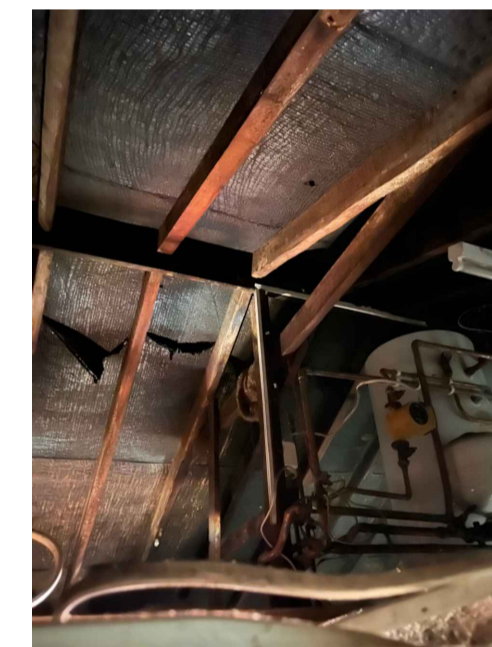
1 Damaged Bitumen Membrane To Roof  
image SCALE 1: na

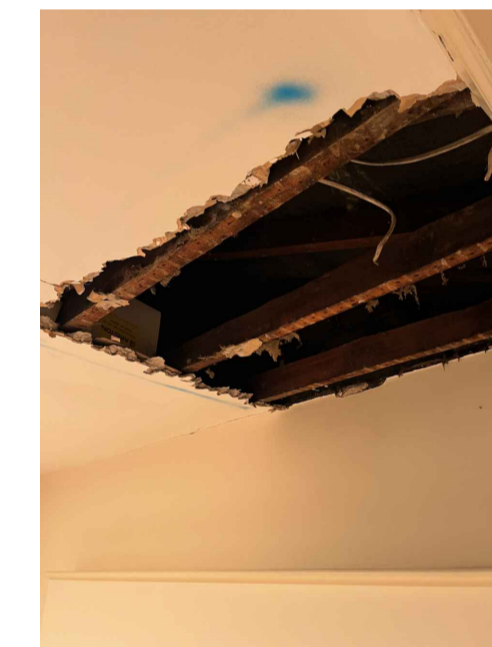
2 Damaged Plasterboard Ceiling In Loft  
image SCALE 1: na

The existing attic ceilings have been partially removed due to water ingress damage. These were constructed using plasterboard which was fixed directly to the ceiling structure. It is proposed to replace these ceilings new plasterboard ceiling and finished with a 3mm plaster skim coat.

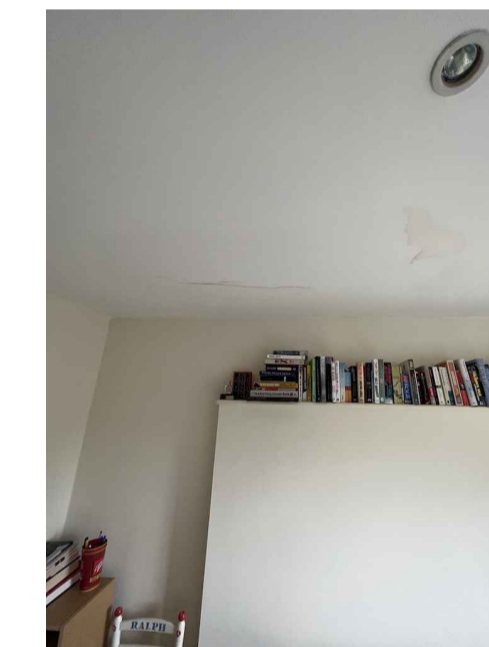
3 Water Damage To Ceiling In Loft  
image SCALE 1: na

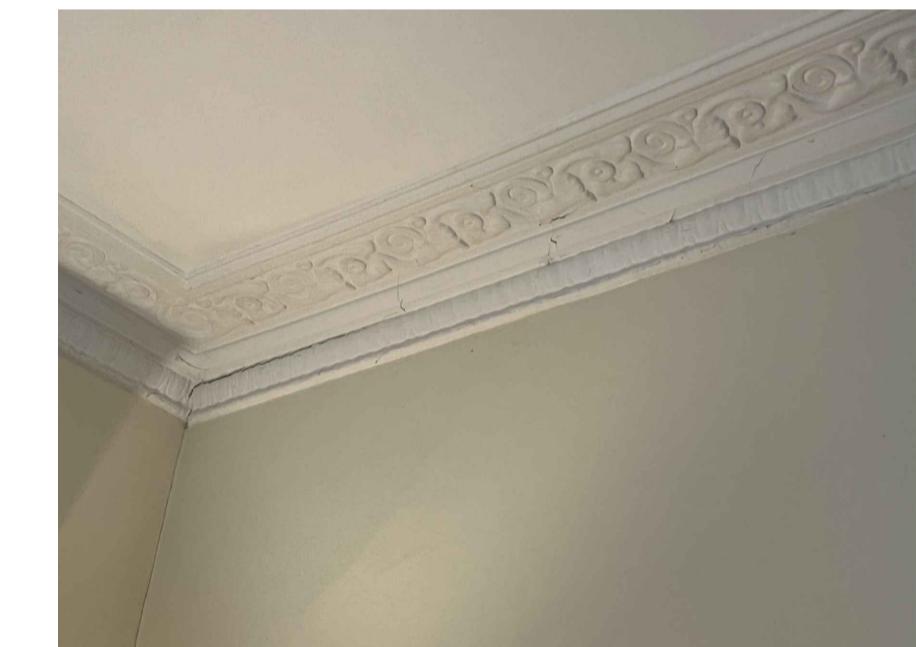
4 Existing Damages Cornicing  
image SCALE 1: na

All existing cornices to be retained. Areas where cornices have been affected by multiple layers of paint, then these should be treated by steaming the affected areas and removing the paint. Chemical solutions should be avoided. Where necessary the use of 'Peel Away' remover may be required. The cornices should be then cleaned thoroughly, all paint debris and flakes removed before the re application of any paint.
