No 2 Bedford Square Works to Railings

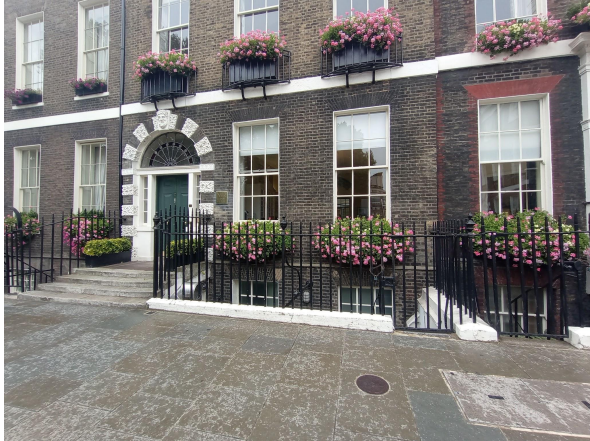
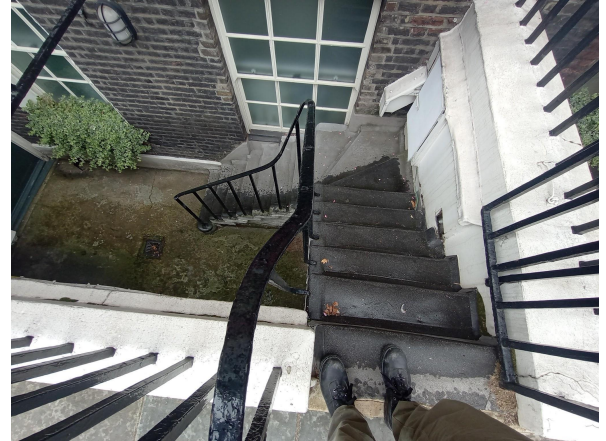
General overview of the railings at No 2 Bedford Square. The railings provide guarding to the front lightwell area. There are also railings and balustradings guarding the outer edge of the winder steps leading to the basement of the building.

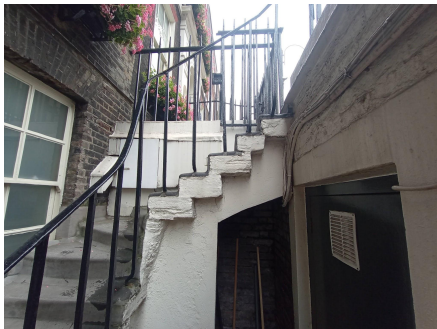
The balusters which require replacing/repairing are located on these steps, as highlighted.

There are two railings which have decayed where they meet the steps. The intention is to remove the lead fill to the socket into the steps and remove the damaged section of the iron balustrading.

A new section of balustrading would be welded to the existing baluster, although depending on the quality of the iron, this may not be possible. If it is not possible then new wrought iron balusters will be manufactured and installed. The lead surround would then be reinstalled.

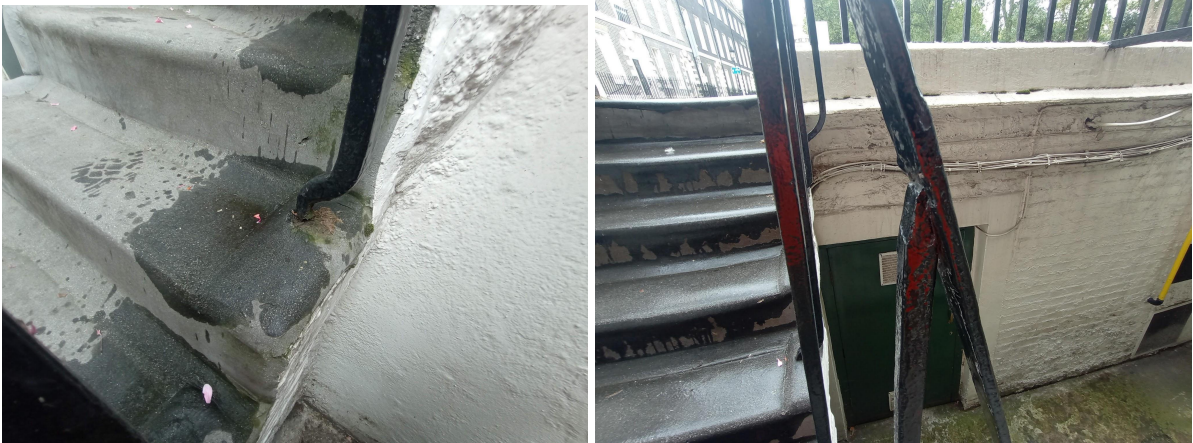
Baluster 1

The bottom of the baluster has rusted through and is drawn so the bottom is offset from the main baluster. The top of the baluster is chamfered and appears to be riveted to the handrail. The baluster is a simple square section.

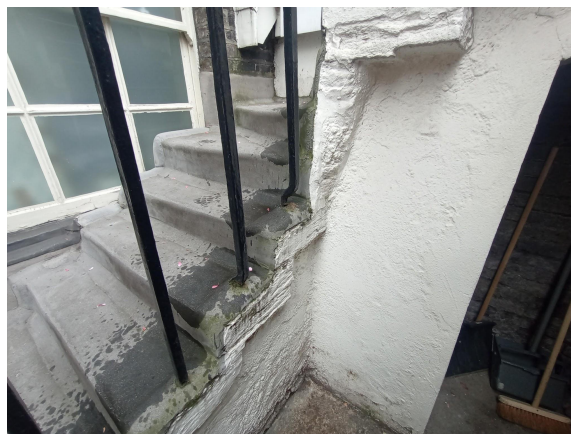
Baluster 2

The bottom of the baluster has partly rusted through and once the paint has been fully removed, it is likely that the damage will be more extensive than first appears. Therefore we have allowed to repair/replace this baluster as well. The baluster is a straight square section. It is unclear how the baluster fits to the railing, although likely to be riveted in place.
