**96 HEATH STREET**

**STATEMENT IN SUPPORT OF LISTED BUILDING APPLICATION FOR  
MINOR WORKS AND REPAIRS TO THE FRONT OF PROPERTY**

*Rev. B\_05.10.23*

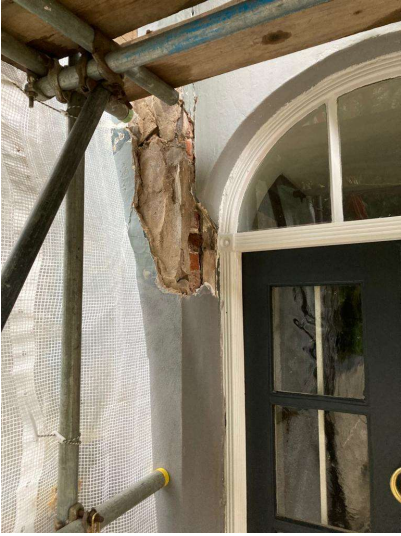
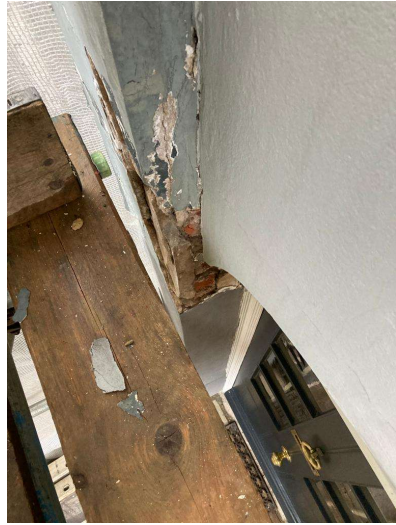
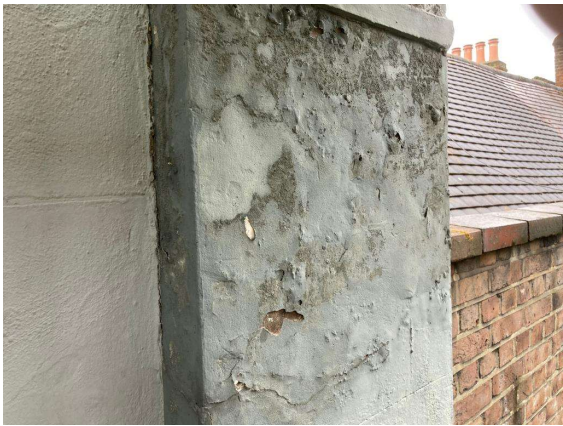
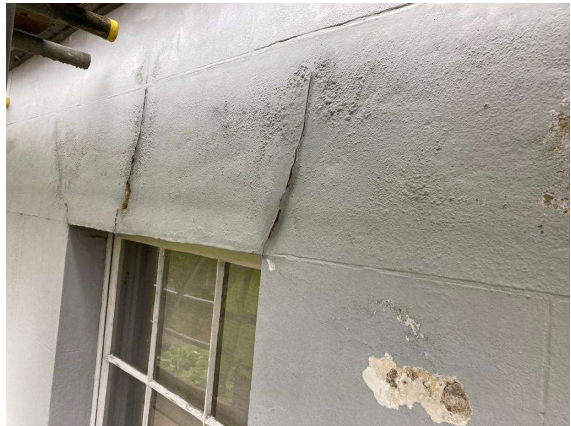
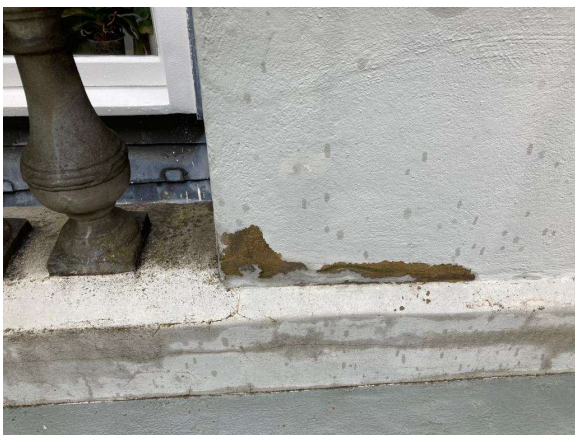
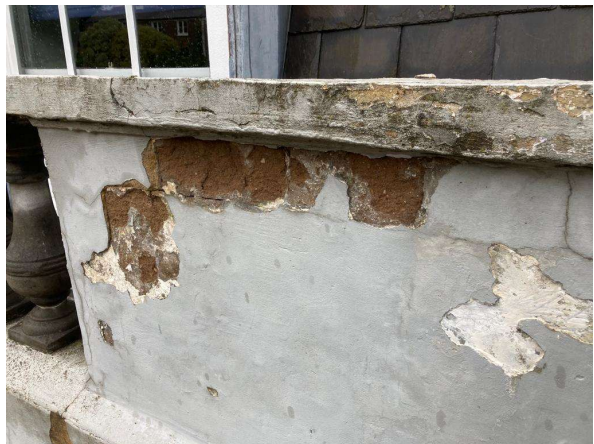
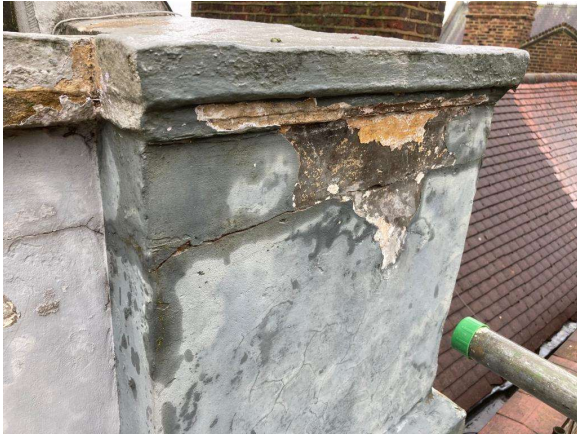
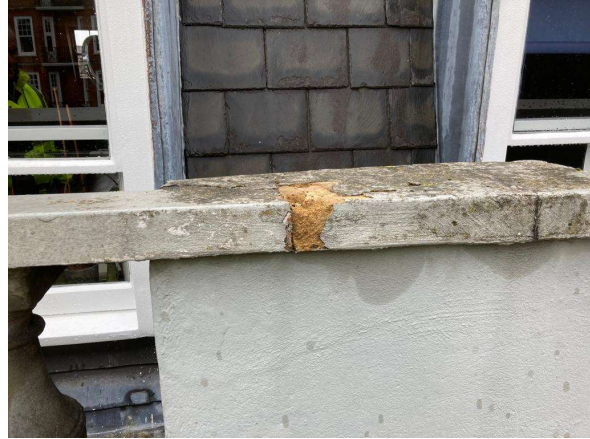
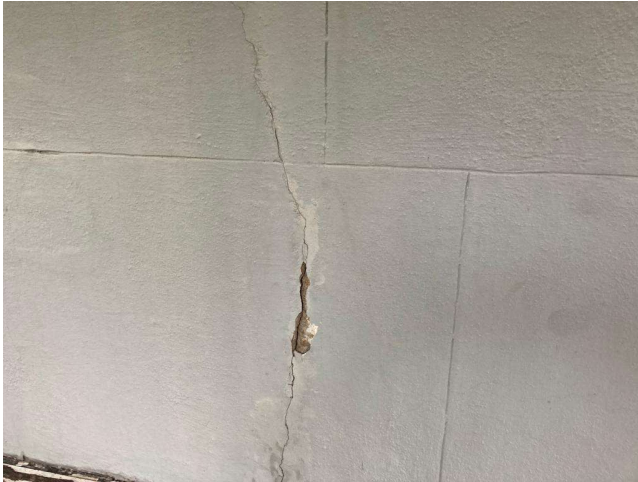
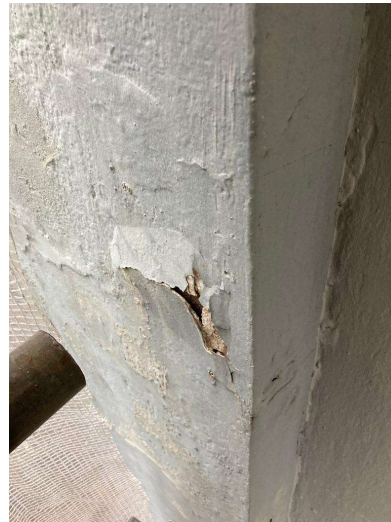
2.1 The existing Rendering is in sound condition and has not delaminated from the sub straight. However, due to use of internal polyfillers and distemper like paint ,water has blistered the finish and over time has ingressed between the rendering and painted surfaces (see photos below):

- Removal of loose paint;
- Prime and stain stopping areas affected;
- Face-fill treated areas with lime based or similar compatible decorative filler;
- Lightly sand and prepare surfaces for paint application;
- Apply two coats Farrow and Ball external paint.

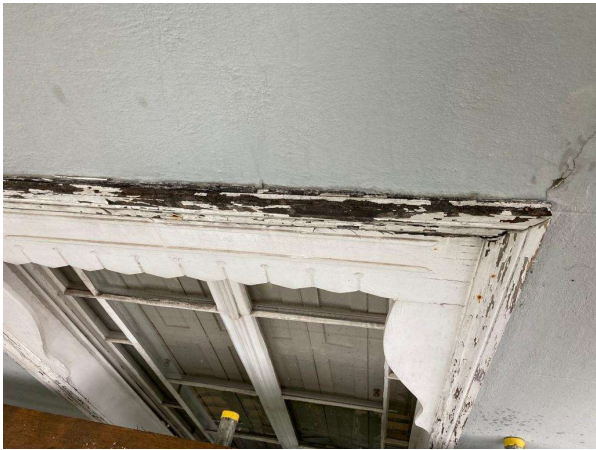
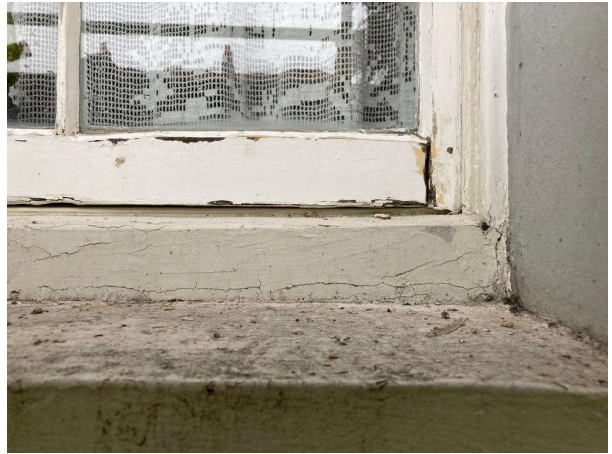
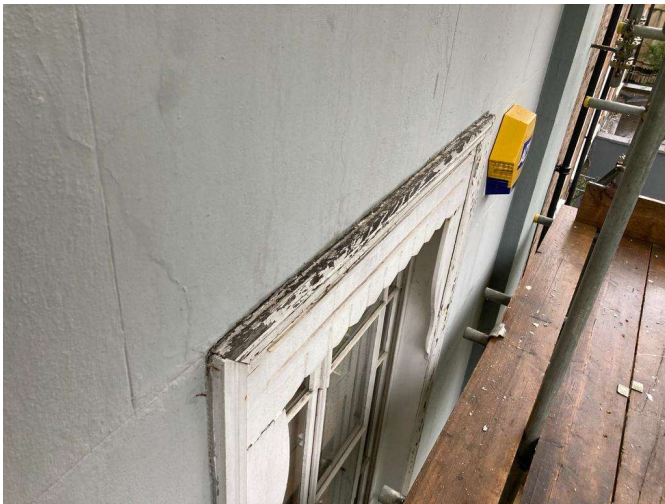
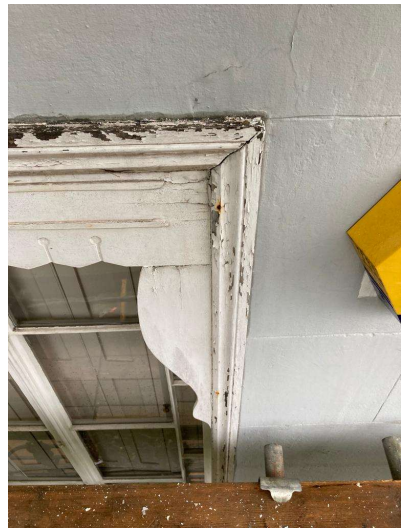
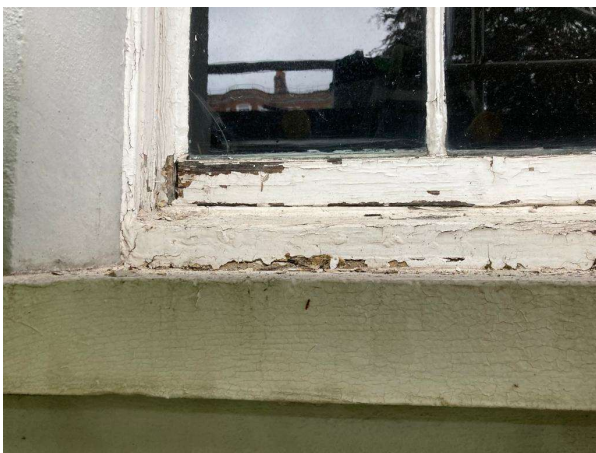
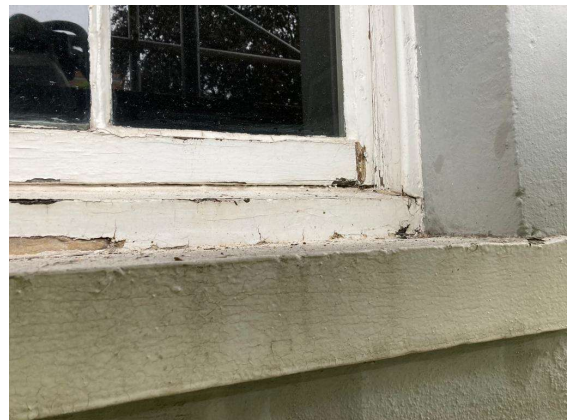
2.4 Following inspection, it is clear they have not been decorated for many years and existing paint has deteriorated allowing for water ingress (see photos below).

2.5 The timber has only small areas of wet rot and no timber replacement is required. Proposed repair works are:

- Sand woodwork to remove loose and frayed paint;
- Application of wood hardener in areas of wet rot found;
- Filling of open sliding sash joints to be done with repair resin treatment;
- Woodwork spot primed with two layers of undercoat and finished in a Dulux exterior paint or similar.

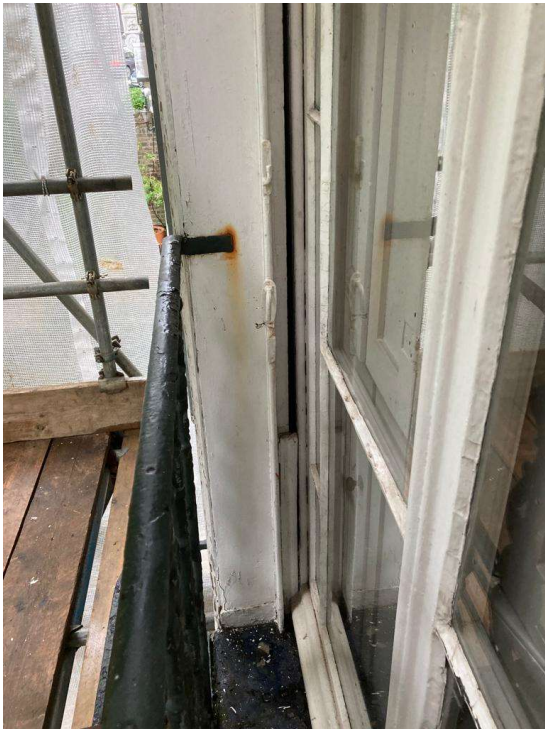
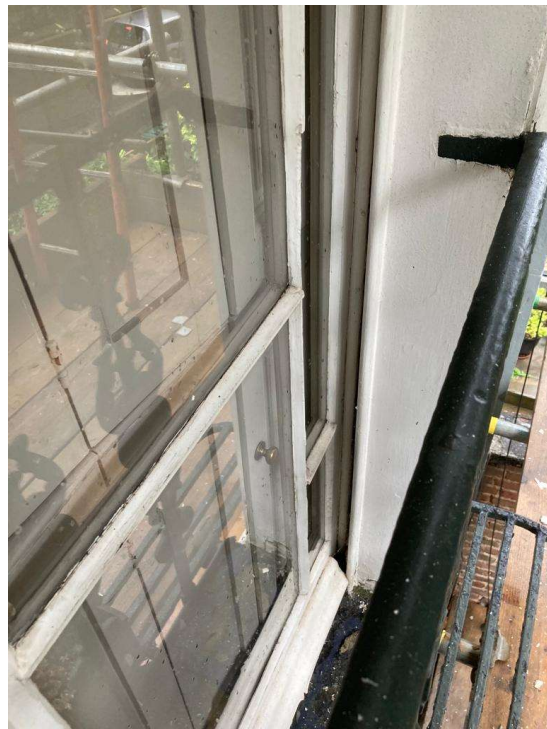
2.6 The balustrades have been found to be completely rusted throughout the base area and are now only fixed by the location pins on the handrail (see photos below):

2.7 Their loose fixing makes them very dangerous as well because they are coming away from the wall and if not rectified, may well fall on some unsuspecting person. The following repairs are proposed:

- Unscrew railings from timber window surround and carefully take down;

- Metal frame cleaned of existing paint and prepared for specialist welding to re-attach cast balustrading to frame;
- Rust treat metalwork subframe and handrail with pre paint treatment and red oxide paint;
- Redecorate with primer, undercoat and final Farrow and Ball exterior metal paint;
- Reinstall finished detailed metalwork back to original location as in photographs.

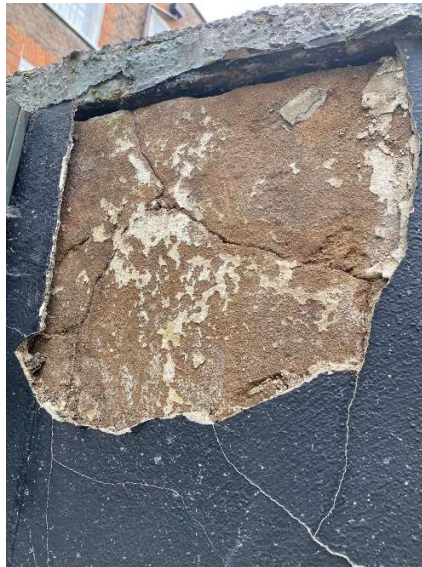
2.9 The existing render on the garden wall between 96 and 98 will be removed after being found to be completely live and not bonding to existing brickwork- The most likely cause of deterioration has been due to the roots of the magnolia tree at 98 being allowed to grow and its roots having grown through the wall and undermining the paving to the front courtyard (see photo below):

2.7 This is exacerbated by the raised ground level against the wall at 98. The tree has pushed the wall over so the copings are out of line and showing a bow in the wall. Rectification required after party wall agreement in place. It is proposed to put back exactly as it was, with lime based or similar compatible rendering.

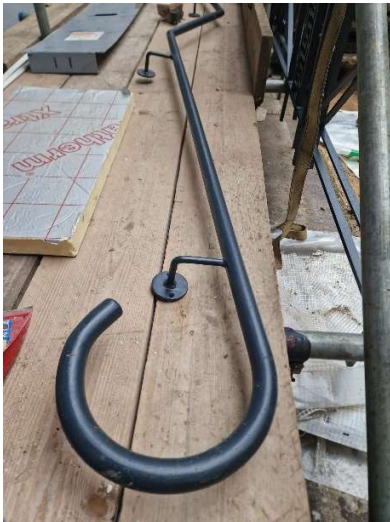
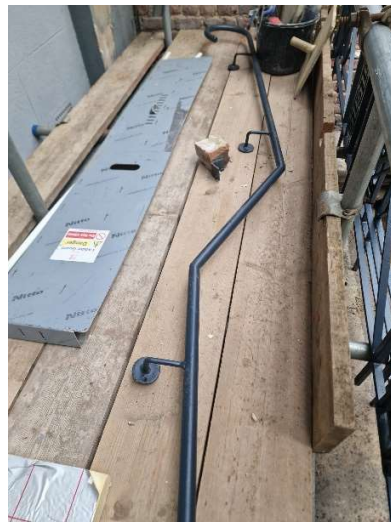
2.9 The handrail to the basement area had to be removed from the wall and this is in a condition which requires just cleaning and repainting with two layers of undercoat and final Farrow and Ball paint before attaching to the wall in exactly the same location (see photos below):

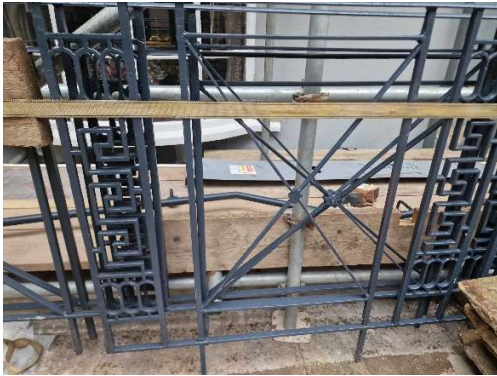
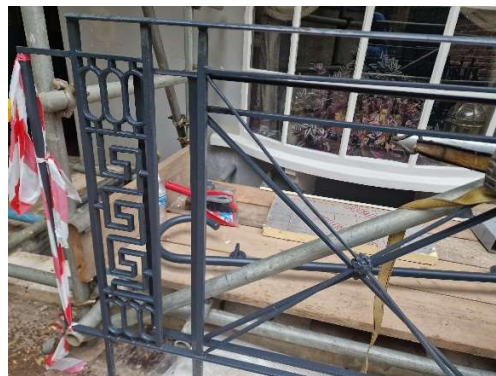
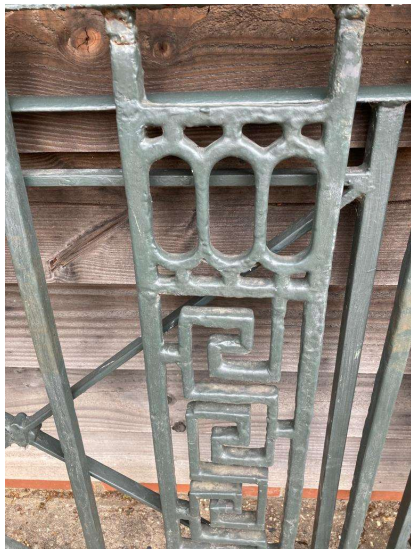
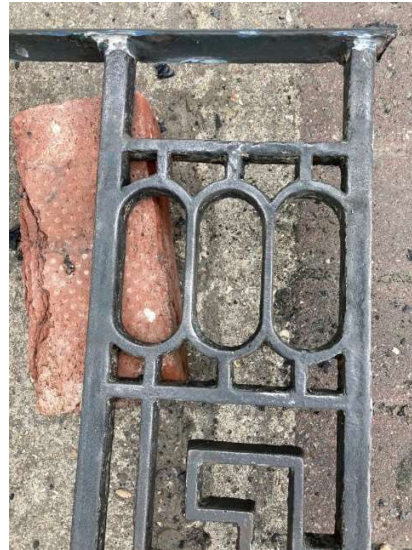
2.9 The railings in the front garden were found to have been bracketed and screwed once the Indian sandstone coping and adhesive were removed. They were rusty in areas where more recent welding had been done and had possibly up to a dozen layers of paint on them. They have been taken to a workshop and all the excess paint has been removed. The metalwork will have rust treatment, pre painted with a red oxide paint and then redecorated with a primer, undercoat and Farrow and Ball finish to look exactly as before , except with the detailing being visible (see photos below):

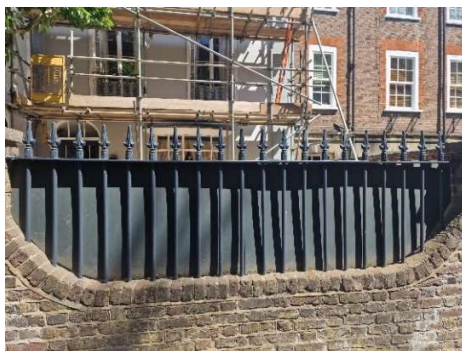
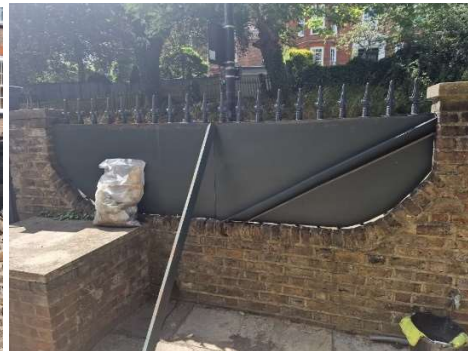
2.10 Finally, it is proposed to replace the metal panel that is attached to the rear of the railings to the front which is rusted with a new one. Again a like for like replacement is proposed.
