## Arboricultural Consultancy for LV=

| Insured | | Address | 29 Edis Street, London, NW1 8LE | | |
| Report Date | 09/03/2023 | | | | |

# GEOTECHNICAL

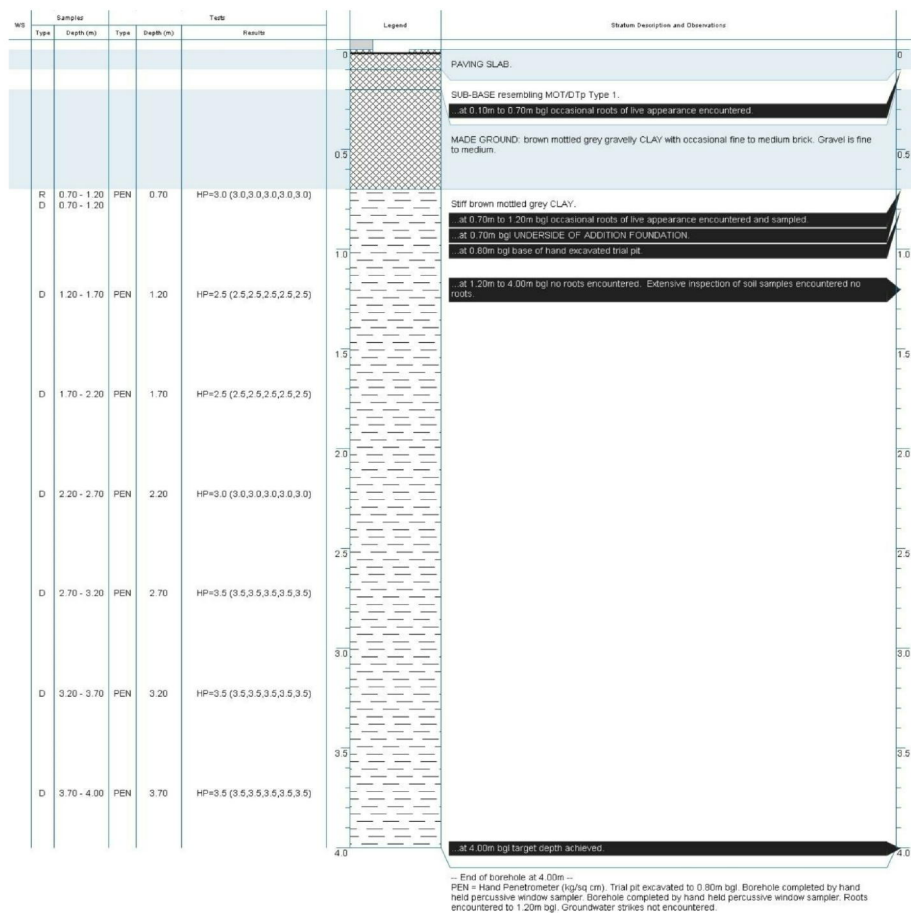
## TP/BH1 Foundation Detail and Borehole Log

Addition foundation comprised of brick wall to 700mm bgl with no projection from the elevation. Underside of foundation (USF) was exposed to 100mm back from the face of the foundation and probed 400mm back from the face of the foundation.

At 0.70m bgl UNDERSIDE OF ADDITION FOUNDATION in TP/BH1.
