PRELIMINARY ARBORICULTURAL REPORT

31 Daleham Gardens, NW3 5BU

DATE: September 2021

OUR REF: SHA 1198

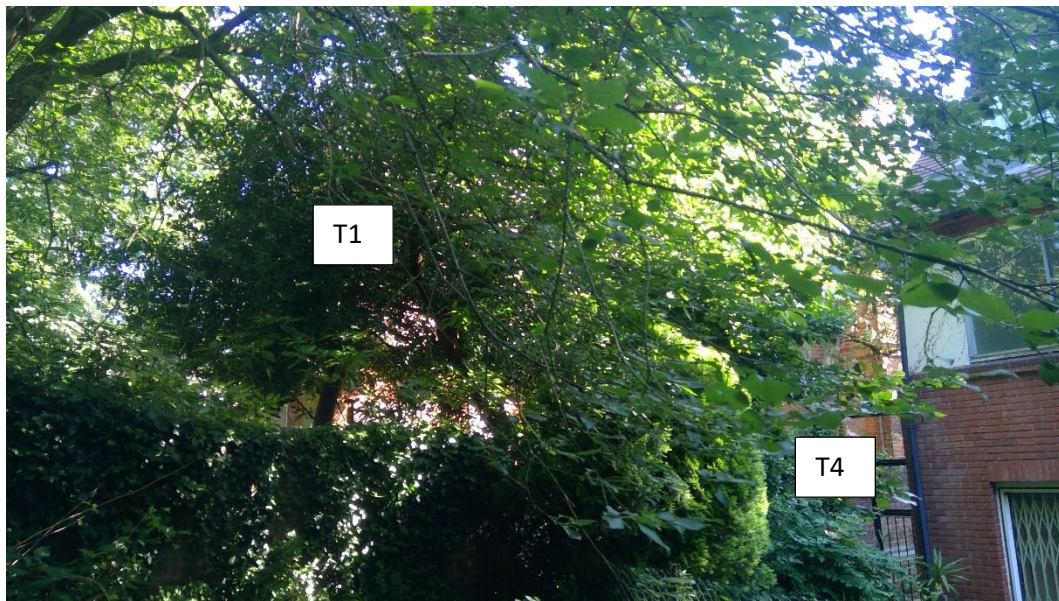
T4 is a 2.5m high slow growing cultivar of golden cypress growing close to the boundary, under the canopy of T1 cherry. It is highly unlikely that this small tree would have any roots on the site side, and there is no canopy overhang. It is highly unlikely to have any impact on development at 31 Daleham Gardens, but consideration must be given to its soil drying potential when designing new foundations.

Photo 1 of T4 showing the overhang of T1 cherry over 31a Daleham Gardens. Looking north-east

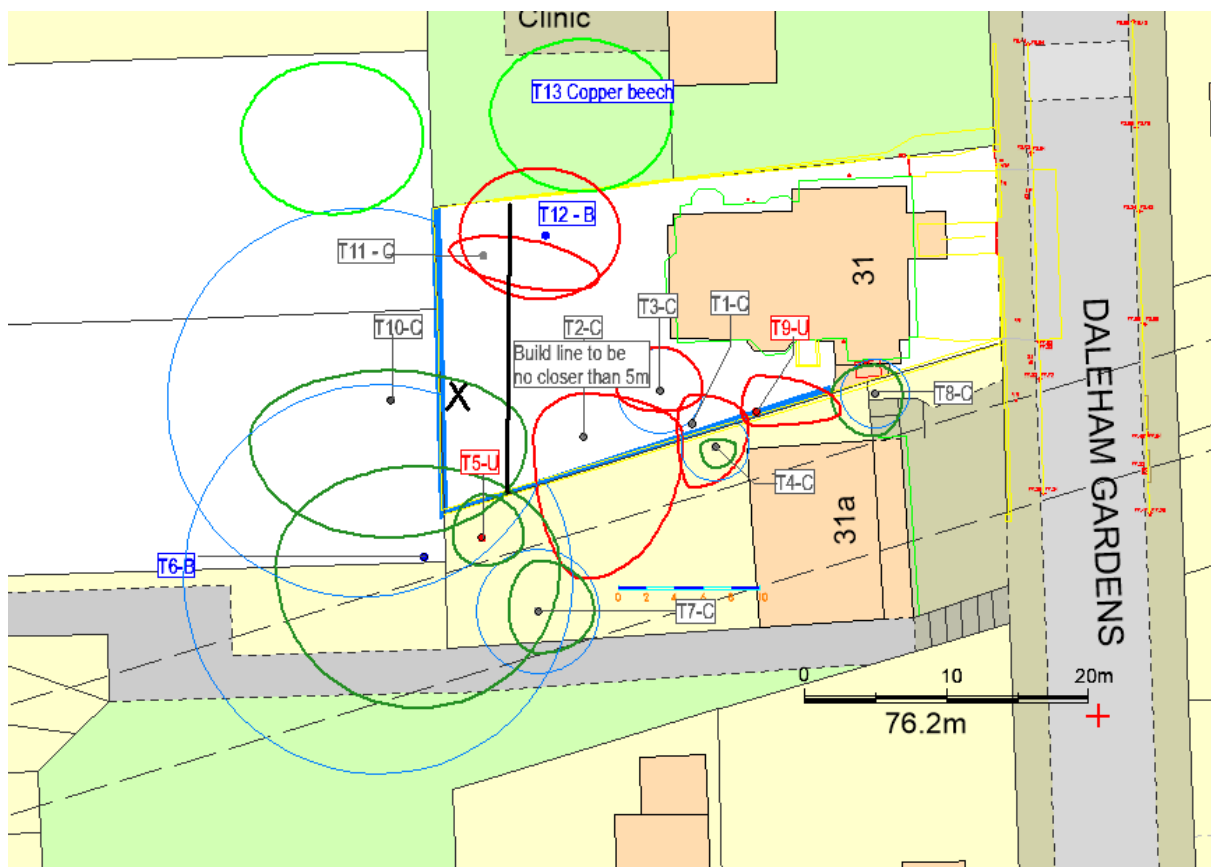
Plan 1 – extract from SHA 1198 TSP – do not scale. North is vertical. Full plan and key at appendix

T5 is an over mature laurel which is in a very poor condition with a sprawling form and 50% dead wood. There is no impact to, or from, the site. Ideally this tree should be removed, but this is a matter for Camden Council.

T7 is an early mature Lawson cypress, currently 15m with potential to reach 25m. It is approximately 9m from the site boundary and its future growth potential should be considered for foundation design, but there is no impact to, or from the tree for future design.

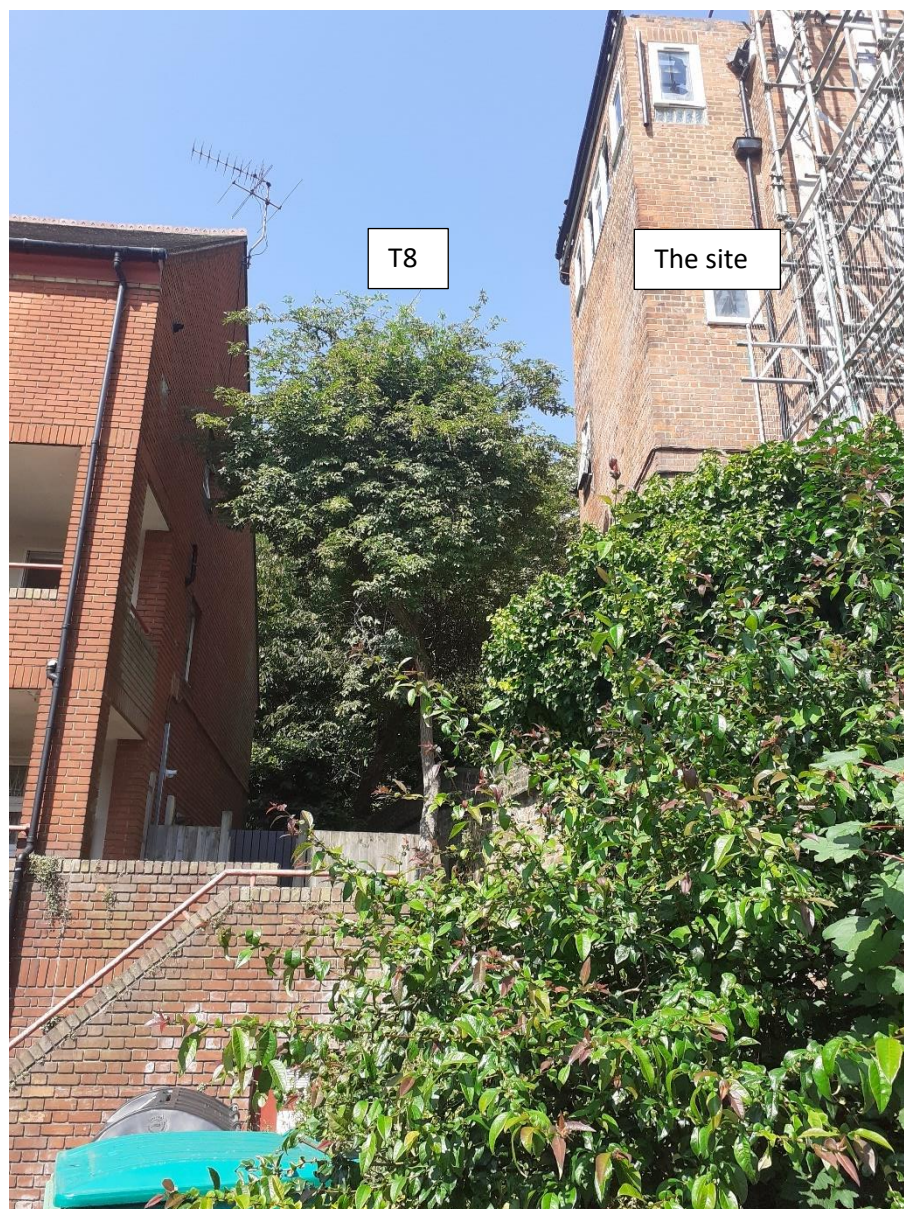
T8 is an early mature elder growing right next to a low wall. It is in a reasonable form and condition and slightly overhangs the site. The roots will be constrained by the wall and will not be entering the site.

Photo 2 of T8 looking from the car park for 31a Daleham Gardens, looking west

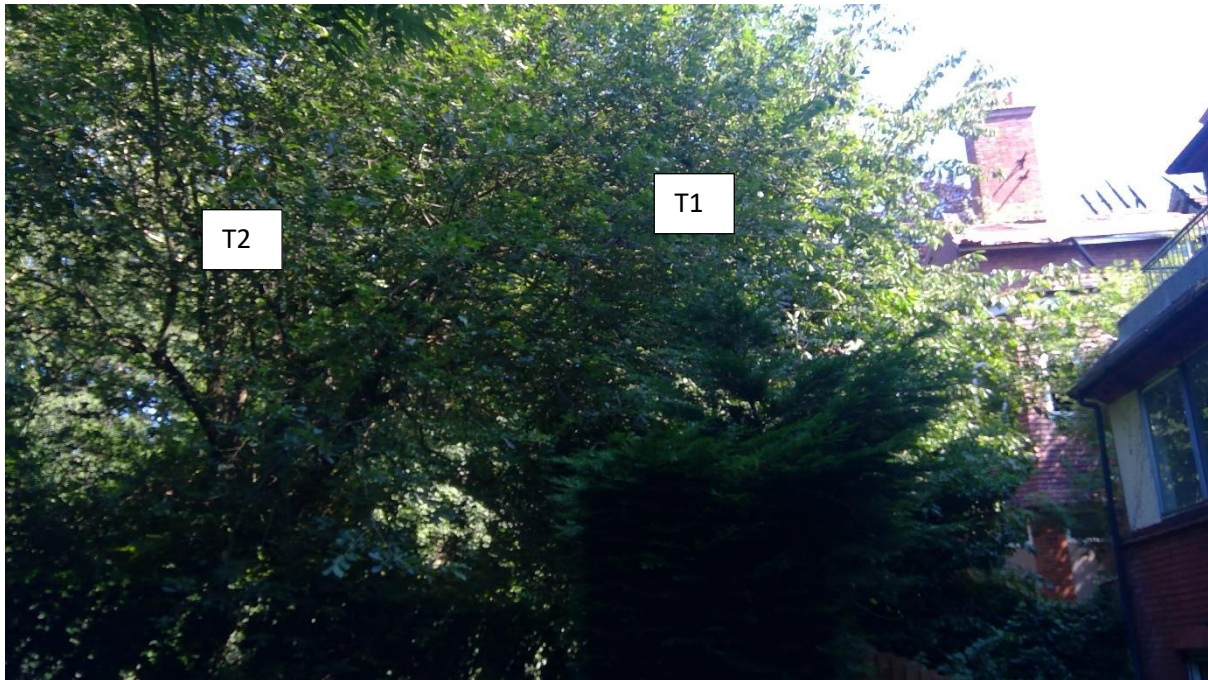
T1 is a semi-mature cherry which leans heavily and there is some dieback in the crown. T2 is growing close to the wall and leans over the site with long, low branches. Both trees cast considerable shade in the garden of 31a Daleham Garden. T3 is a semi mature holly observed behind the crowns of T1 and T2. T9 is a low quality leaning elder.

Photo 3 of T1 and T2 looking north from 31a Daleham Gardens

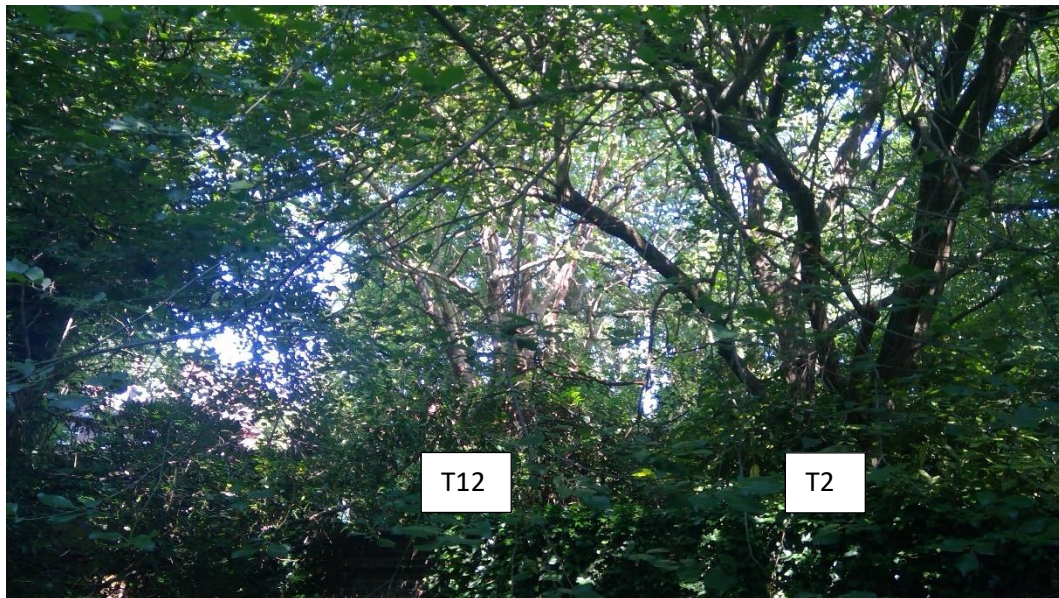
Photo 6 of T12 and T2 looking north-west

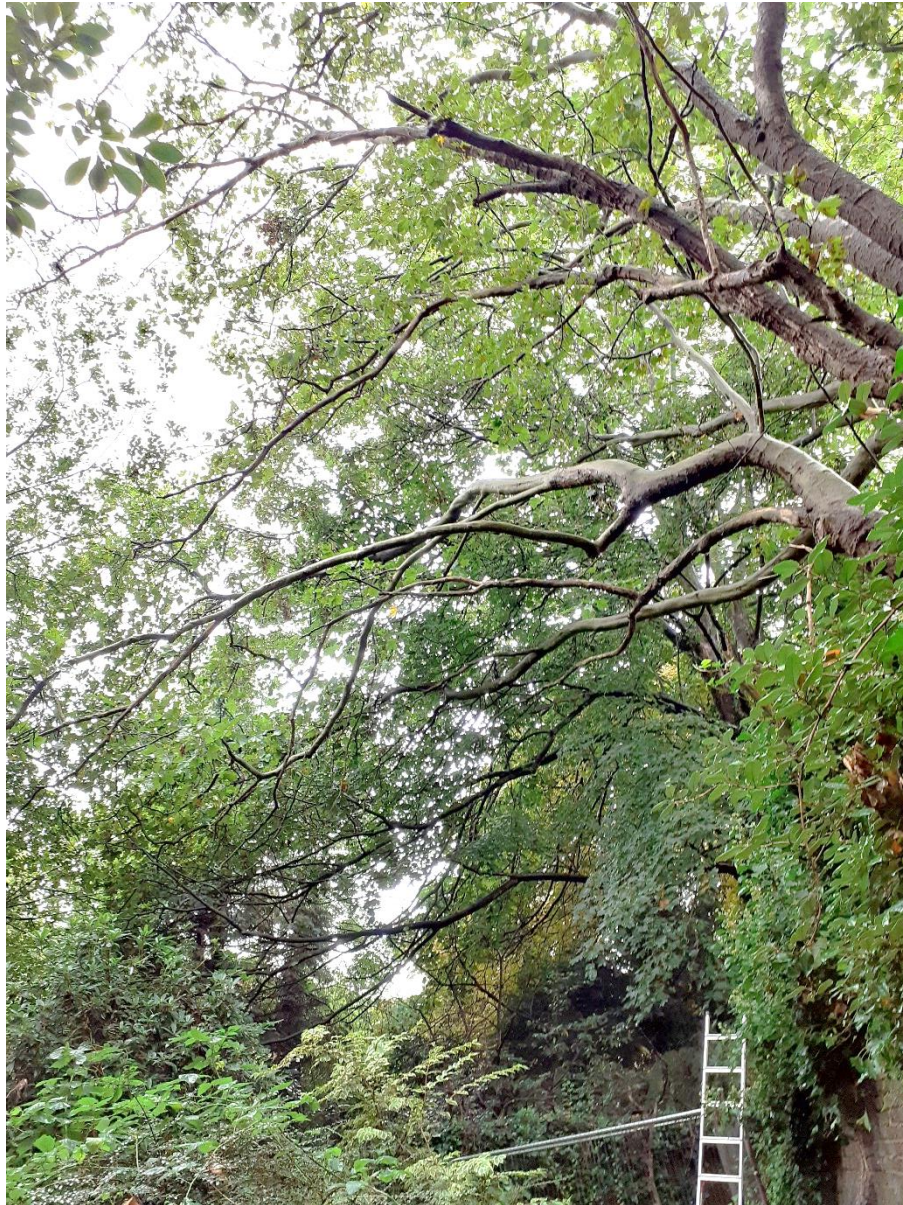
T10 London plane has a poor structural form and low vitality, most likely due to Massaria disease. This has resulted in a crown density of approximately 40% with a large dead branches overhanging the site, some of which have fallen.

Photo 7 of T10 looking south

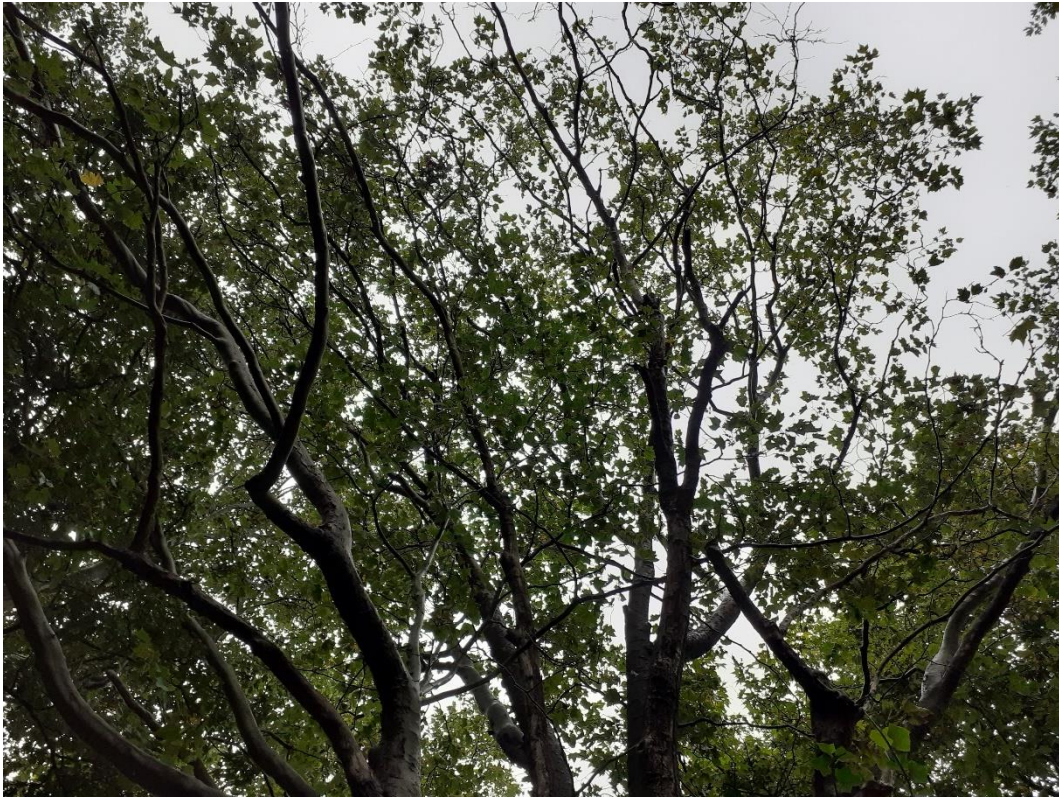
Photo 8 of T10 looking up the crown

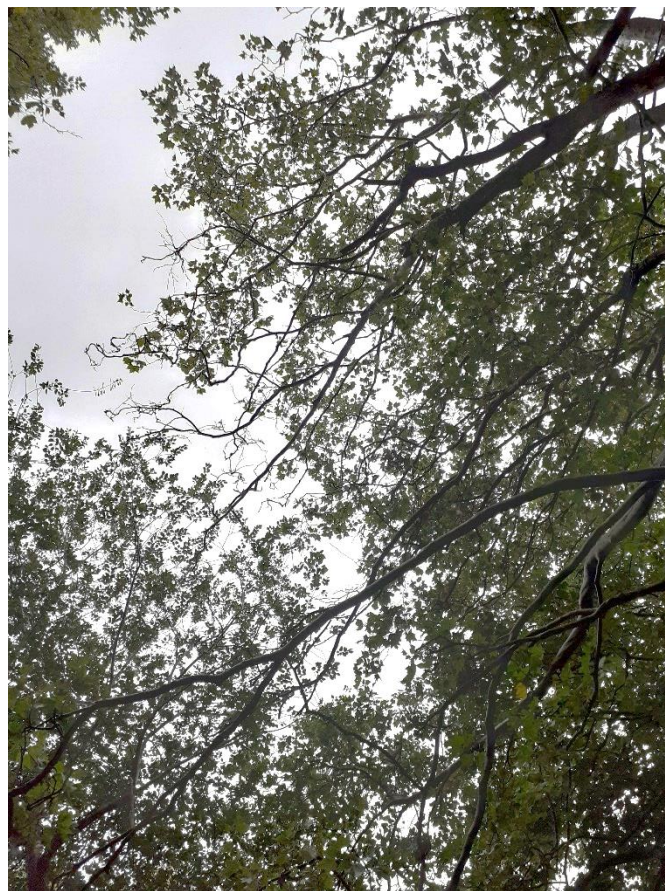
Photo 9 of T10 looking up the crown showing dieback

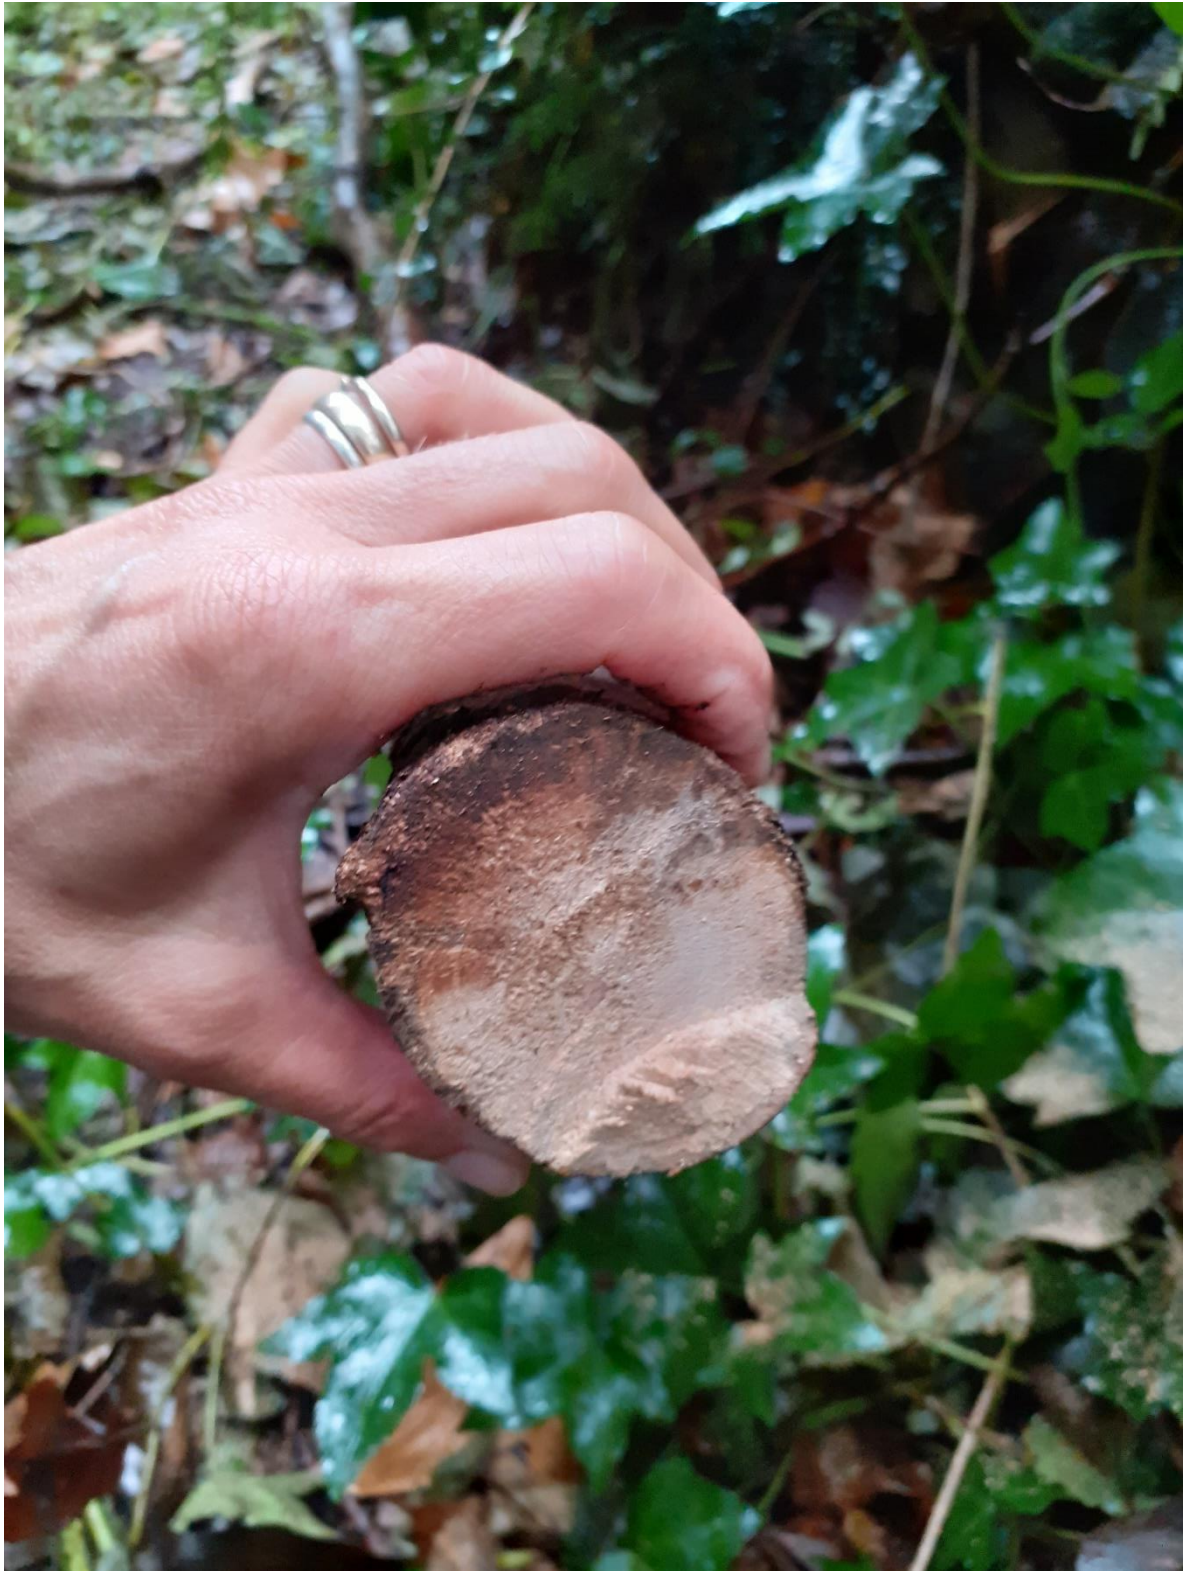
Photo 10 showing decay caused by Massaria but this is less conclusive than I have seen before in that there is not a distinct wedge of decay at the top

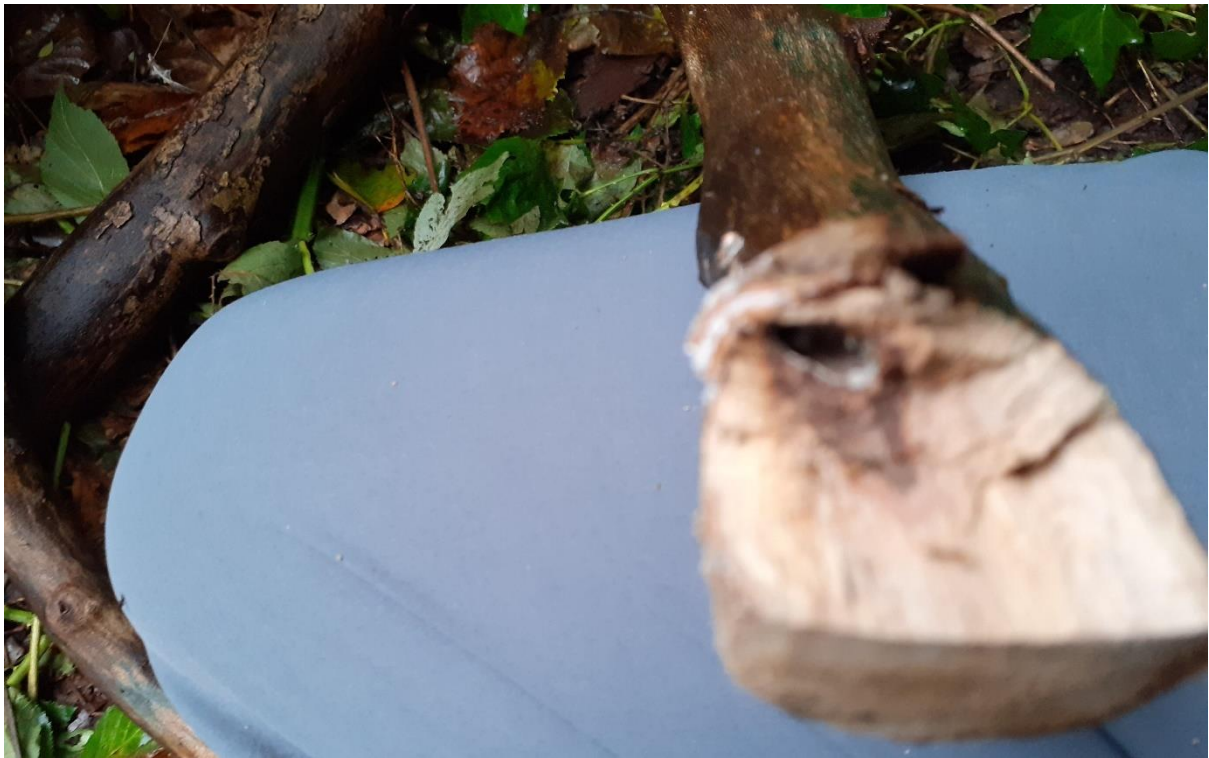
Photo 11 - This photo (poor focus) shows a more clearer area of decay

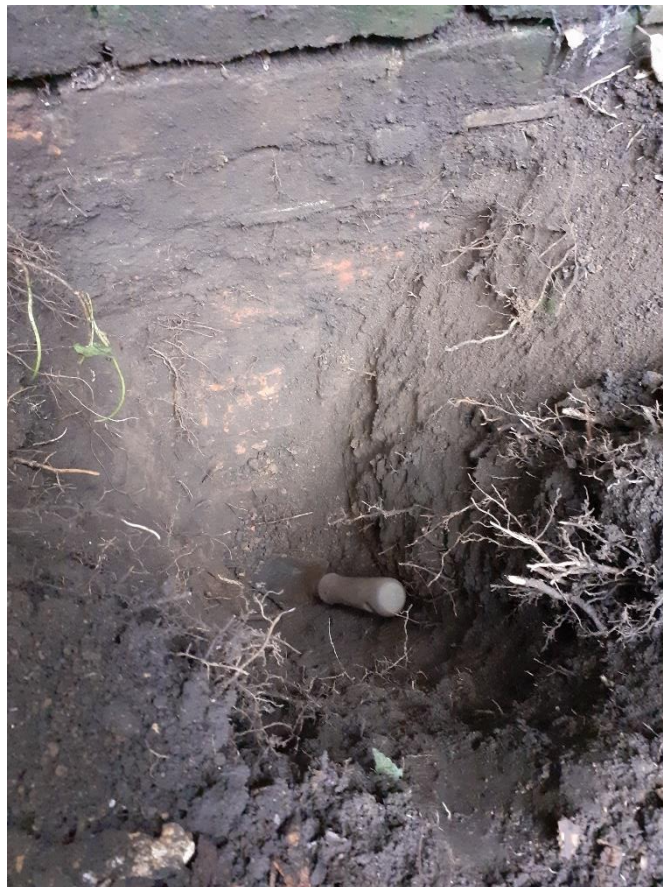
A trial pit was dug with the arboriculturist present next to the wall (see X on the plan SHA 1198 TSP and TOP). This found that the wall had a 750mm deep foundations with no roots just below. It is reasonable to assume that the wall is acting as a root barrier to this tree. As

the wall continues along the boundary, it is reasonable to assume that the wall acts a root barrier to T6 as well.

Photo 12 of the depth of the wall foundations – roots were from on site ivy which has been mostly removed

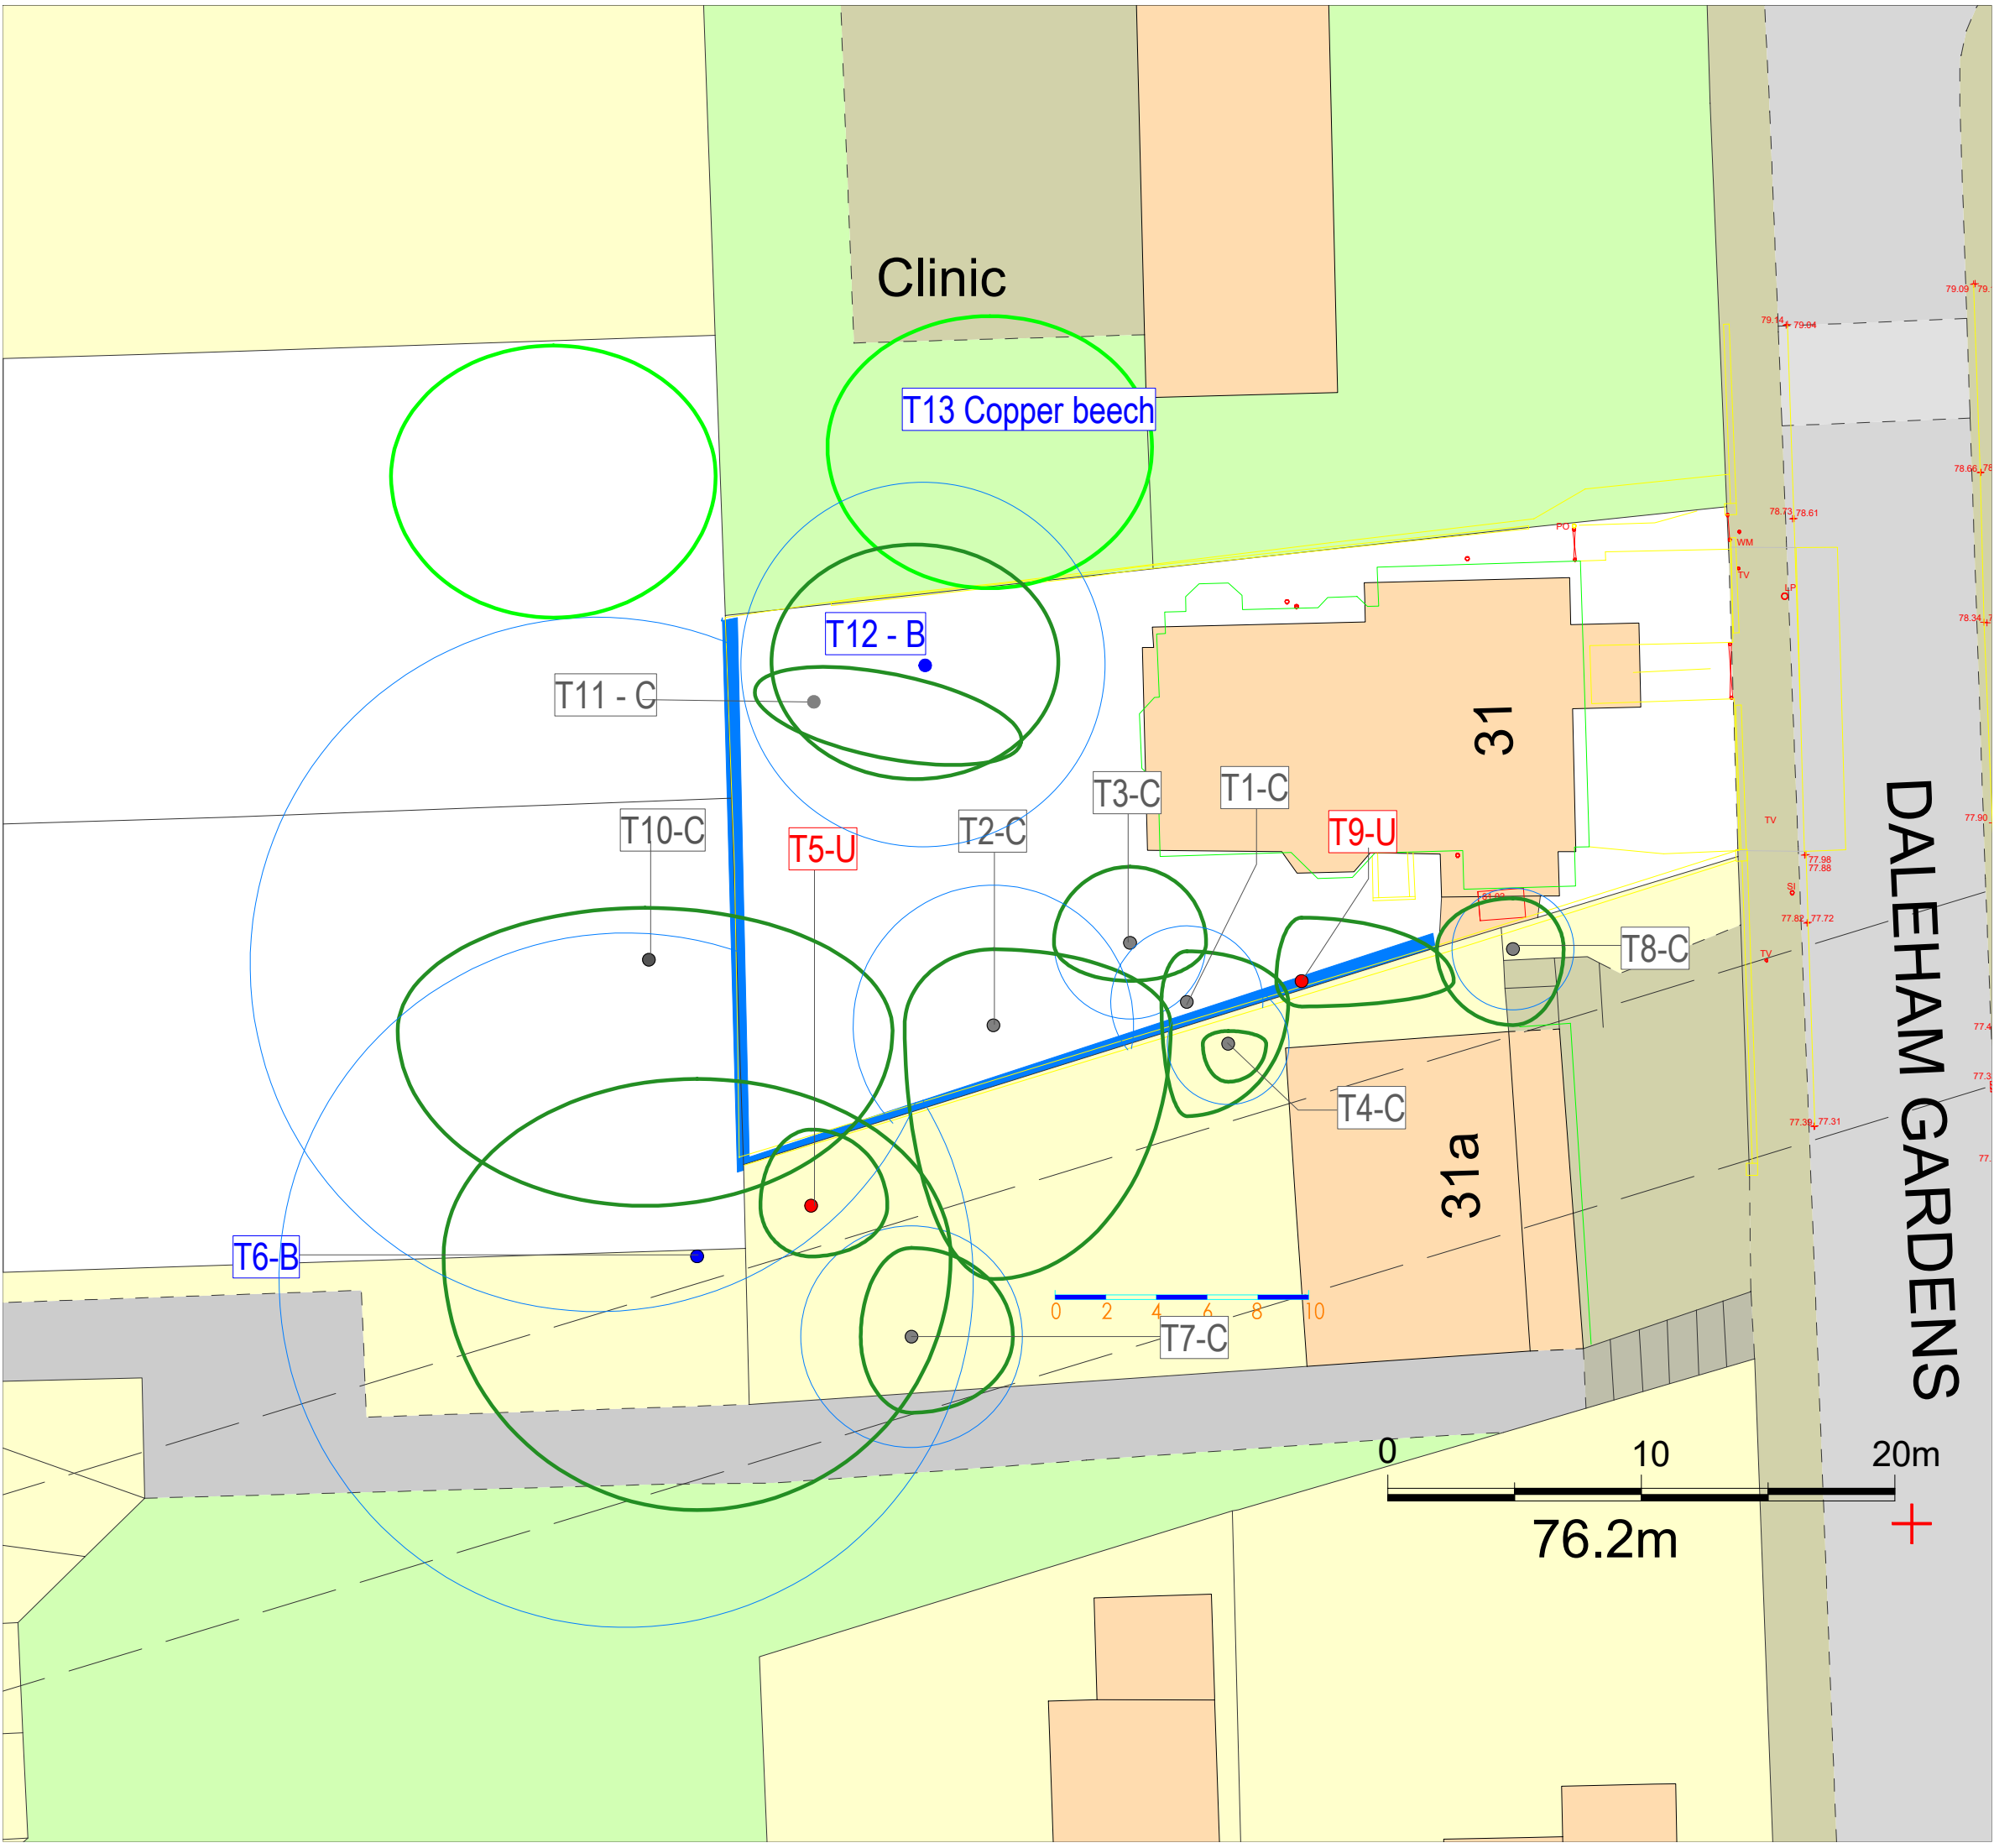
Tree survey plan SHA 1198 TSP

Wall with 750mm deep foundations as observed from trial pit X. No roots found just below. Acts as a root barrier to at least the depth of foundations, most likely total root barrier.
