## Revised Arboricultural Appraisal Report

### Subsidence Damage Investigation at:

22a Harley Road  
Hampstead  
London  
NW3 3BN

CLIENT: Crawford & Company  
 CLIENT REF: [REDACTED]  
 MWA REF: [REDACTED]  
 MWA CONSULTANT: Andy Clark  
 REPORT DATE: 02/10/2023

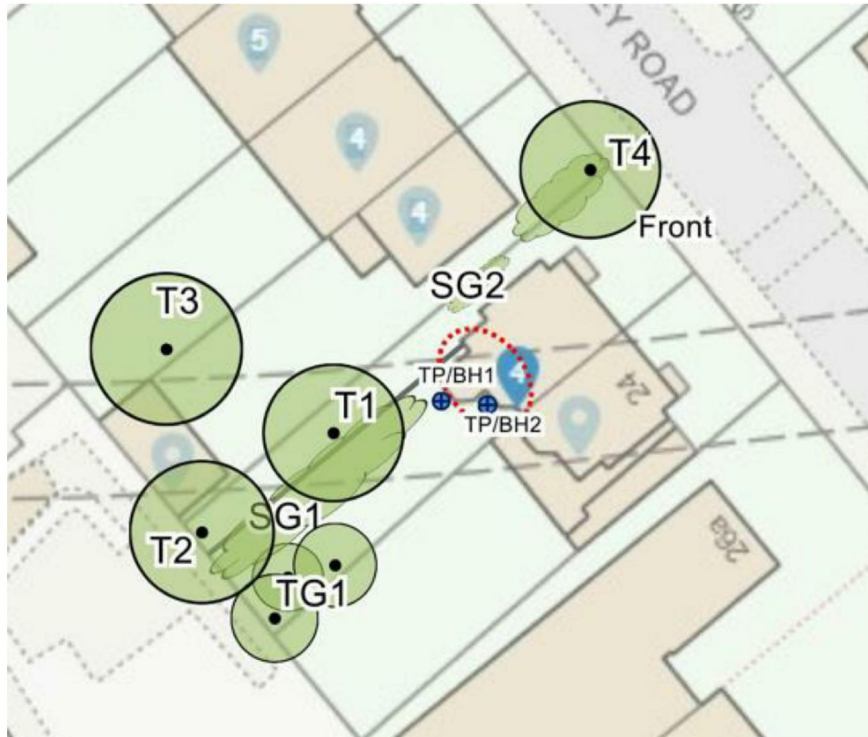
Site Plan

Approximate areas of damage

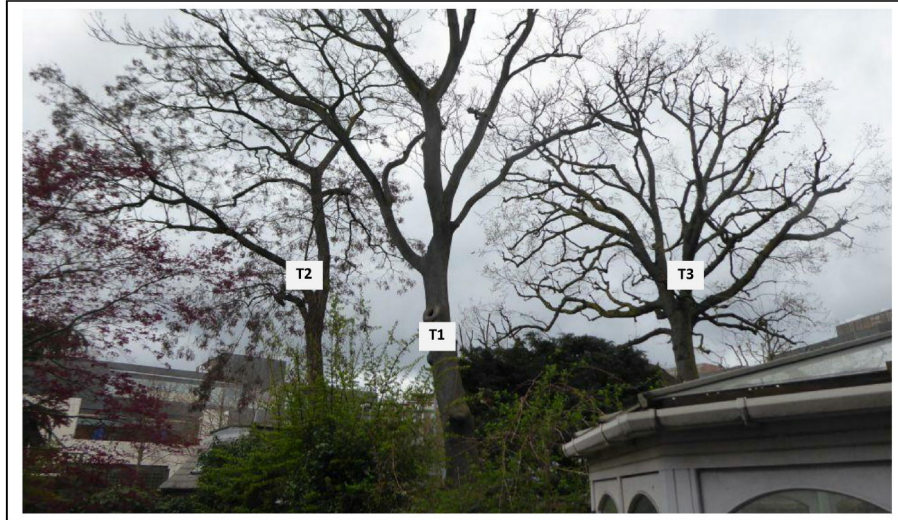
The origin of the Vitaceae spp. roots will be the grape of SG1 and are not considered significant to the current damage. The source of the Leguminosae spp. roots will be T2 False Acacia, the either Quercus spp. or [the related] Castanea spp. roots will emanate from T3 Oak, and the Ailanthus spp. roots will originate from T1 Tree of Heaven.

View of T1 Tree of Heaven, T2 False Acacia and T3 Oak

If an arboricultural solution is to be implemented to mitigate the influence of the implicated trees/vegetation we recommend that T1 Tree of Heaven and T2 False Acacia are removed at this stage. If movement persists the removal of the oak may become necessary.

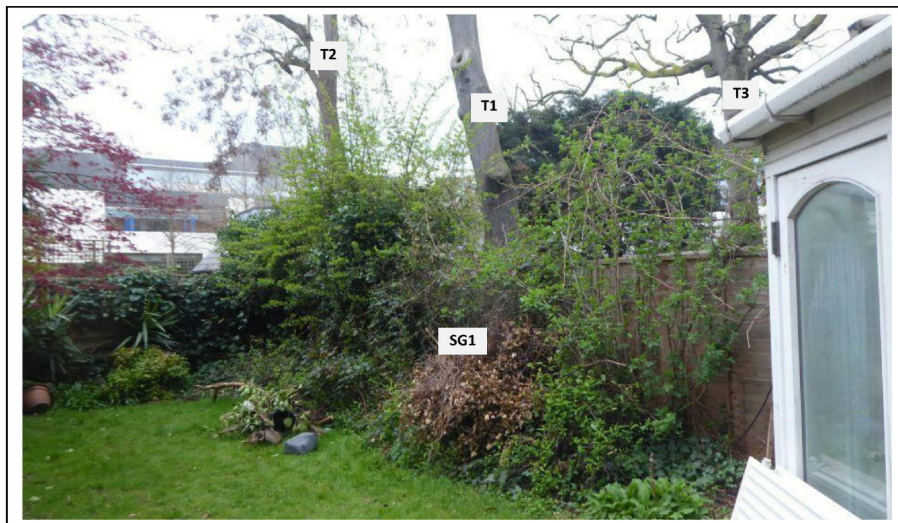
View of SG1 group with stems of T1, T2 and T3 visible beyond

SG1	Mixed spp. hedgerow group of mostly Grape, Elder, Pyracantha and Ivy	4.5	70 Ms *	5.0	0.7	Younger than Property	Policy Holder
Management history		No significant recent management noted.					
Recommendation		Reduce height to 2.0m and cut back width to 1.0m to restore to suitably managed hedge. Re-prune thereafter on an annual cycle to maintain at broadly reduced dimensions.					
SG2	Fatsia and Viburnum group	3.0	40 Ms *	4.5	1.9	Younger than Property	Policy Holder
Management history		Subject to past management/pruning - appears regularly trimmed.					
Recommendation		Maintain broadly at no more than current dimensions by periodic pruning.

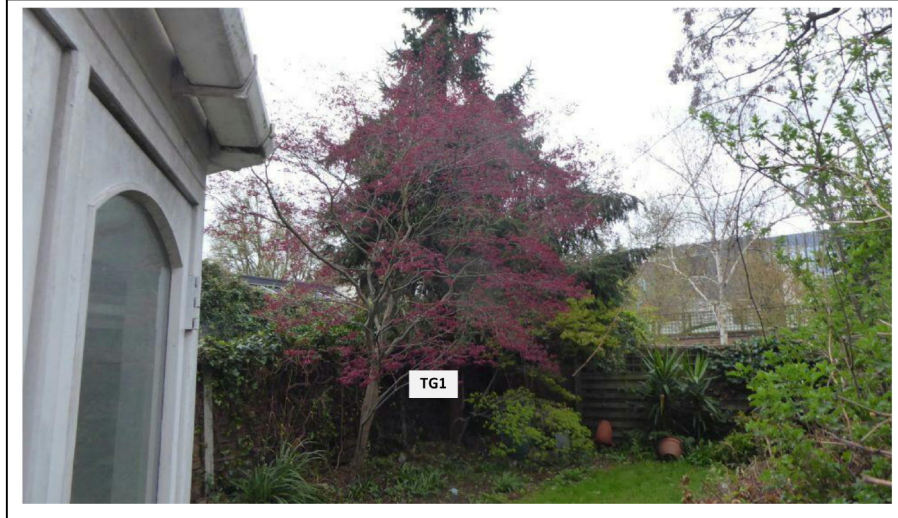
View of TG1 group
