TECHNICAL REPORT ON A SUBSIDENCE CLAIM

**Fivecourts Limited
22A Harley Road
Hampstead
London
NW3 3BN**

SUBSIDENCE CLAIM

13th April 2022

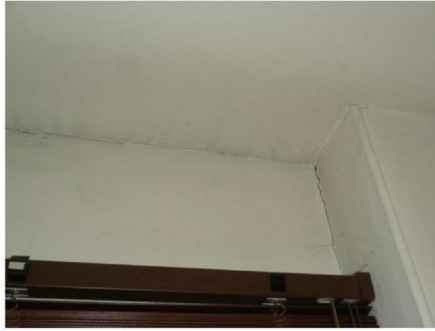
Cracking in the living room over the rear bay reveal

- Hairline crack over the right corner of the opening through to the kitchen area which appears longstanding and not related to subsidence.
- Hairline cracks either side of the archway through to the rear bay area.
- 1mm wide cracks over both corners of the French doors in the rear bay.

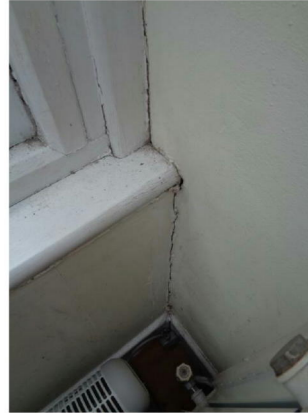
Crack at the right side of the conservatory at the junction with the main building

- Vertical 3mm wide crack to the right hand side of the conservatory at the junction with the main house.
- 2mm wide crack to the left hand side of the conservatory alongside the door through to the living room at the same junction.

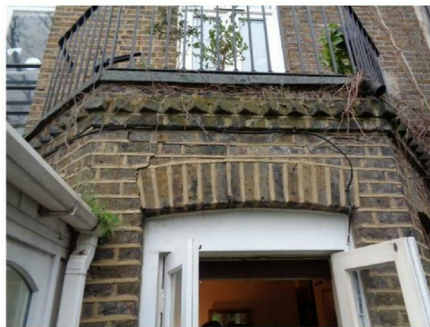
The damaged arch over the French doors in the single storey rear bay

- 10mm wide crack over the left corner of the arch over the French doors to the rear bay. The arch has slipped and requires re-setting.
- Vertical cracks either side of the conservatory at the junction with the main rear elevation up to approximately 2mm width.
- Stepped crack over the left corner of the first floor window which did not extend any further upwards or downwards. This appeared longstanding and had been previously repaired and was not consistent with subsidence.
- An historic bow in the brickwork both to the rear and left hand elevations at first floor level which is not related to subsidence.

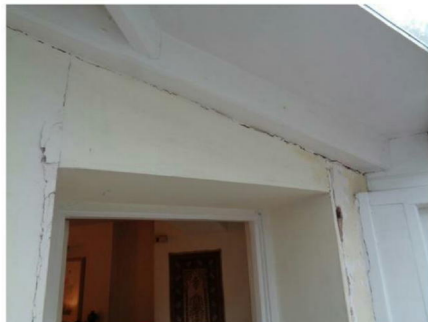
Cracking in the conservatory over the door to the living room

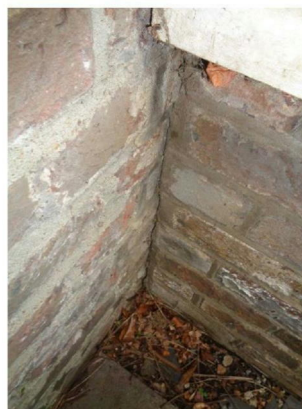
Crack to the left side of the conservatory
