## SITE INVESTIGATION FACTUAL REPORT

Report No: [REDACTED]  
Client: Crawford Claims Management  
Site: 22A Harley Road, Hampstead  
Client Ref: [REDACTED]  
Date of Visit: 3/5/2022

# Investigation Layout Plan

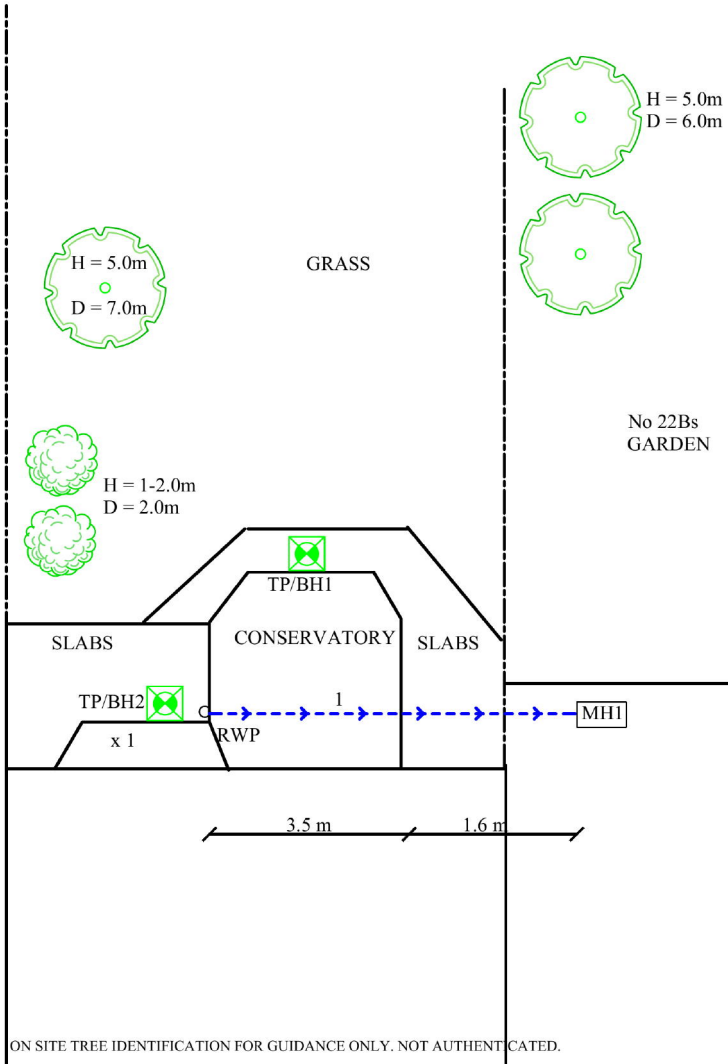
ON SITE TREE IDENTIFICATION FOR GUIDANCE ONLY. NOT AUTHENTICATED.

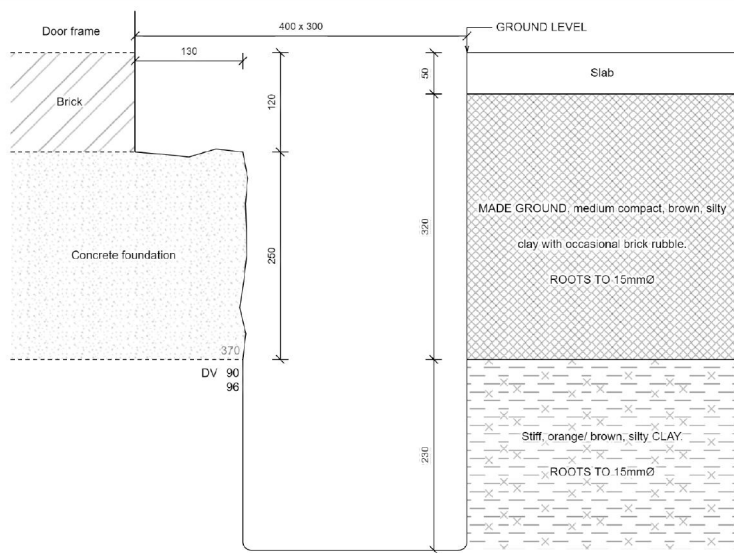
TEST REPORT: Trial Pit

For Strata below 600mm see Bore Hole log

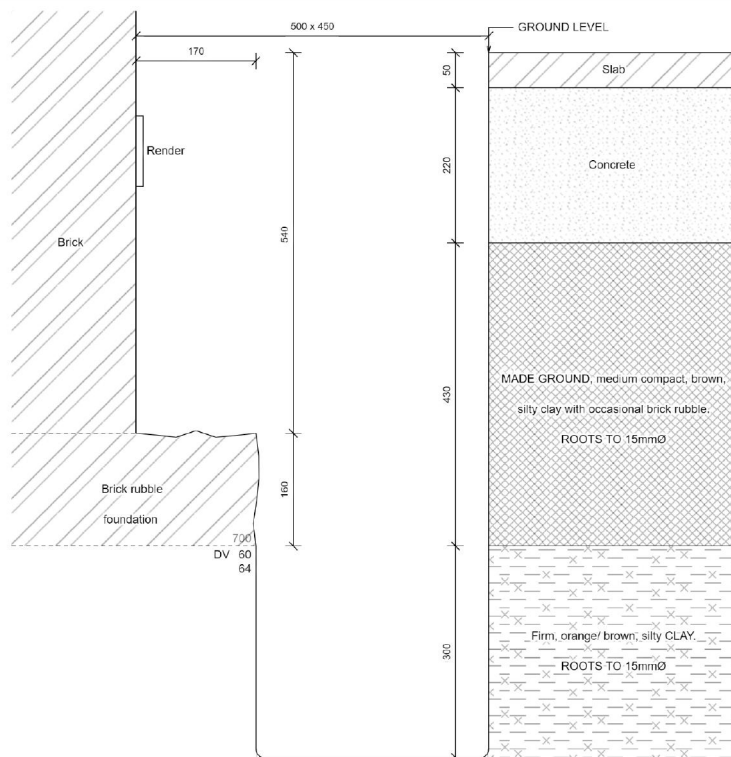
TRIAL PIT REF: TP2

For Strata below 1000mm see Bore Hole log

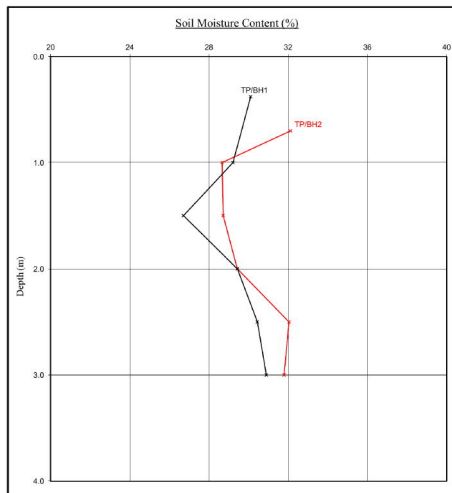
## Moisture Content Profiles

**Notes:**  
 1. If plotted,  $0.4LL$  and  $PI-2$  (after Driscoll, 1983) should only be applied to London Clay (and similarly overconsolidated clay) at shallow depths.  
 2. Unless specifically noted the profiles have not been related to a site datum.

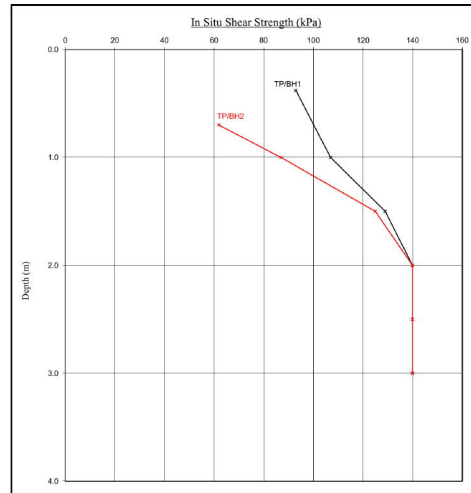
## Shear Strength Profiles

**Note:**  
 1. Unless otherwise stated, values of Shear Strength were determined *in situ* by CTS using a Pilon Hand Vane the calibration of which is limited to a maximum reading of 140 kPa.  
 2. Unless specifically noted the profiles have not been related to a site datum.
