Monitoring Details

Provider Name:	My Home Needs Ltd	Monitoring Interval:	2 Monthly
Instruction Date:	06/07/2022	Number of Visits:	4
Reading Date:	03/10/2022	Visits Completed:	2
Date of Issue:	04/10/2022	Visits Outstanding:	2

Occupier:	[REDACTED]
Address:	22a Harley Road, Hampstead, London, NW3 3BN

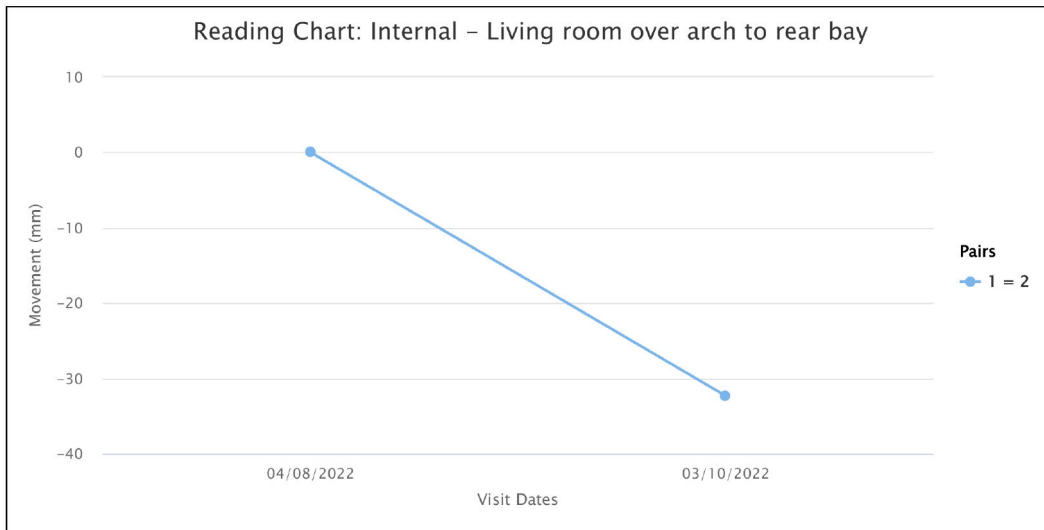
Crack Reading Chart

Crack Readings (Displayed in millimetres) - Living room over arch to rear bay

Visits	1 = 2 H
04/08/2022	85.14
03/10/2022	52.78

Visits	1 = 2 H
04/08/2022	N/A
03/10/2022	-32.36 ↓

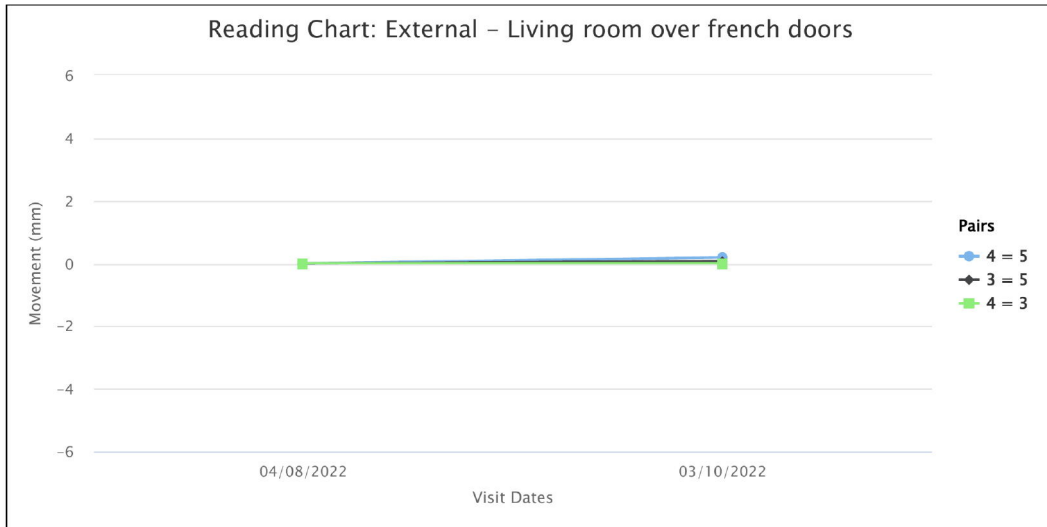
Crack Reading Chart

Crack Readings (Displayed in millimetres) - Living room over french doors

Visits	4 = 5 H	3 = 5 V	4 = 3 DC
04/08/2022	81.36	74.28	97.19
03/10/2022	81.55	74.35	97.19

Visits	4 = 5 H	3 = 5 V	4 = 3 DC
04/08/2022	N/A	N/A	N/A
03/10/2022	0.19 ↑	0.07 ↑	0.00 =

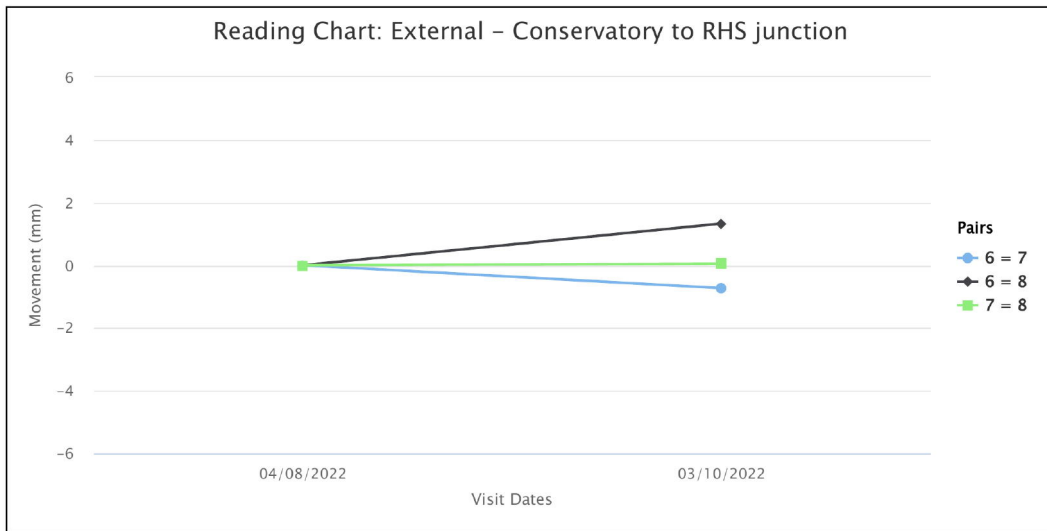
Crack Reading Chart

Crack Readings (Displayed in millimetres) - Conservatory to RHS junction

Visits	6 = 7 H	6 = 8 V	7 = 8 DC
04/08/2022	78.11	95.79	129.54
03/10/2022	77.38	97.12	129.59

Visits	6 = 7 H	6 = 8 V	7 = 8 DC
04/08/2022	N/A	N/A	N/A
03/10/2022	-0.73 ↓	1.33 ↑	0.05 ↑

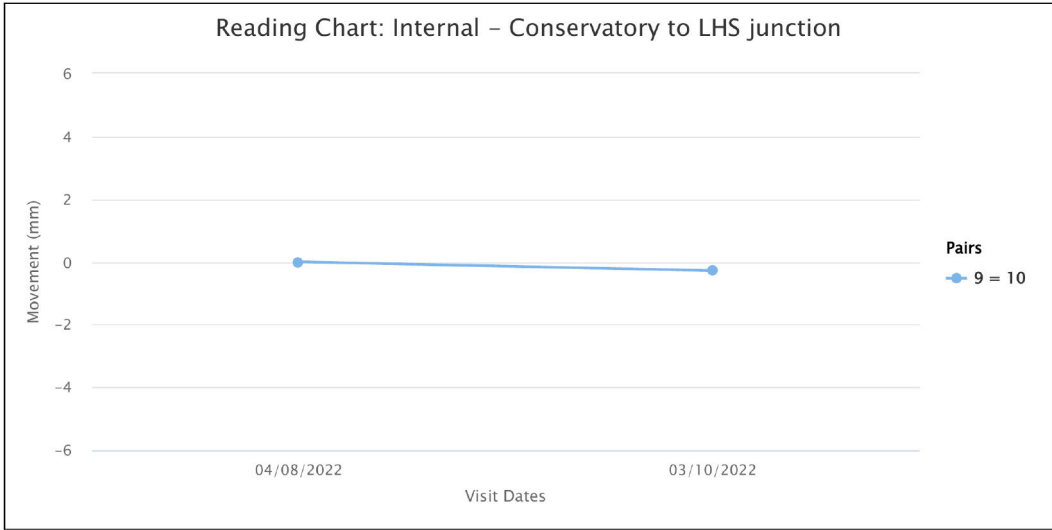
Crack Reading Chart

Crack Readings (Displayed in millimetres) - Conservatory to LHS junction

Visits	9 = 10 H
04/08/2022	76.54
03/10/2022	76.26

Visits	9 = 10 H
04/08/2022	N/A
03/10/2022	-0.28 ↓
