/ 8 GUILFORD STREET ROOM SCHEDULE

6569

REV 01

26/09/2023

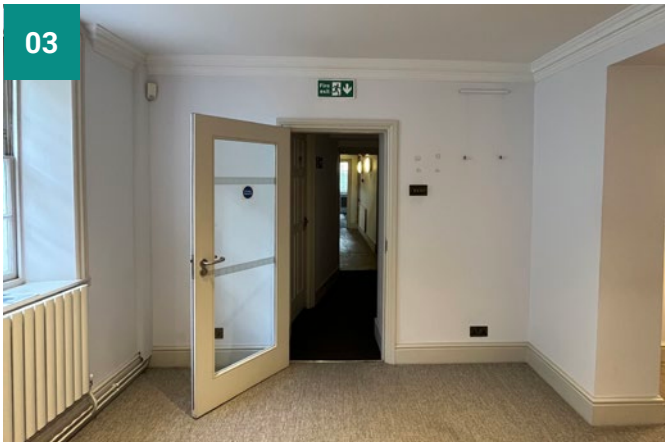
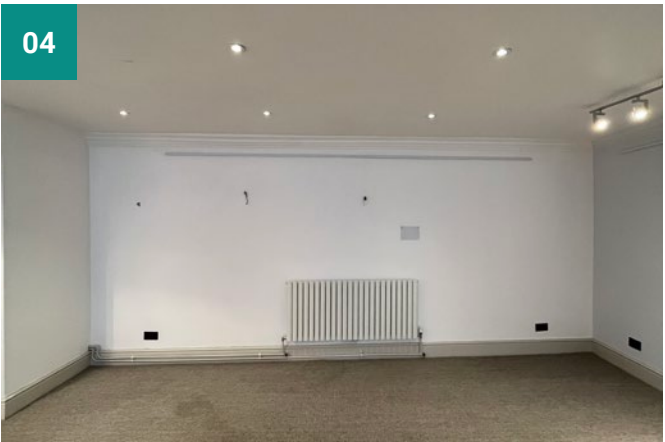
FIGURE 01 ROOM LG.01/02

LOCATION	DESCRIPTION	CONDITION / SCOPE OF REPAIR	COMMENTS
LG.01 / LG.02	Ceiling / Cornice	<ul style="list-style-type: none">Modern suspended ceiling with recessed spotlightsModern cornice only partially present,	<ul style="list-style-type: none">All to be adapted to suit layout of conversion to residential use
LG.01 / LG.02	Floor	Carpet covering poor condition concrete slab	<ul style="list-style-type: none">All to be adapted to suit layout of conversion to residential use
LG.01 / LG.02	Walls / Skirting	<ul style="list-style-type: none">Good conditionModern skirting, architraves and fixture & fittings	<ul style="list-style-type: none">All to be adapted to suit layout of conversion to residential useWalls to be repaintedSkirting to be replaced
LG.01 / LG.02	Windows	<ul style="list-style-type: none">Existing timber sliding Sash windows, single glazed to be retained and refurbished.Windows do not work and present several layers of paint	<ul style="list-style-type: none">Windows to be kept and secondary glazing to be installedExternal metal bars to be removed

LG.01 / LG.02	Internal Doors	Modern door with vision panel and architrave	All to be adapted to suit layout of conversion to residential use
LG.01 / LG.02	Fireplace	Exposed bricks fireplace, no insert	Clean the bricks and possibly reinstate an original reclaimed Victorian fireplace insert
LG.01 / LG.02	Radiators	Modern water filled radiators and surface mounted pipework	All to be adapted to suit layout of conversion to residential use

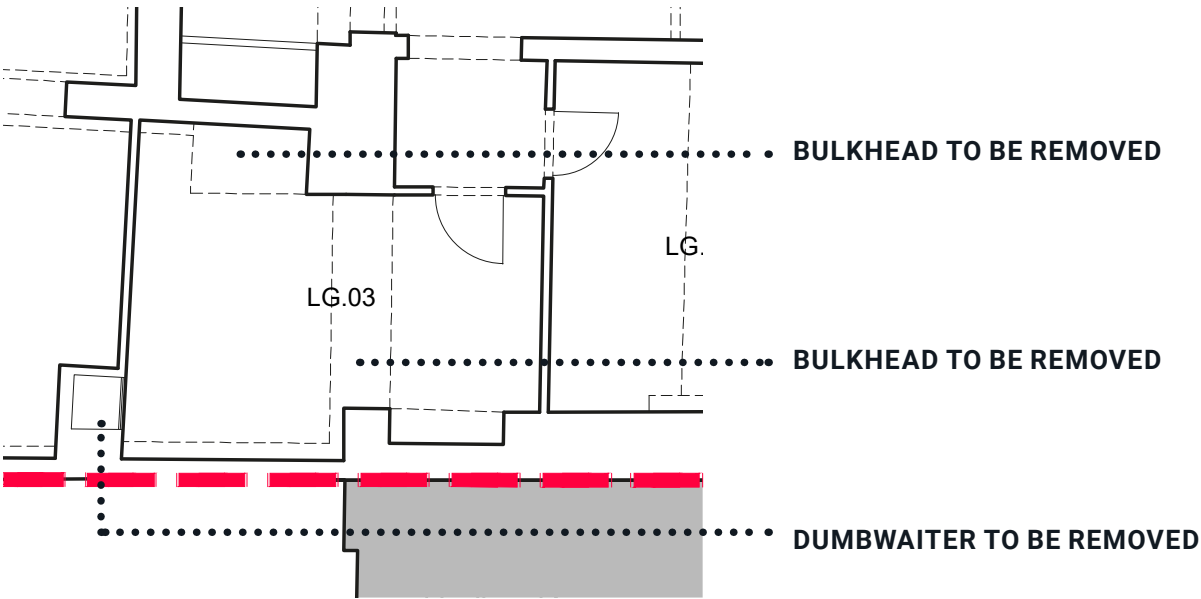
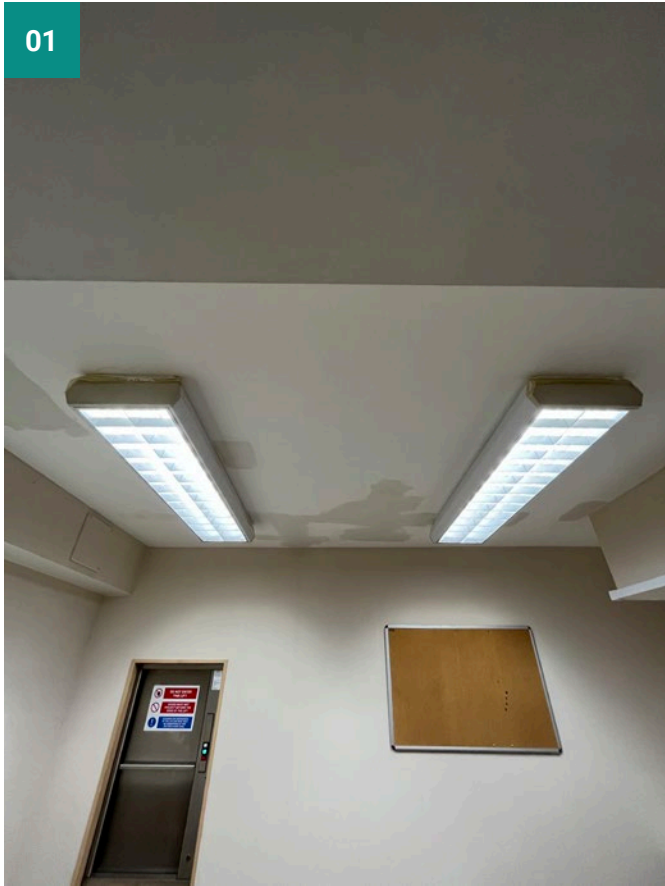
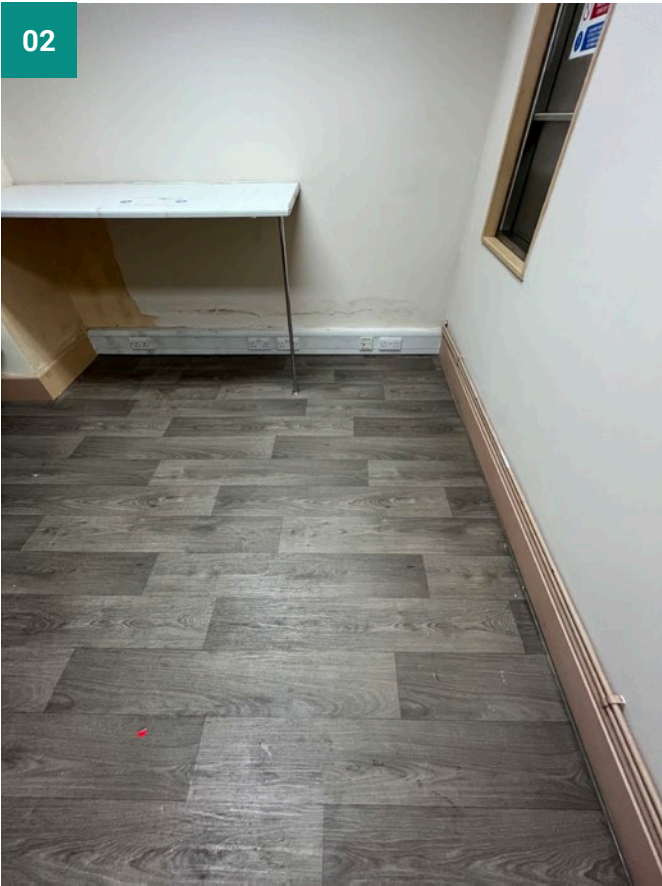
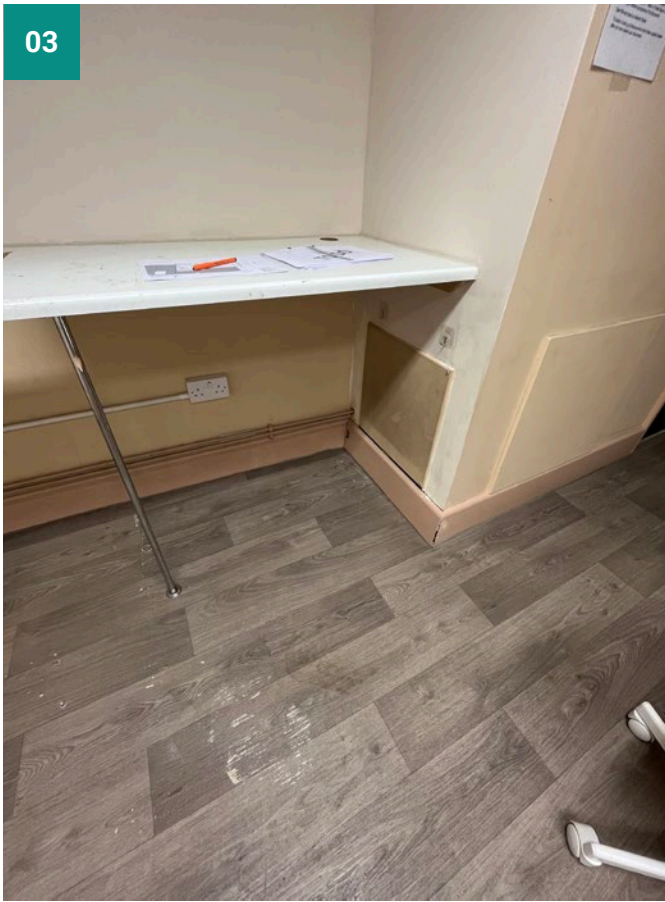
FIGURE 02 ROOM LG.03

LOCATION	DESCRIPTION	CONDITION / SCOPE OF REPAIR	COMMENTS
LG.03	Ceiling	Modern plasterboard ceiling, poor condition with various bulkheads	All to be adapted to suit layout of conversion to residential use
LG.03	Floor	Modern vinyl floor, covering concrete slab	All to be adapted to suit layout of conversion to residential use
LG.03	Walls / Skirting	<ul style="list-style-type: none">• Modern plasterboard• Modern skirting, poor condition	All to be adapted to suit layout of conversion to residential use
LG.03	Internal Doors	Modern doors and fittings	All to be adapted to suit layout of conversion to residential use

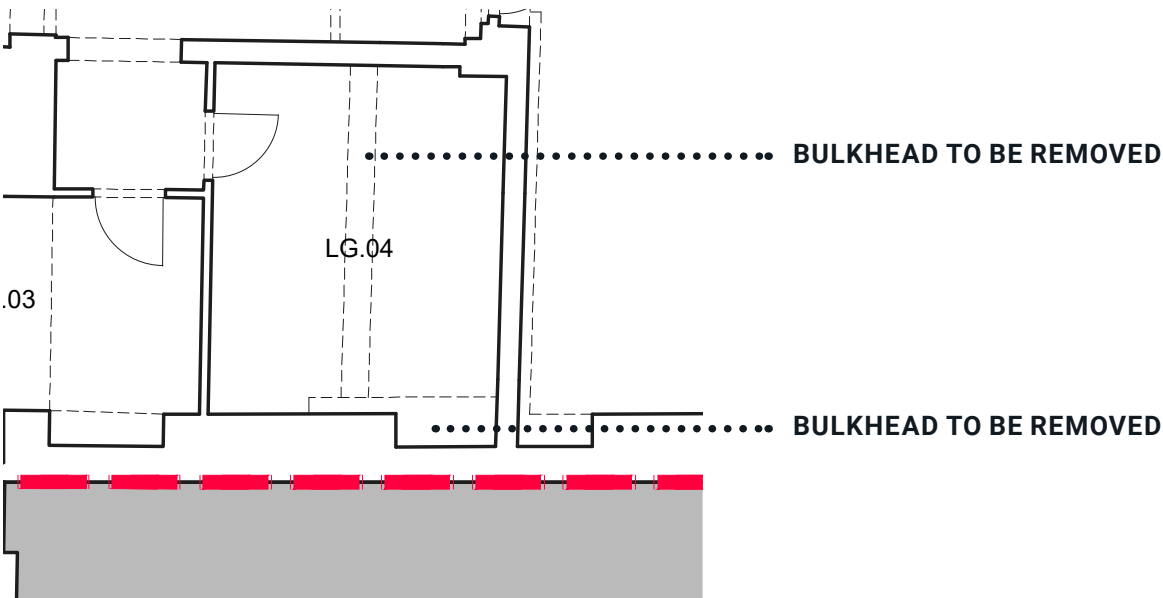
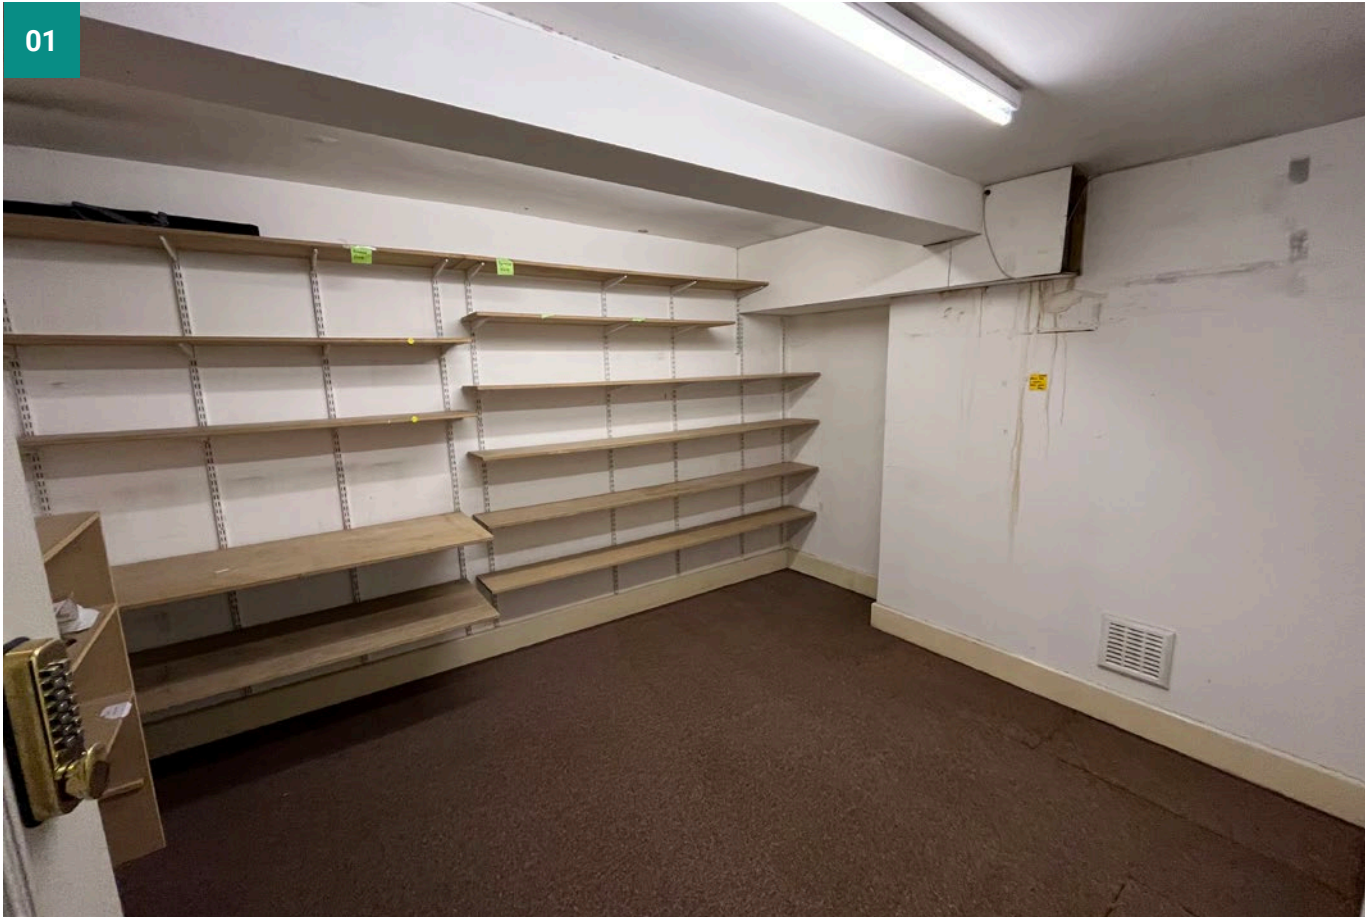
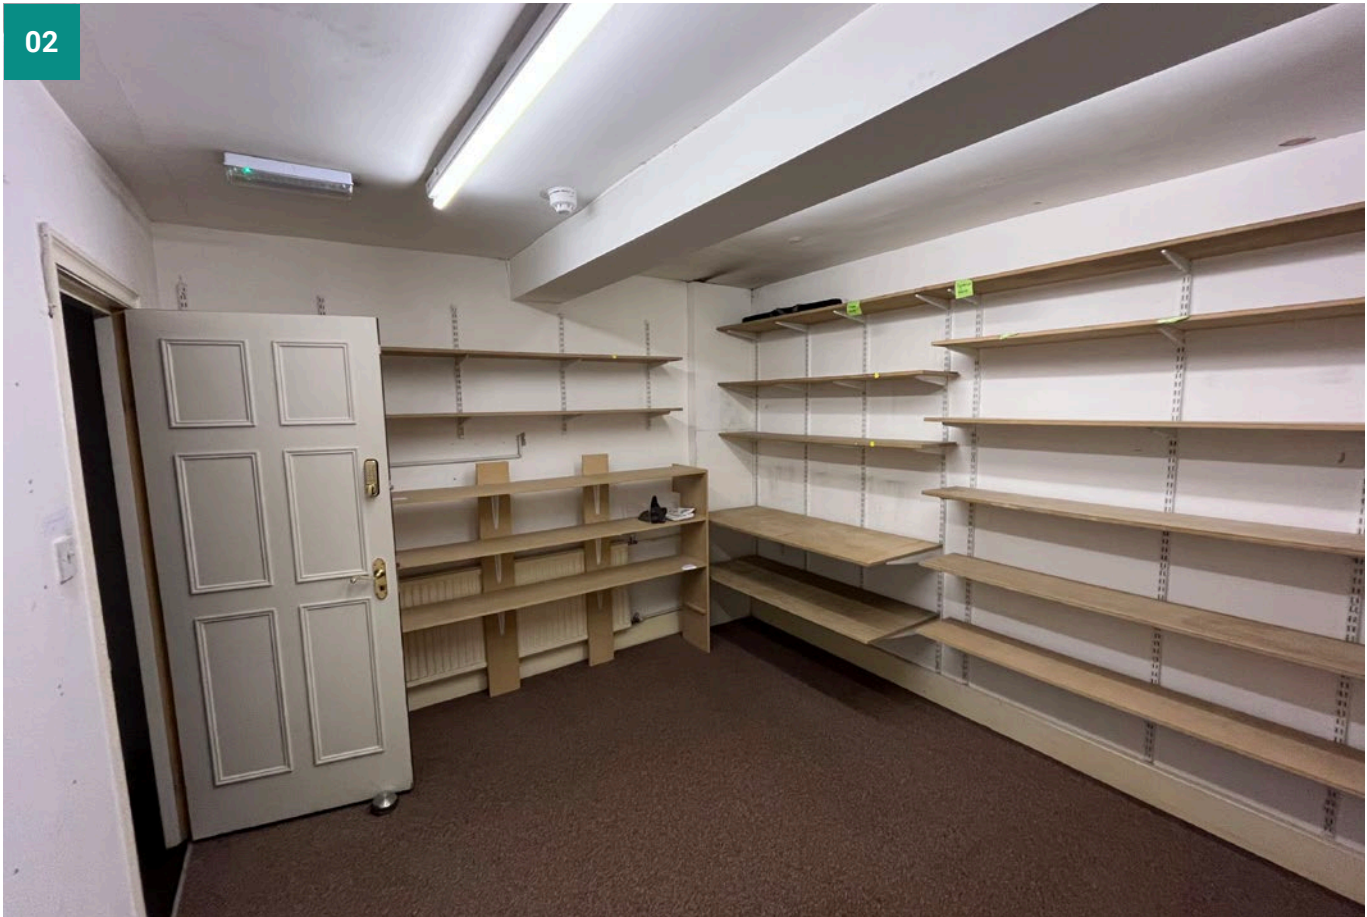
FIGURE 03 ROOM LG.04

LOCATION	DESCRIPTION	CONDITION / SCOPE OF REPAIR	COMMENTS
LG.04	Ceiling	Modern ceiling in bad condition with cracks and black spots in corners. A bulkhead spans from North wall to the chimney breast (now closed up with modern vent louvre)	Restore the ceiling plaster, repaint, check option of creating a suspended ceiling to conceal bulkhead (subject to bulkhead height)
LG.04	Floor	Poor condition modern carpet, covering concrete slab	Carpet to be removed, new floor to be installed above existing concrete.
LG.04	Walls / Skirting	<ul style="list-style-type: none">Shelving & Fixings to be removedModern skirting, poor condition	<ul style="list-style-type: none">Walls to be made good and repainted where keptSkirting to be replacedSince LG03 and LG04 are to be connected, option to reinstate fireplace
LG.04	Internal Doors	Modern door and ironmongery	Door to be removed
LG.04	Radiators	Modern panel radiators with surface mounted pipework	To be removed

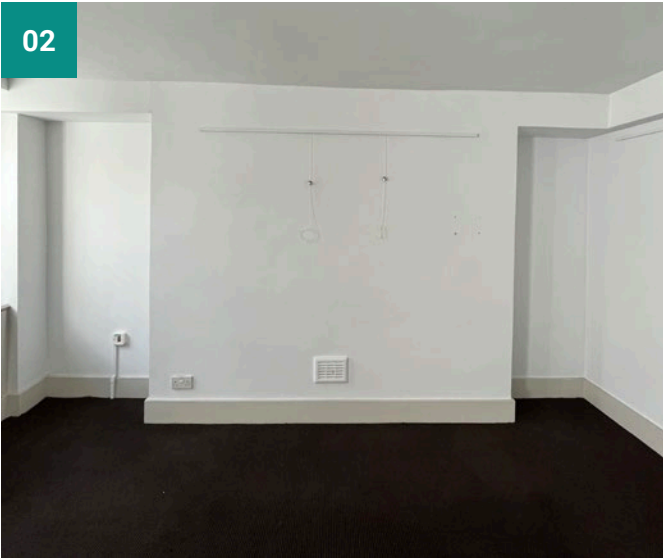
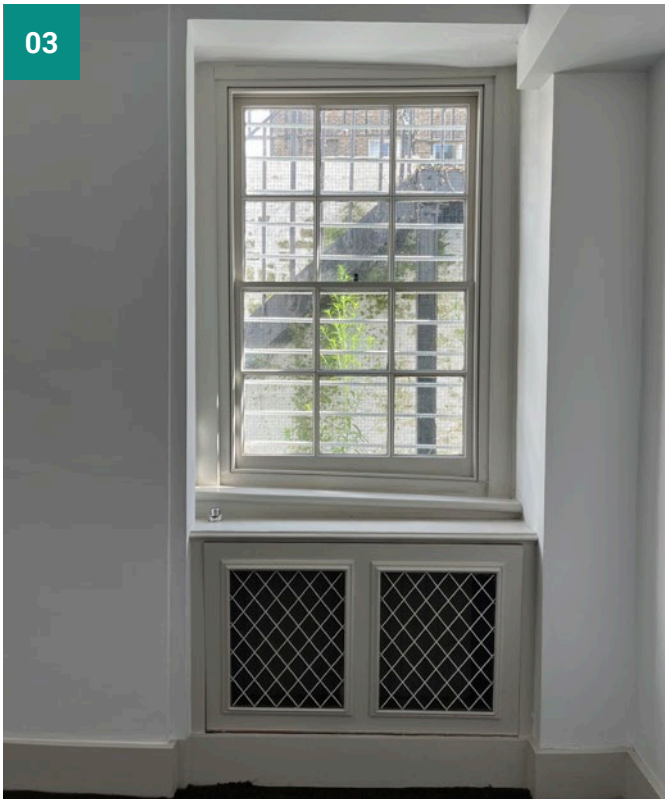
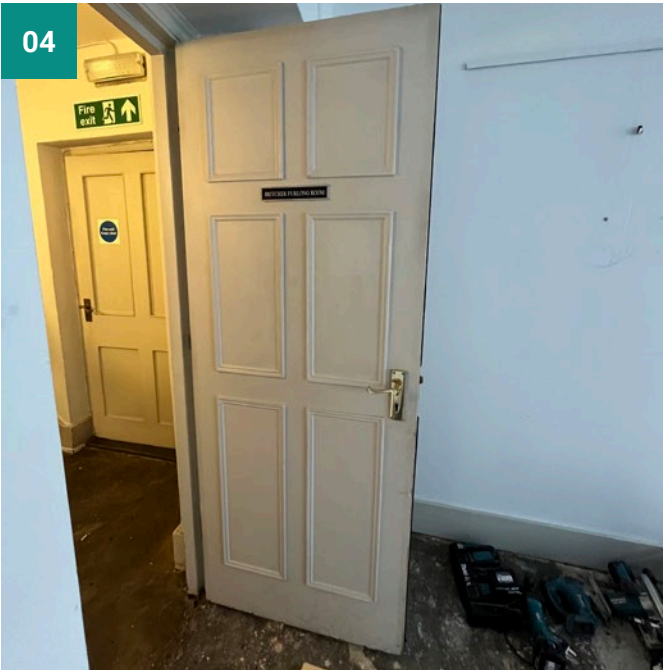
FIGURE 04 ROOM LG.05

LOCATION	DESCRIPTION	CONDITION / SCOPE OF REPAIR	COMMENTS
LG.05	Ceiling / Cornice	<ul style="list-style-type: none">• Modern plasterboard ceiling with modern fittings• Bulkheads running around room perimeter to conceal services	Ceiling to be renewed
LG.05	Floor	Poor condition modern carpet, covering concrete slab	Carpet to be removed, new floor to be installed above existing concrete.
LG.05	Internal Door	Existing door to be retained	modern fixtures and fittings to be removed and replaced
LG.05	Walls / Skirting	<ul style="list-style-type: none">• White painted walls• Modern skirting	<ul style="list-style-type: none">• Where walls are to be kept, make good and repaint• Option to reinstate fireplace• Skirting to be retained and redecorated
LG.05	Windows	<ul style="list-style-type: none">• Existing timber sliding sash windows to be retained• Windows do not work and present several layers of paint	<ul style="list-style-type: none">• Windows to be kept and secondary glazing to be installed.• External metal bars to be removed

LG.05	Radiators and covers	Modern radiators and covers are located beneath each window	to be removed and replaced

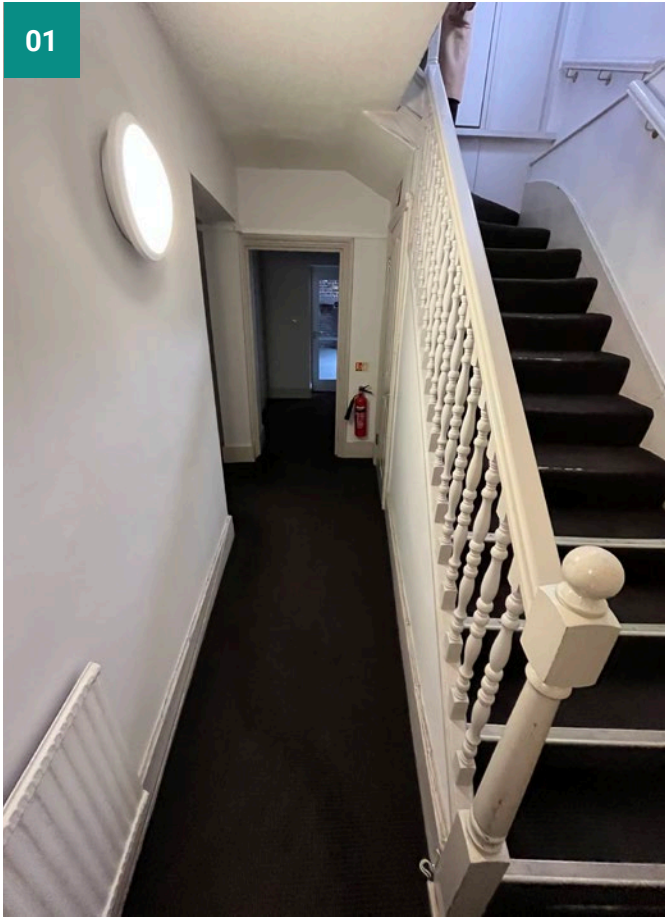
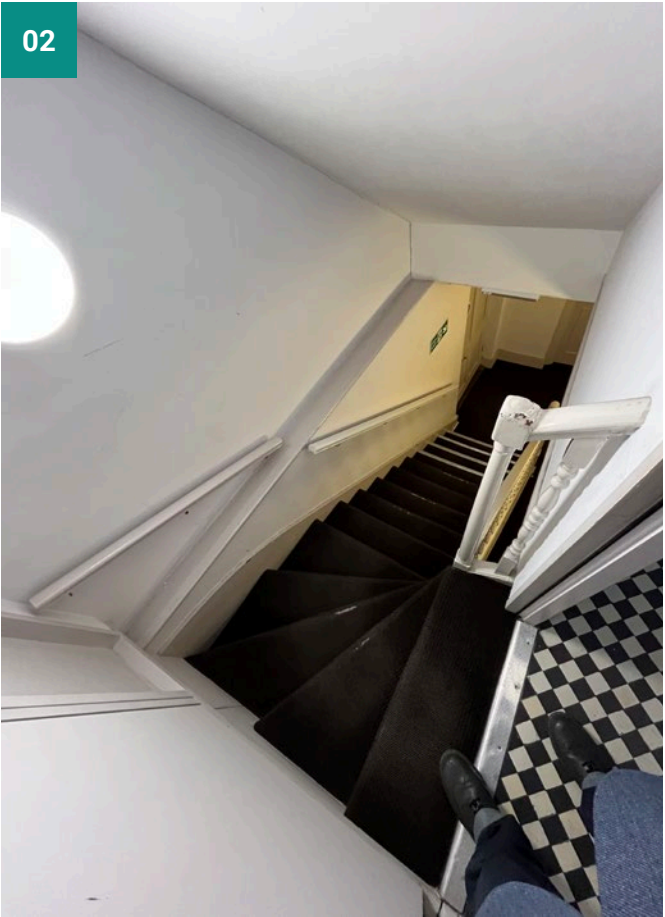
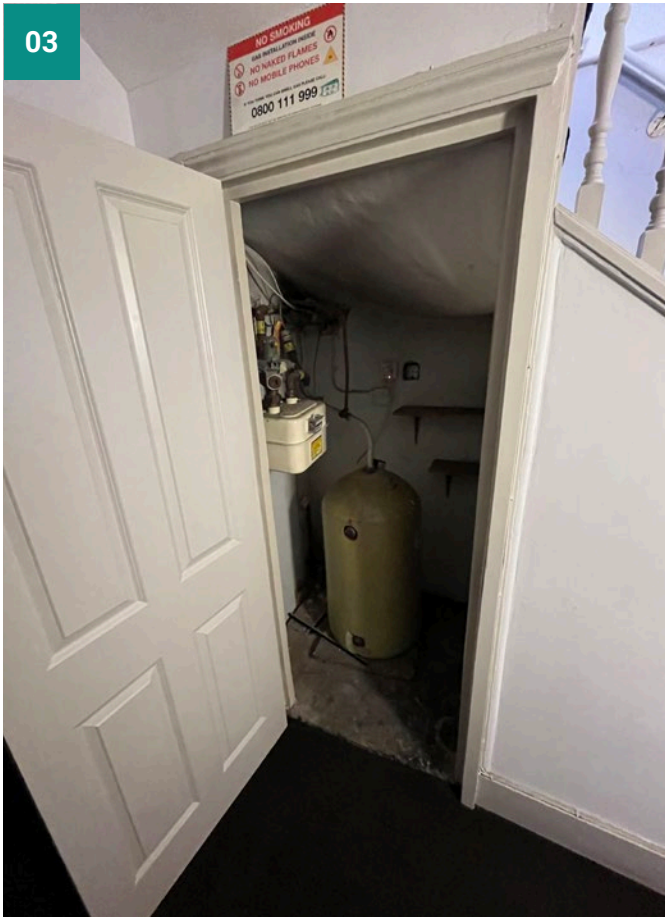
FIGURE 05 ROOM LG.06

LOCATION	DESCRIPTION	CONDITION / SCOPE OF REPAIR	COMMENTS
LG.06	Stairs	Steps covered by modern carpet	Carpet to be removed and stairs to be repaired and redecorated
LG.06	Hand rails, newel posts and balusters	All to be retained	All to be repaired and redecorated
LG.06	Floor	Modern carpet, covering concrete slab	Carpet to be removed, new floor to be installed above existing concrete.
LG.06	Walls	White painted walls	To be made good and repainted
LG.06	Internal door to services cupboard	Existing door to be retained	To be repaired and redecorated with new ironmongery & fittings

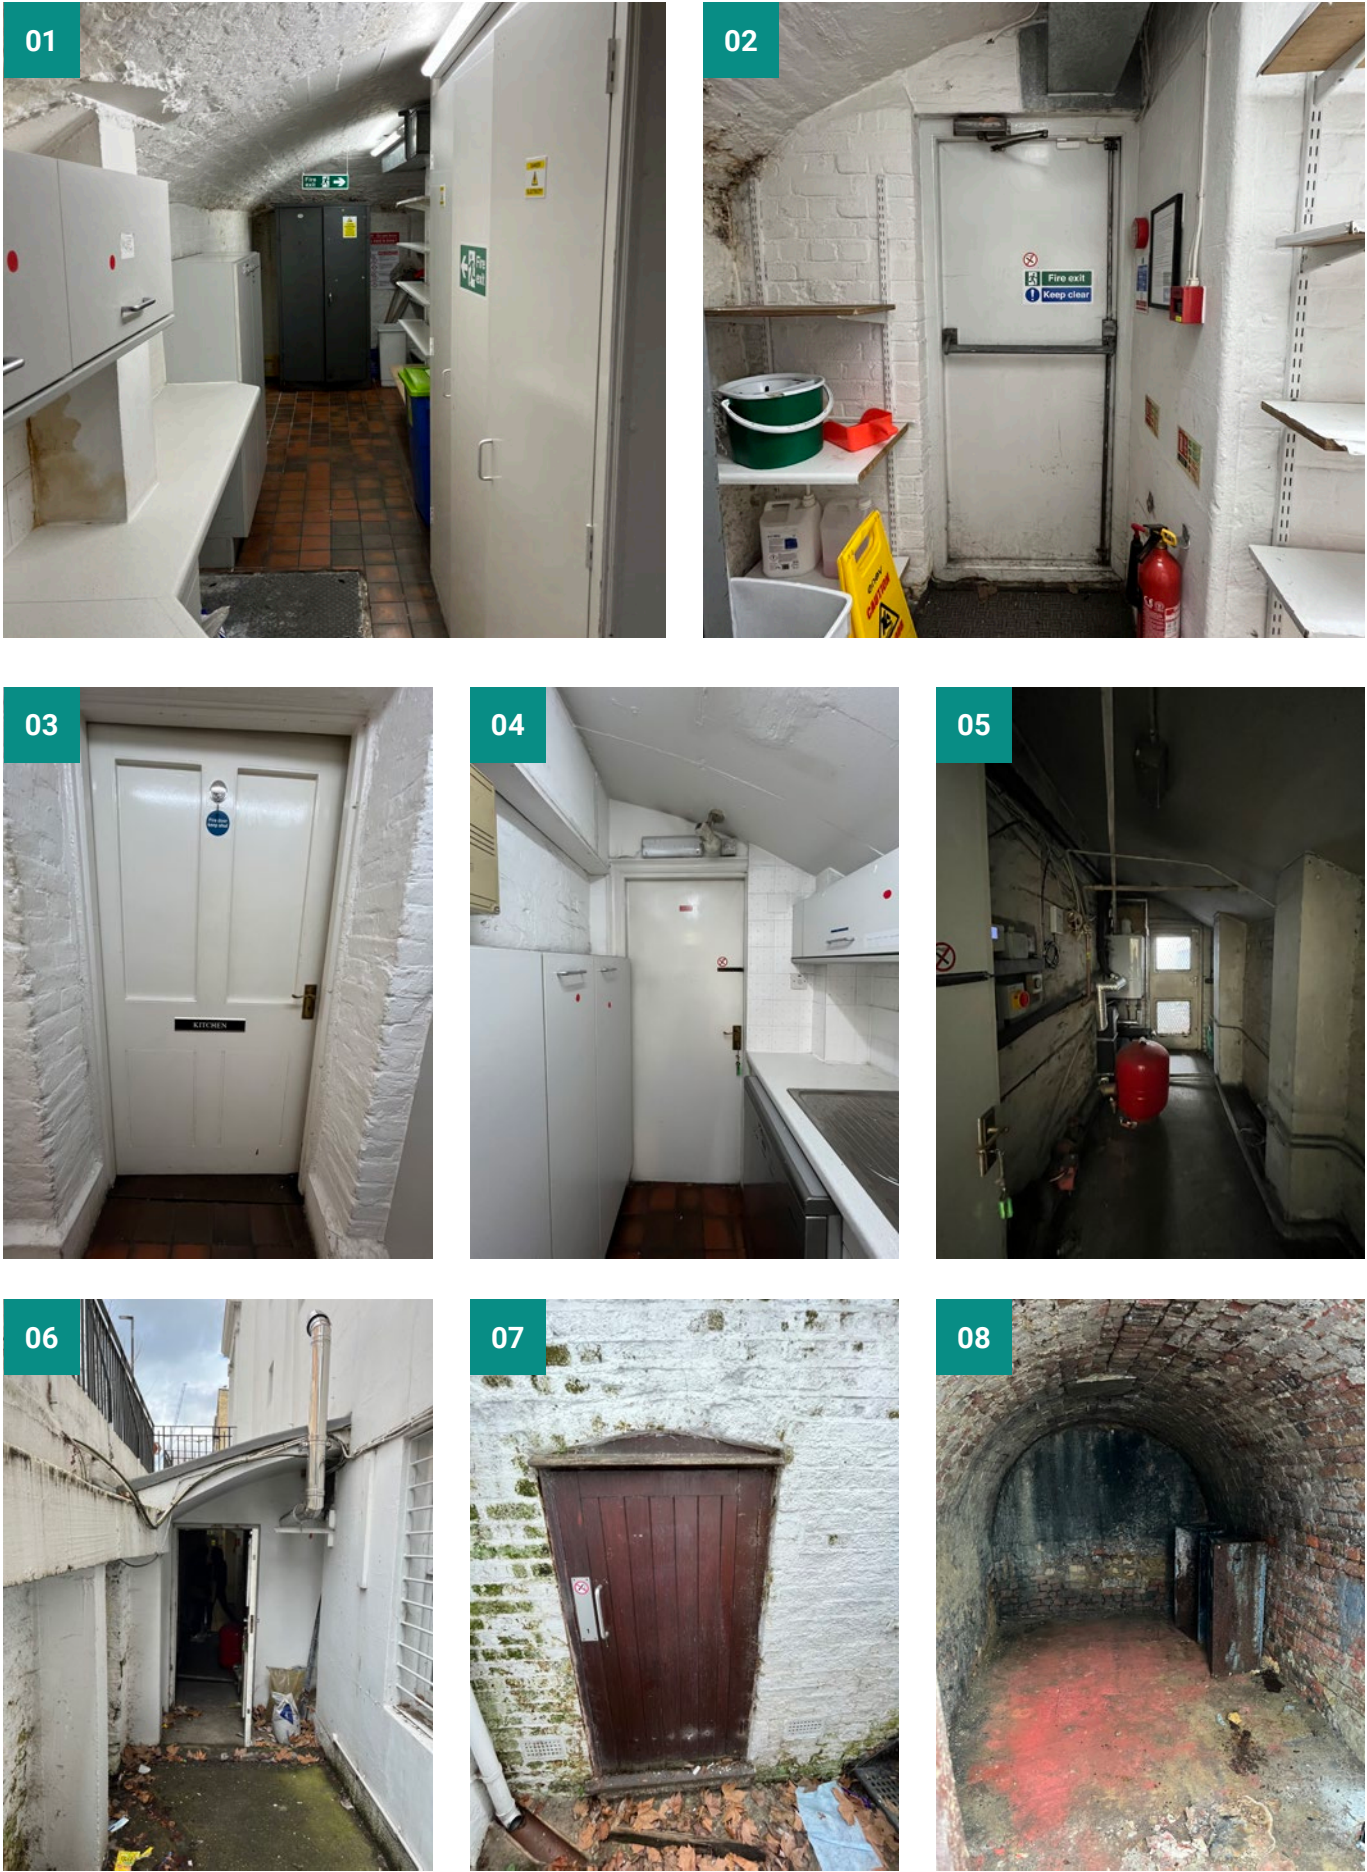
FIGURE 06 ROOM LG.07

LOCATION	DESCRIPTION	CONDITION / SCOPE OF REPAIR	COMMENTS
LG.07	Ceiling	Vaulted ceiling with partially exposed bricks and partially concealed by a plaster layer	All to be repaired and redecorated
LG.07	Floor	Modern terracotta tiles and exposed concrete slab in boiler room	Tiles to be stripped out and all the floor to be repaved
LG.07	Walls	Modern wall tiles and painted brickworks	Tiles to be removed and walls to be repaired and repainted
LG.07	Internal Door	Door beween LG06 & LG07 to be retained	<ul style="list-style-type: none">Doors to be retained, replaced and redecoratedNew ironmongery to be installed
LG.07	External Doors	All modern doors to be removed and renewed	To be removed and replaced
LG.07	Kitchen	Poor quality modern kitchen and shelving	All removed and replaced

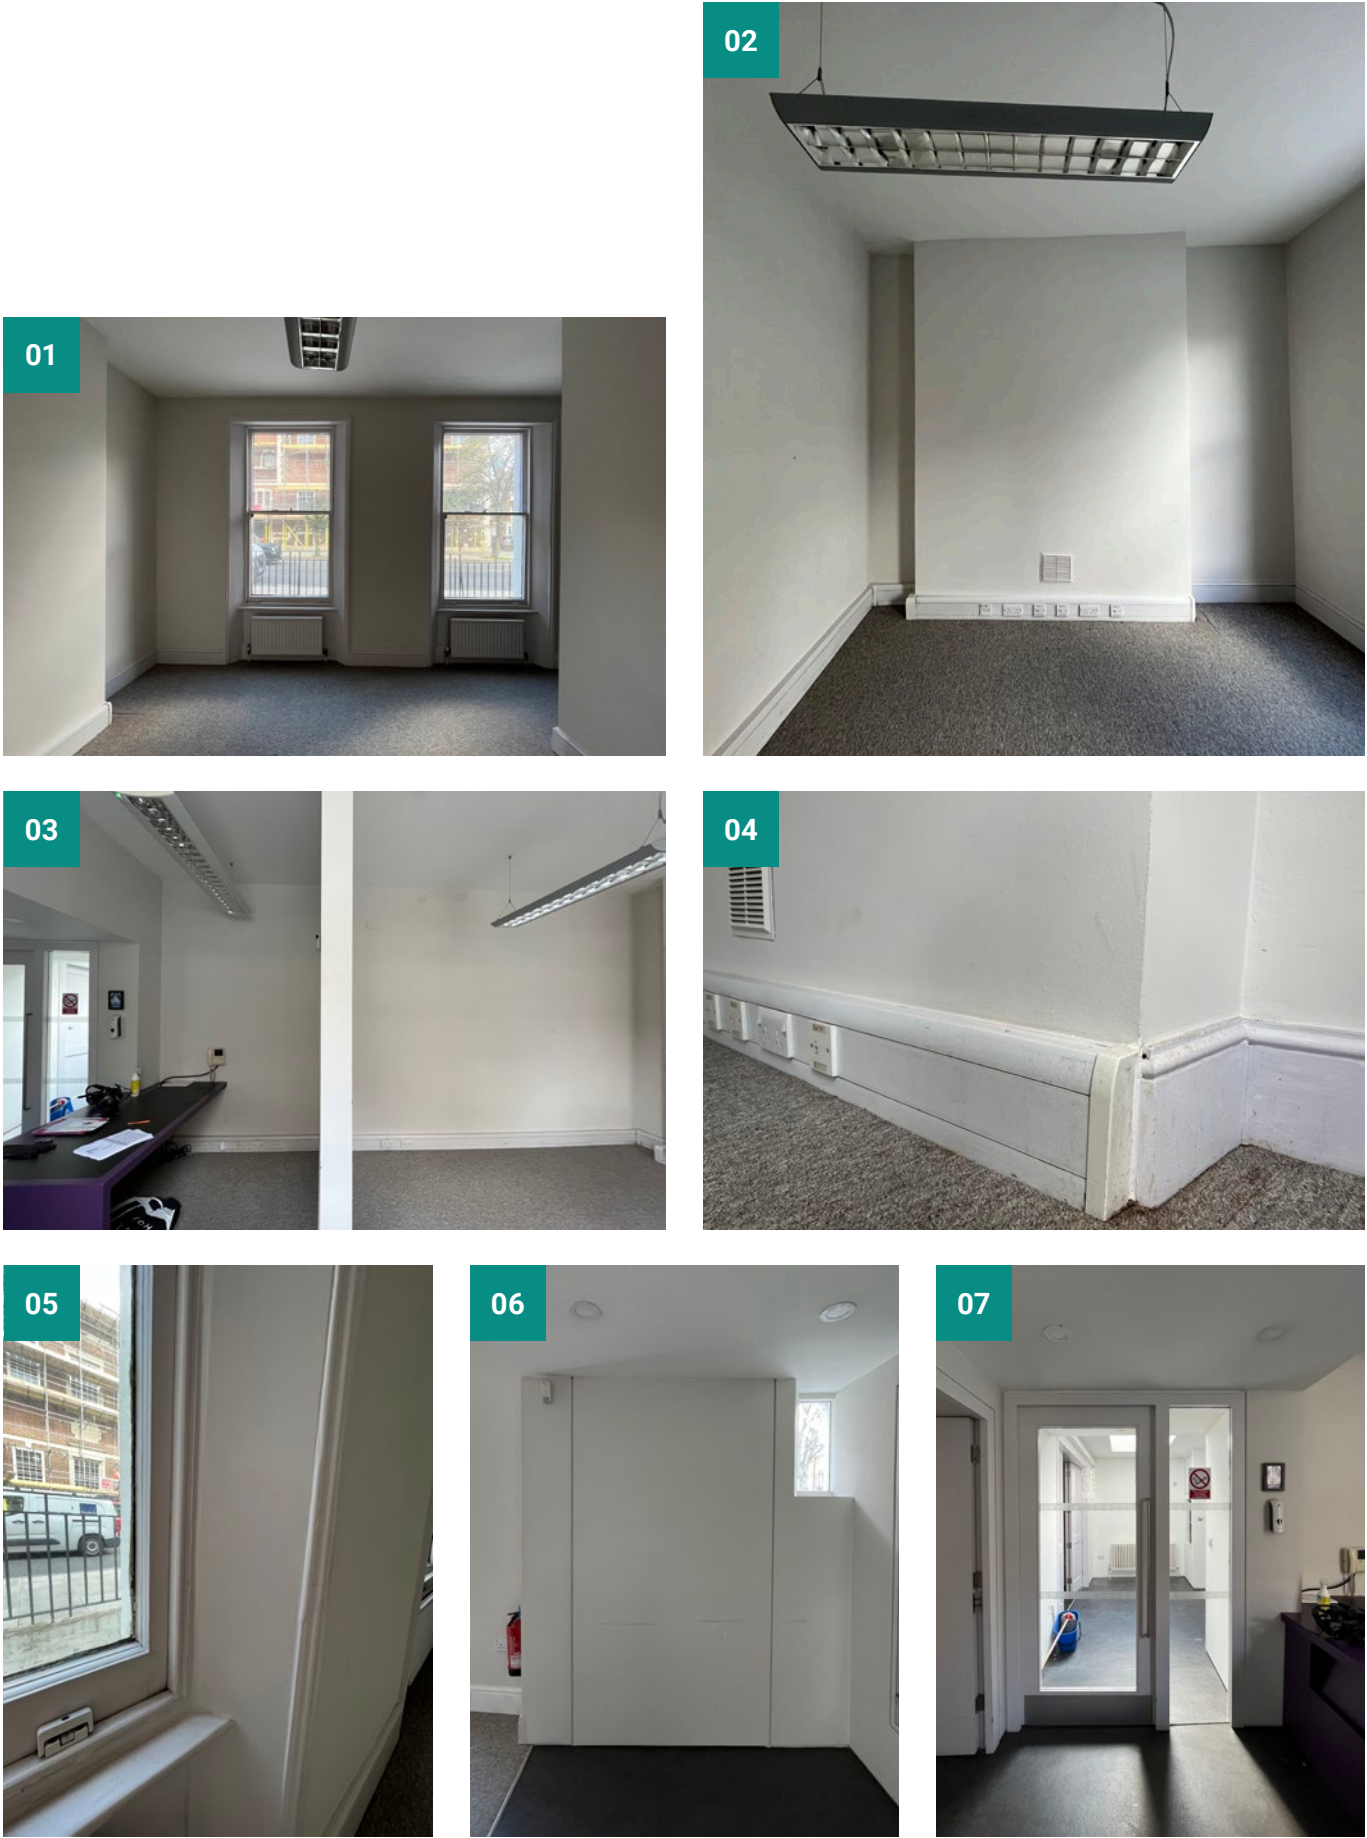
FIGURE 07 ROOM G.01 / G.02

LOCATION	DESCRIPTION	CONDITION / SCOPE OF REPAIR	COMMENTS
G.01 / G.02	Ceiling / Cornice	<ul style="list-style-type: none">• High ceiling, no spotlights except for bulkhead• No cornice	All to be adapted to suit layout of conversion to residential use
G.01 / G.02	Floor	Part carpet, part vinyl covering concrete slab	All to be adapted to suit layout of conversion to residential use
G.01 / G.02	Walls / Skirting	<ul style="list-style-type: none">• Good condition• Mostly modern skirting with plastic electrical conduits• Skirting below indows appers to be original	<ul style="list-style-type: none">• All to be adapted to suit layout of conversion to residential use• Original skirting to be retained
G.01 / G.02	Windows	Timber sliding sash windows, single glazed. Windows do not open and present several layers of paint.	Existing windows to be retained and refurbished with secondary glazing added
G.01 / G.02	Internal Doors	New door with vision panel, good condition - non original	All to be adapted to suit layout of conversion to residential use

G.01 / G.02	Fireplace	Chimney breast present, no fireplace insert	Option to reinstate a reclaimed fireplace
G.01 / G.02	Radiators	Modern double panel radiators located beneath windows, with concealed pipework	All to be adapted to suit layout of conversion to residential use

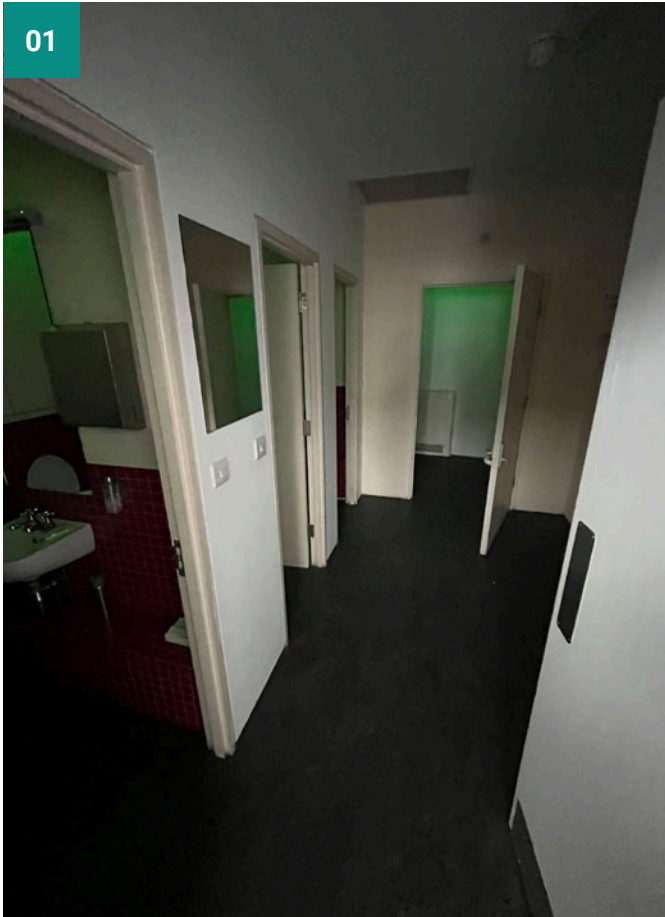
FIGURE 08 ROOM G.03

LOCATION	DESCRIPTION	CONDITION / SCOPE OF REPAIR	COMMENTS
G.03	Ceiling / Cornice	Modern suspended ceiling	All to be adapted to suit layout of conversion to residential use
G.03	Floor	Modern vinyl covering concrete slab	All to be adapted to suit layout of conversion to residential use
G.03	Walls / Skirting	Modern partitions	All to be adapted to suit layout of conversion to residential use
G.03	Internal Doors	All are plain modern doors	All to be adapted to suit layout of conversion to residential use

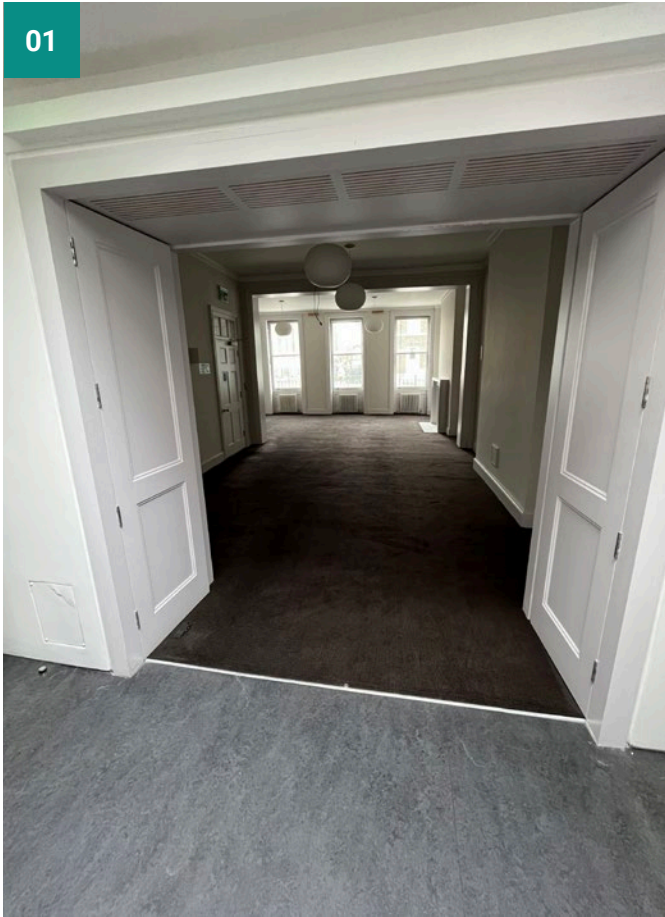
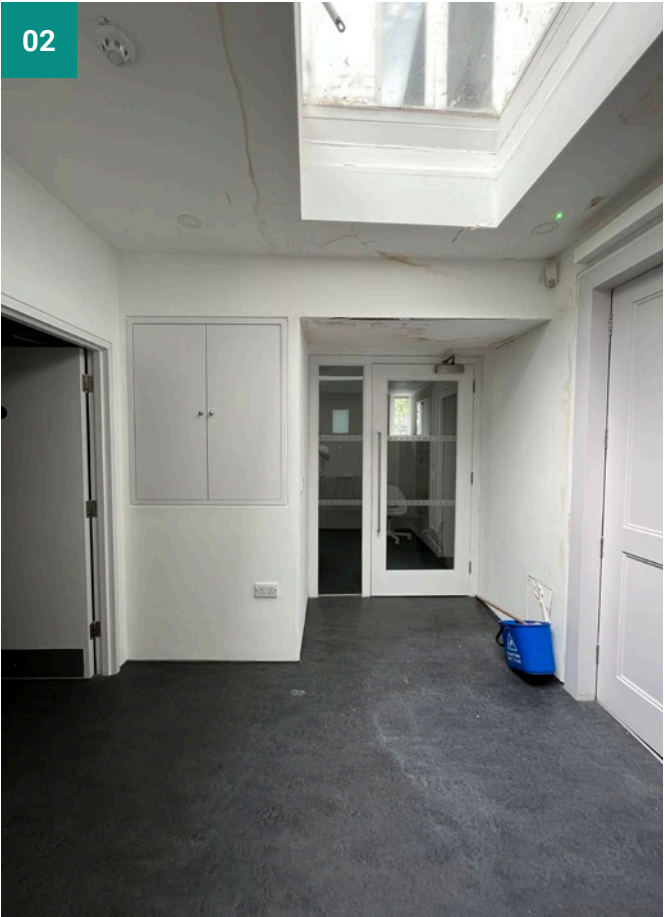
FIGURE 09 ROOM G.04

LOCATION	DESCRIPTION	CONDITION / SCOPE OF REPAIR	COMMENTS
G.04	Ceiling / Cornice	<ul style="list-style-type: none">• Modern Suspended ceiling• No cornice• Modern plastic rooflight	All to be adapted to suit layout of conversion to residential use
G.04	Floor	Part carpet, part vinyl covering concrete slab	All to be adapted to suit layout of conversion to residential use
G.04	Walls / Skirting	<ul style="list-style-type: none">• Modern plasterboard• Modern skirting and panels	All to be adapted to suit layout of conversion to residential use
G.04	Windows	N/A	N/A
G.04	Internal Doors	Modern door with vision panel	All to be adapted to suit layout of conversion to residential use
G.04	Fireplace	Chimney breast present, no fireplace insert	All to be adapted to suit layout of conversion to residential use
G.04	Radiators	Tubular Radiators	All to be adapted to suit layout of conversion to residential use

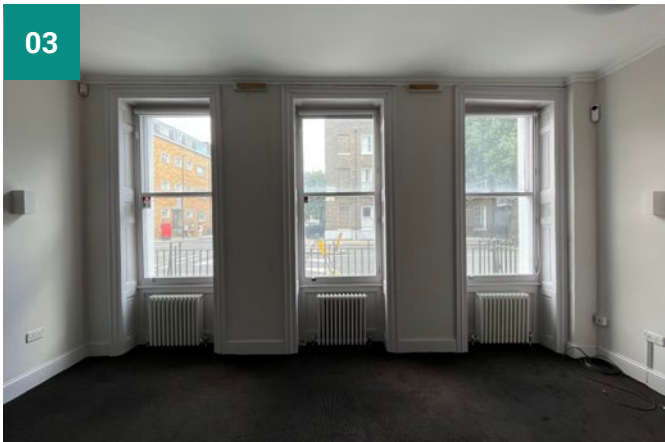
FIGURE 10 ROOM G.05 / G.06

LOCATION	DESCRIPTION	CONDITION / SCOPE OF REPAIR	COMMENTS
G.05 / G.06	Ceiling / Cornice	<ul style="list-style-type: none">Plasterboard ceilingCornice with floral pattern	<ul style="list-style-type: none">Ceiling and cornice to be repaired and redecorated
G.05 / G.06	Floor	Modern Carpet	Carpet to be stripped out renewed
G.05 / G.06	Walls / Skirting	<ul style="list-style-type: none">Plaster wallModern skirtingFrame to opening non original	Walls and skirting to be repaired and repainted
G.05 / G.06	Windows	Existing timber sash windows, single glazed and secondary glazing to be retained	Existing windows and secondary glazing repaired and redecorated, including architrves, cills, panelled reveals and panels below windows
G.05 / G.06	Internal Doors	Existing doors to stair/lobby retained Modern cupboard doors and screens to be removed	Existing doors to the stair lobby to be retained and refurbished including the fanlight above

G.05 / G.06	Fireplace	<ul style="list-style-type: none">G.06: Fireplace retainedG.05: Chimney breast present, no fireplace insert	G.05: Option to reinstate a reclaimed fireplace
G.05 / G.06	Radiators	Modern radiators beneath windows	Radiarors to be replaced

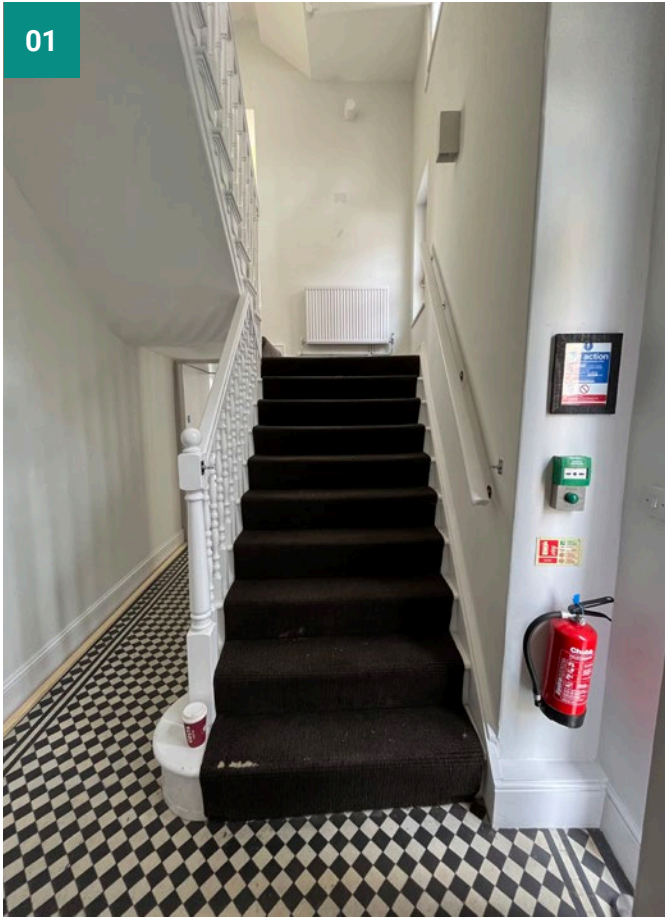
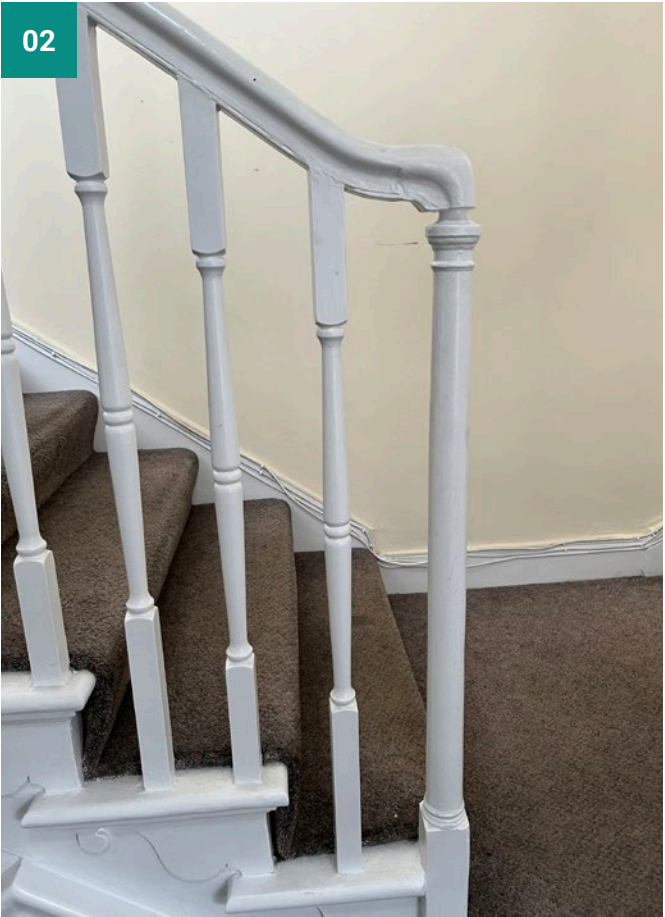
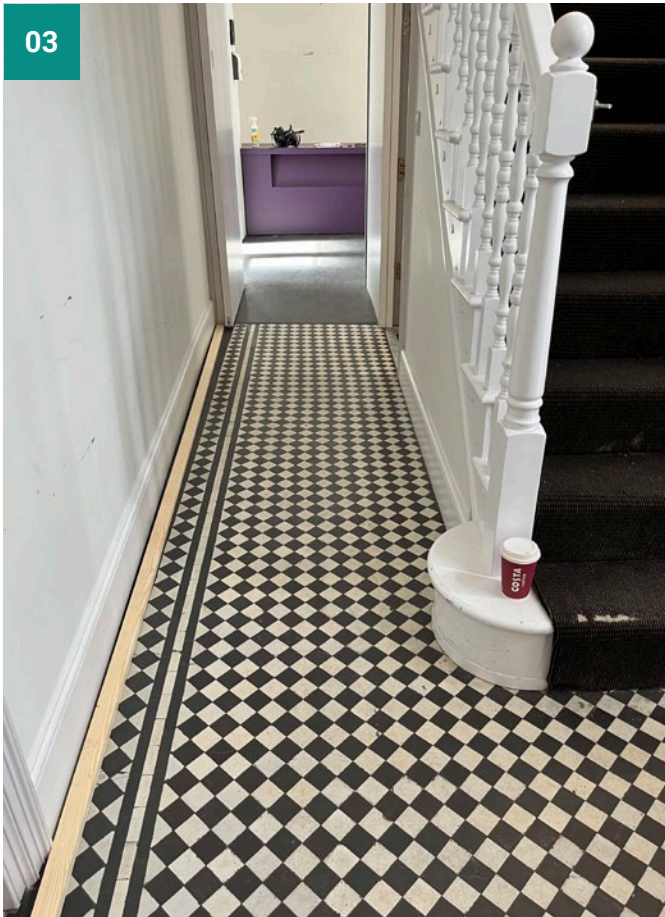
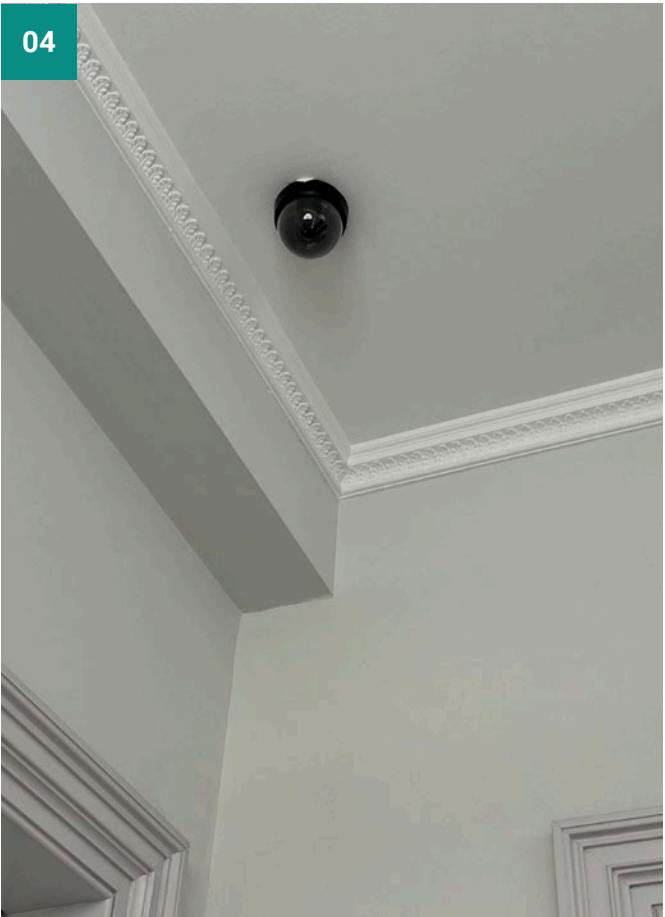
FIGURE 11 ROOM G.07

LOCATION	DESCRIPTION	CONDITION / SCOPE OF REPAIR	COMMENTS
G.07	Stairs	Modern balusters, but newel post & baluster handrail appears to be original components	<ul style="list-style-type: none">• Carpet removed and replaced• All joinery renovated
G.07	Floor	Chequer tile floor to be retained	Tiled floor to be repaired where needed and retained
G.07	Walls	White painted walls	To be made good and repainted
G.07	Ceiling	Modern plasterboard ceiling Cornice with floral pattern	Ceiling and cornice to be redecorated and retained
