/ 8 GUILFORD STREET ROOM SCHEDULE

6569

REV 01

26/09/2023

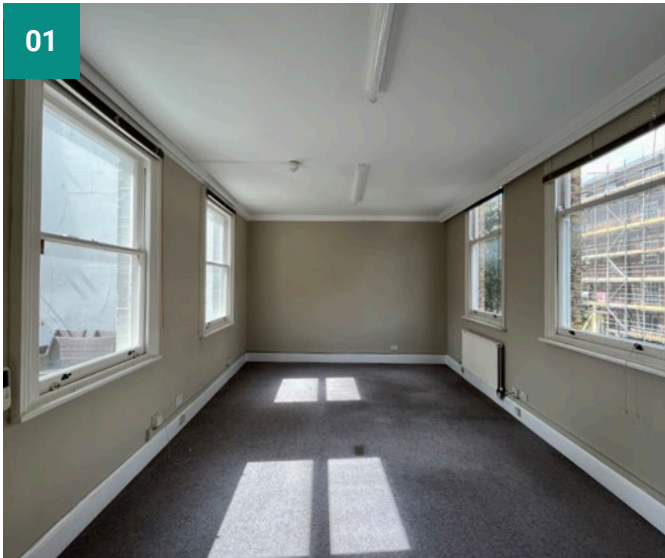
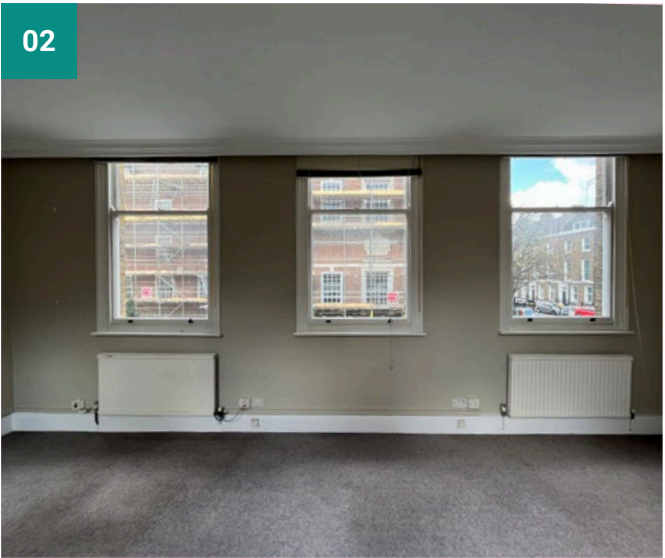
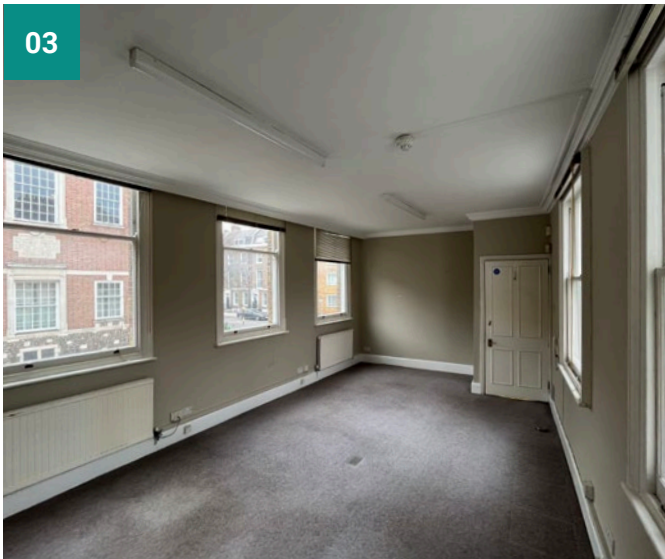
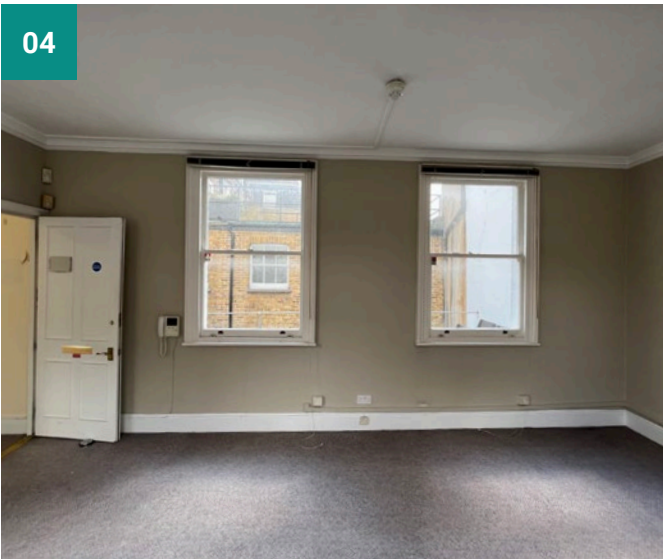
FIGURE 12 ROOM 01.01

LOCATION	DESCRIPTION	CONDITION / SCOPE OF REPAIR	COMMENTS
01.01	Ceiling / Cornice	<ul style="list-style-type: none">• Modern plasterboard ceiling and cornice• Ceiling bulkhead covering part of existing window	All to be adapted to suit layout of conversion to residential use

01.01	Floor	Modern carpet covering timber floor	All to be adapted to suit layout of conversion to residential use
01.01	Walls / Skirting	<ul style="list-style-type: none">• Plasterboard walls• Modern skirting• Electrical plastic conduit running above skirting	All to be adapted to suit layout of conversion to residential use

01.01	Windows	Surface mounted slideing timber sash windows, single glazed to be retained	<ul style="list-style-type: none">• Windws to be refurbished and redecorated with new secondary glazing installed• Windows to the rear to be replaced to enable extension

01.01	Internal Doors	Modern doors to be retaned for possible reuse	Doors to be retained, refurbished for possible reuse
01.01	Radiators	Modern double panel radiators	Radiators to be removed and replaced

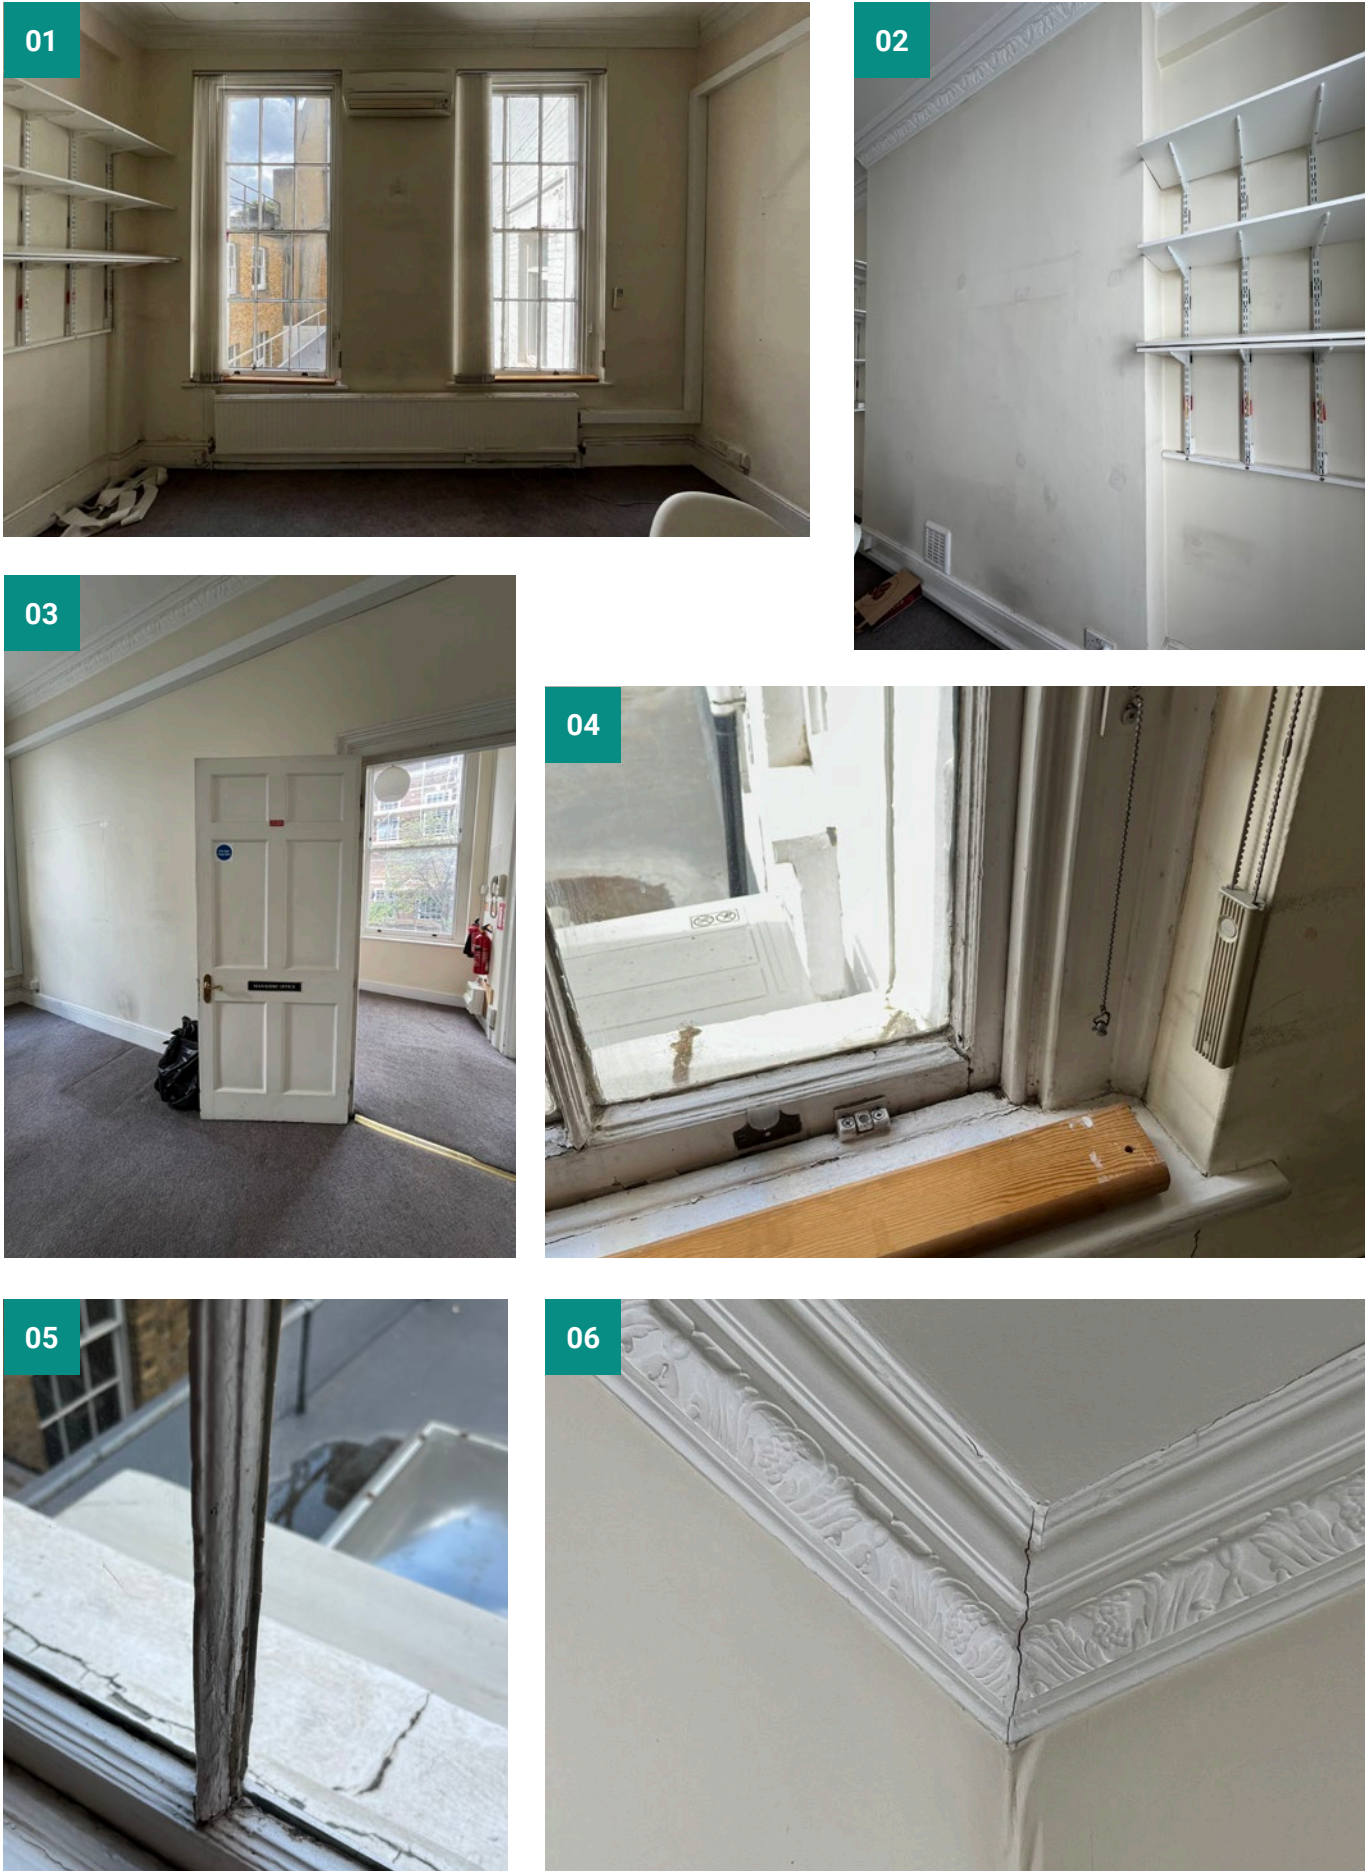
FIGURE 13 ROOM 01.02

The finishes to the walls and ceiling in this room are all in poor condition.

LOCATION	DESCRIPTION	CONDITION / SCOPE OF REPAIR	COMMENTS
01.02	Ceiling / Cornice	Ceiling and cornice in poor condition	All to be retained (where possible), refurbished and redecorated

01.02	Floor	Modern carpet covering floor - to be inspected to confirm condition	Depending on floor quality either sand and stain or replace floor with new boards. joists to be inspected

01.02	Walls / Skirting	<ul style="list-style-type: none">• Poor condition• Skirting to be retained	<ul style="list-style-type: none">• All to be retained (where possible), refurbished and redecorated• All surface mounted fixtures, fixings and services to be removed

01.02	Windows	<ul style="list-style-type: none">• Traditional timber sash windows, single glazed to be retained.• Extremely poor condition, stuck and covered in several layers of painting. Most timber forming the bars seems to be rotten and beyond repairable state	Repair where possible, and replace components beyond repair

01.02	Internal Doors	Six panel door to stair retained	Retained and refurbished, ironmongery to be replaced
01.02	Radiators	Double panel metal radiato beneath windows	Replaced and renewed

All will be retained (where possible), refurbished and redecorated

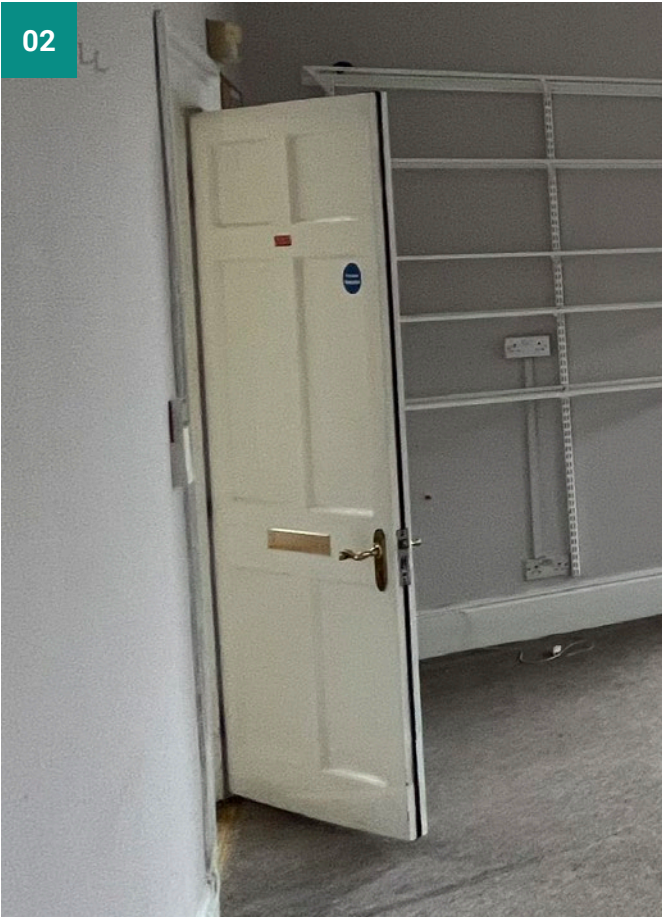
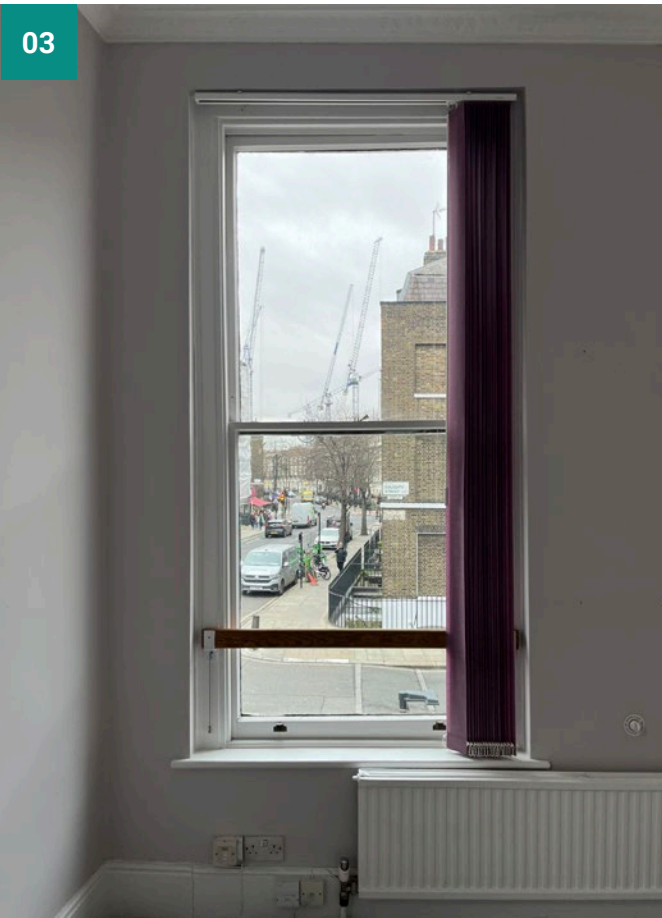
FIGURE 14 ROOM 01.03

LOCATION	DESCRIPTION	CONDITION / SCOPE OF REPAIR	COMMENTS
01.03	Ceiling / Cornice	Plaster ceiling and cornice retained	<ul style="list-style-type: none">All to be repaired and redecorated

01.03	Floor	<ul style="list-style-type: none">Modern carpetfloor to be inspected to confirm condition below carpet	Renew floor finishes
01.03	Walls / Skirting	<ul style="list-style-type: none">Plaster wall and skirting retainedElectrical plastic conduit running above skirting	<ul style="list-style-type: none">Walls to be repaired and redecoratedConduit to be stripped outAll wiring to de concealed under floor/ceiling/walls

01.03	Windows	<ul style="list-style-type: none">Existing sliding sash windows, single glazed retained. Windows are covered in several layers of painting.	<ul style="list-style-type: none">To be refurbished and redecorated (where possible)Secondary glazing to be installed

01.03	Internal Doors	Existing timber door retained	To be retained and redecorated with new ironmongery
01.03	Radiators	Double panel metal radiator	Radiators to be removed and replaced

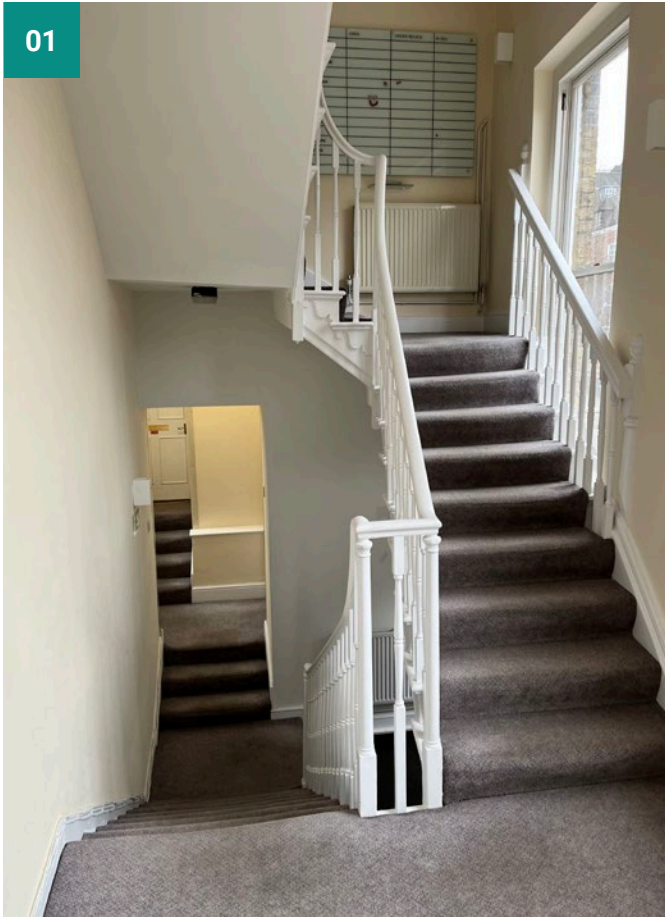
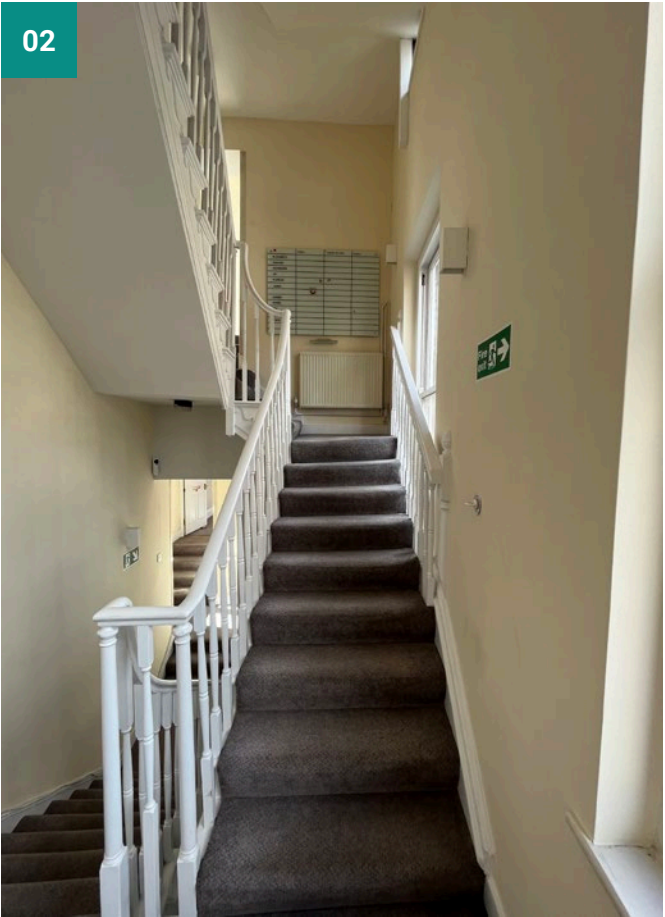
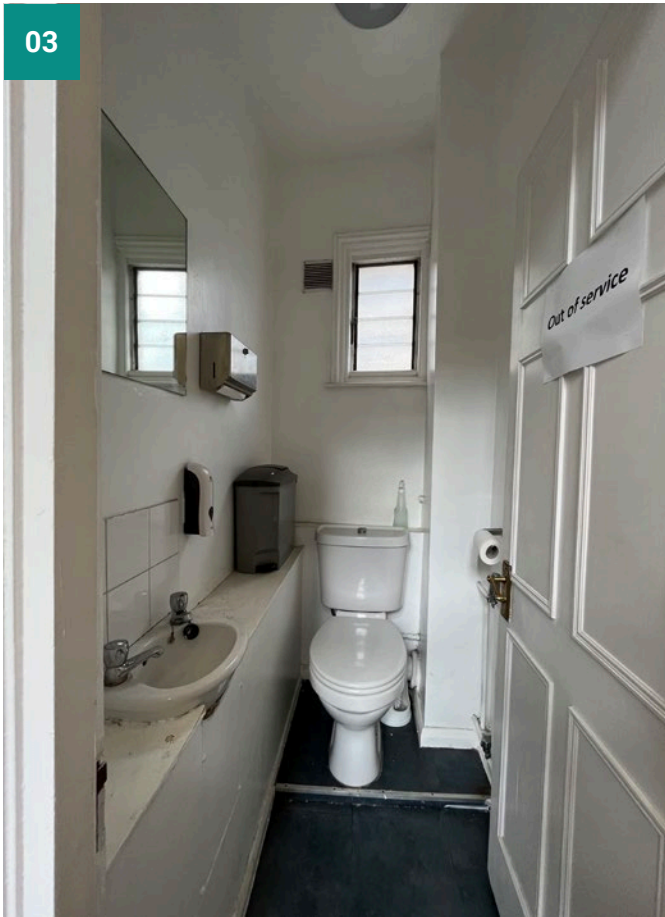
FIGURE 15 ROOM 01.04 - 01.05

Room 01.05: This modern toilet fitout will be removed entirely to suit new residential layout

LOCATION	DESCRIPTION	CONDITION / SCOPE OF REPAIR	COMMENTS
01.04	Stairs	Steps covered with modern new carpet	Carpet to be removed and replaced
01.04	Railings	Handrail to baluster and newel posts appear to be original elements, but the balusters appear to be modern	All to be retained and refurbished
01.04	Floor	Modern carpet	Carpet to be removed and replaced
01.04	Walls	Painted plaster walls	To be made good and repainted
01.05	Toilet		To be removed

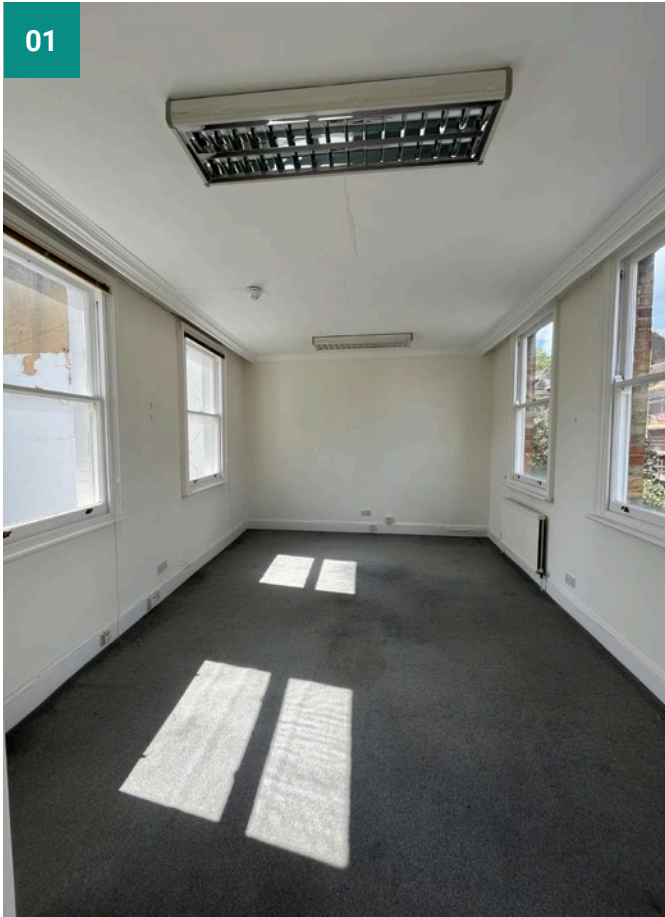
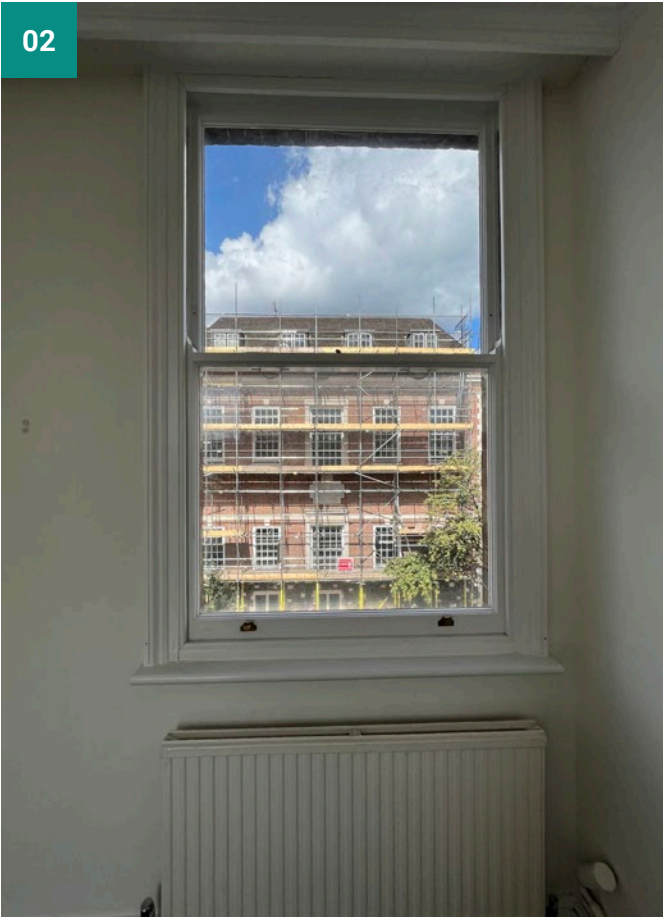
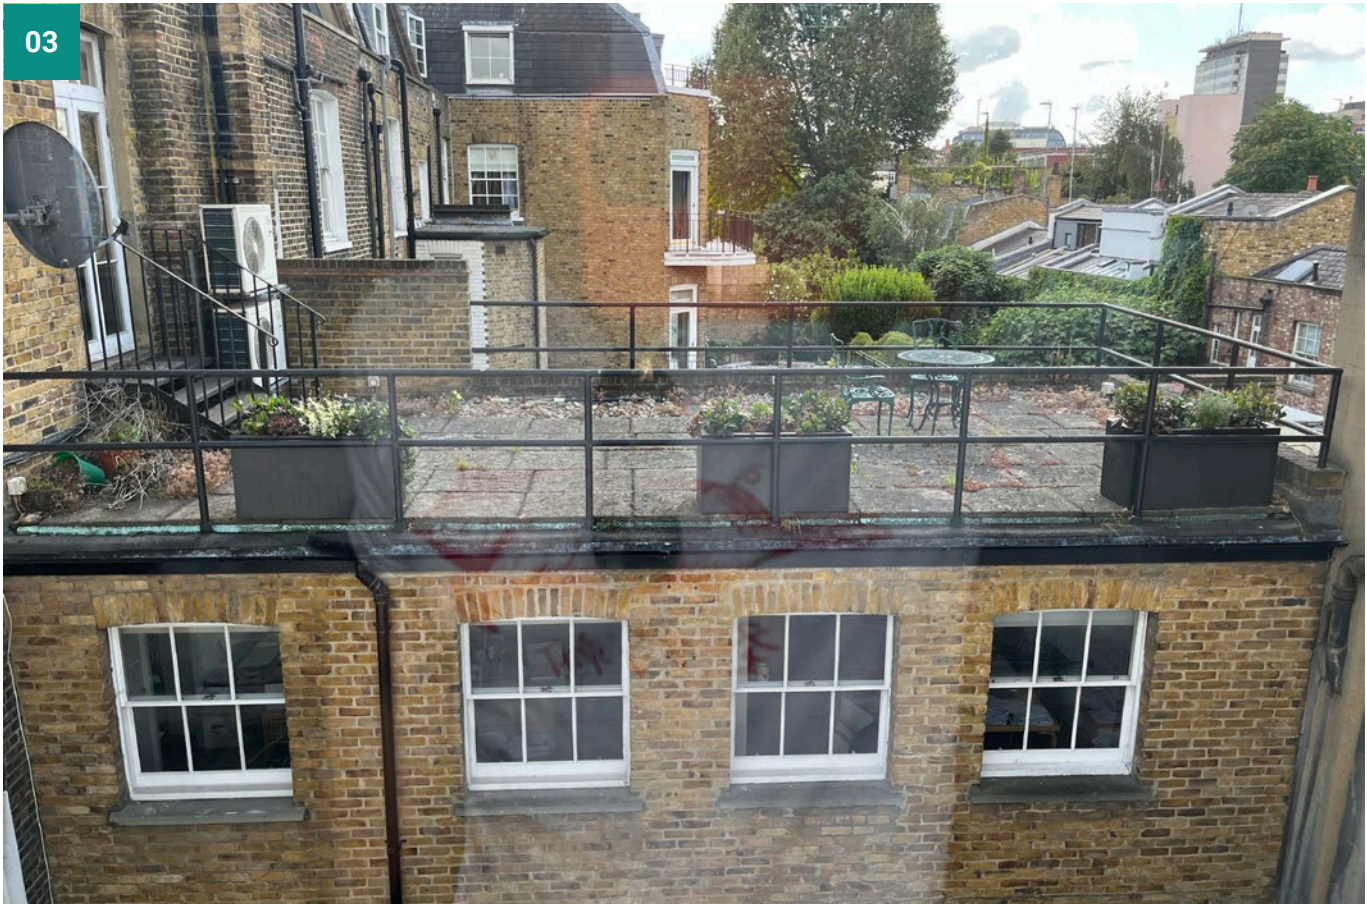
FIGURE 16 ROOM 02.01

LOCATION	DESCRIPTION	CONDITION / SCOPE OF REPAIR	COMMENTS
02.01	Ceiling / Cornice	<ul style="list-style-type: none">• Modern plasterboard ceiling and cornice• Ceiling bulkhead covering part of existing window	All to be adapted to suit layout of conversion to residential use

02.01	Floor	Modern carpet covering timber floor	All to be adapted to suit layout of conversion to residential use
02.01	Walls / Skirting	<ul style="list-style-type: none">• Plasterboard walls• Modern skirting• Electrical plastic conduit running above skirting	All to be adapted to suit layout of conversion to residential use

02.01	Windows	Surface mounted slideing timber sash windows, single glazed to be retained	<ul style="list-style-type: none">• Windows to be refurbished and redecorated with new secondary glazing installed

02.01	Internal Doors	Modern doors to be retaned for possible reuse	Doors to be retained, refurbished for possible reuse
02.01	Radiators	Modern double panel radiators	Radiators to be removed and replaced

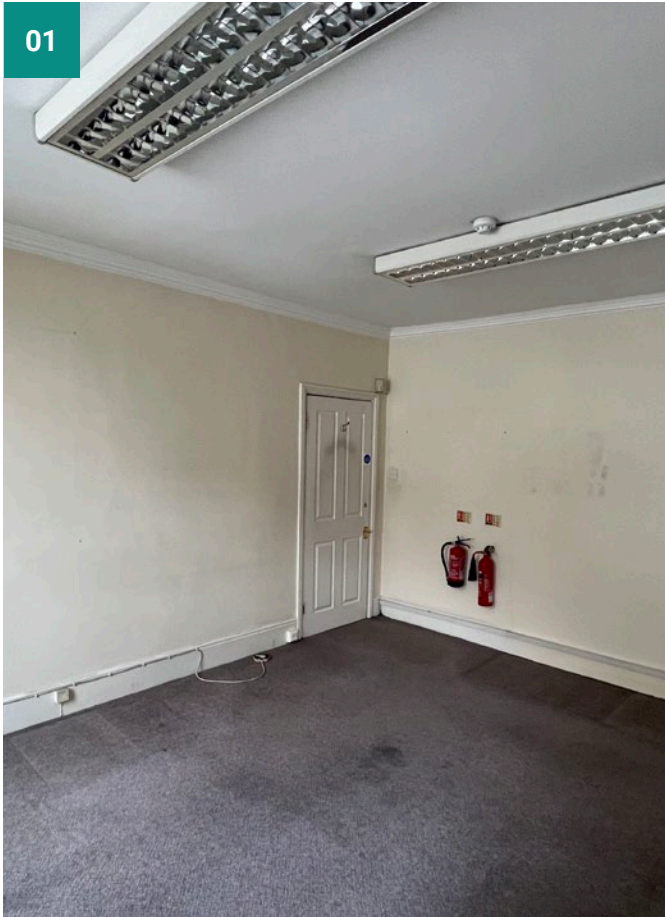
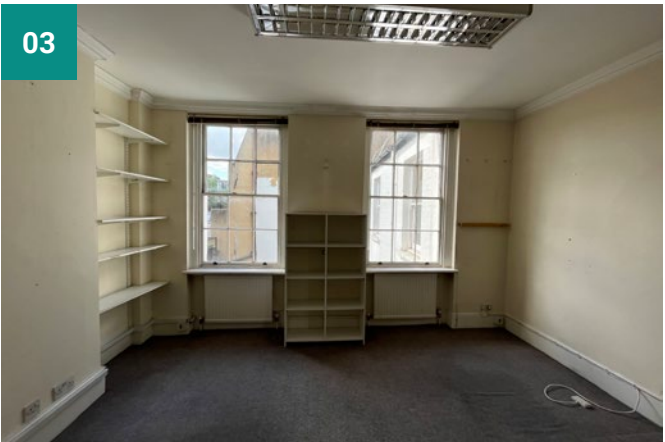
FIGURE 17 ROOM 02.02

LOCATION	DESCRIPTION	CONDITION / SCOPE OF REPAIR	COMMENTS
02.02	Ceiling / Cornice	Ceiling and cornice in poor condition	All to be retained (where possible), refurbished and redecorated

02.02	Floor	Modern carpet covering floor - to be inspected to confirm condition	Depending on floor quality either sand and stain or replace floor with new boards. joists to be inspected

02.02	Walls / Skirting	<ul style="list-style-type: none">• Poor condition• Skirting to be retained	<ul style="list-style-type: none">• All to be retained (where possible), refurbished and redecorated• All surface mounted fixtures, fixings and services to be removed

02.02	Windows	<ul style="list-style-type: none">• Traditional timber sash windows, single glazed to be retained.• Extremely poor condition, stuck and covered in several layers of painting. Most timber forming the bars seems to be rotten and beyond repairable state	Repair where possible, and replace components beyond repair

02.02	Internal Doors	Six panel door to stair retained	Retained and refurbished, ironmongery to be replaced
02.02	Radiators	Double panel metal radiato beneath windows	Replaced and renewed

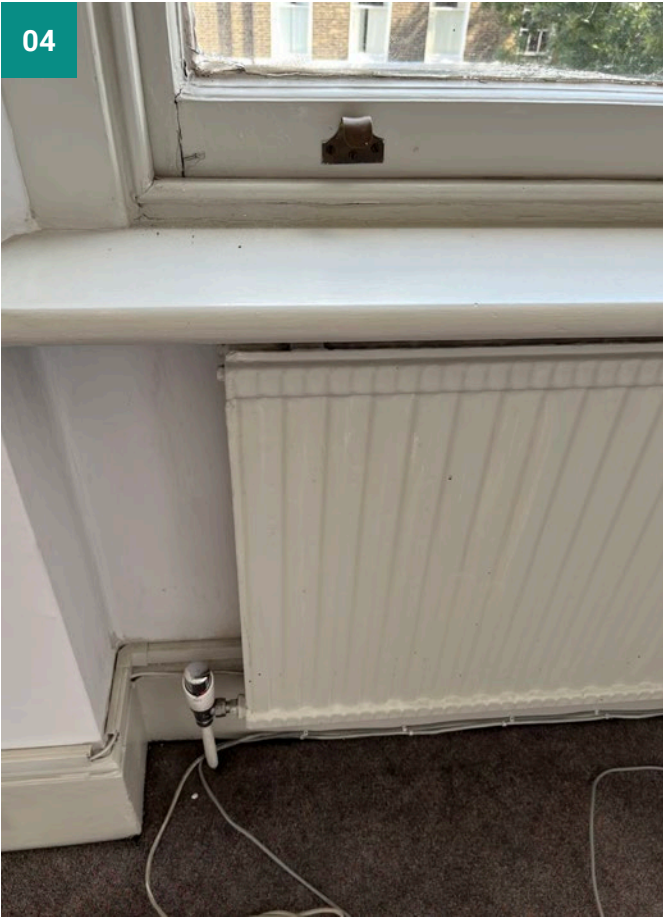
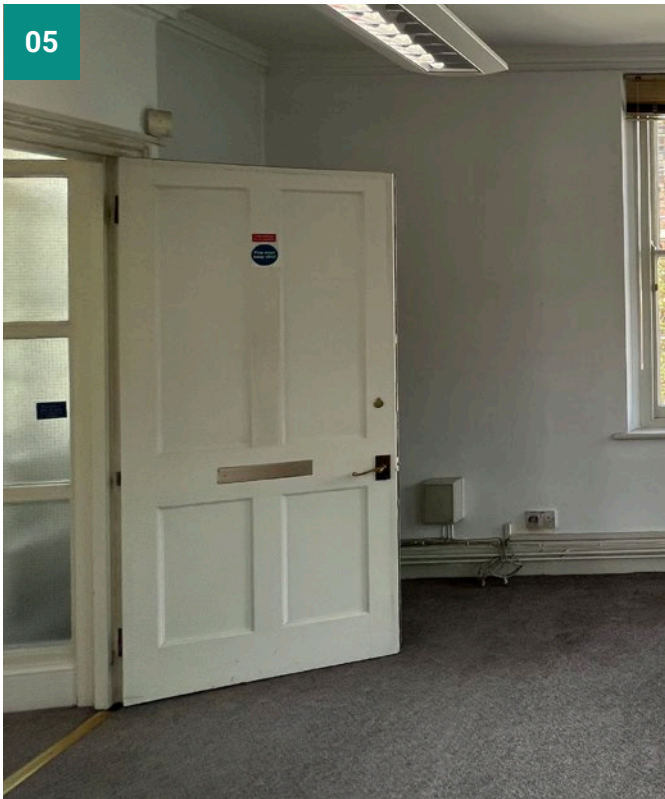
FIGURE 18 ROOM 02.03

LOCATION	DESCRIPTION	CONDITION / SCOPE OF REPAIR	COMMENTS
02.03	Ceiling / Cornice	Plaster ceiling and cornice retained	<ul style="list-style-type: none">All to be repaired and redecorated

02.03	Floor	<ul style="list-style-type: none">Modern carpetfloor to be inspected to confirm condition below carpet	Renew floor finishes
02.03	Walls / Skirting	<ul style="list-style-type: none">Plaster wall and skirting retainedElectrical plastic conduit running above skirting	<ul style="list-style-type: none">Walls to be repaired and redecoratedConduit to be stripped outAll wiring to de concealed under floor/ceiling/walls

02.03	Windows	<ul style="list-style-type: none">Existing sliding sash windows, single glazed retained. Windows are covered in several layers of painting.	<ul style="list-style-type: none">To be refurbished and redecorated (where possible)Secondary glazing to be installed

02.03	Internal Doors	Existing timber door retained	To be retained and redecorated with new ironmongery
02.03	Radiators	Double panel metal radiator	Radiators to be removed and replaced

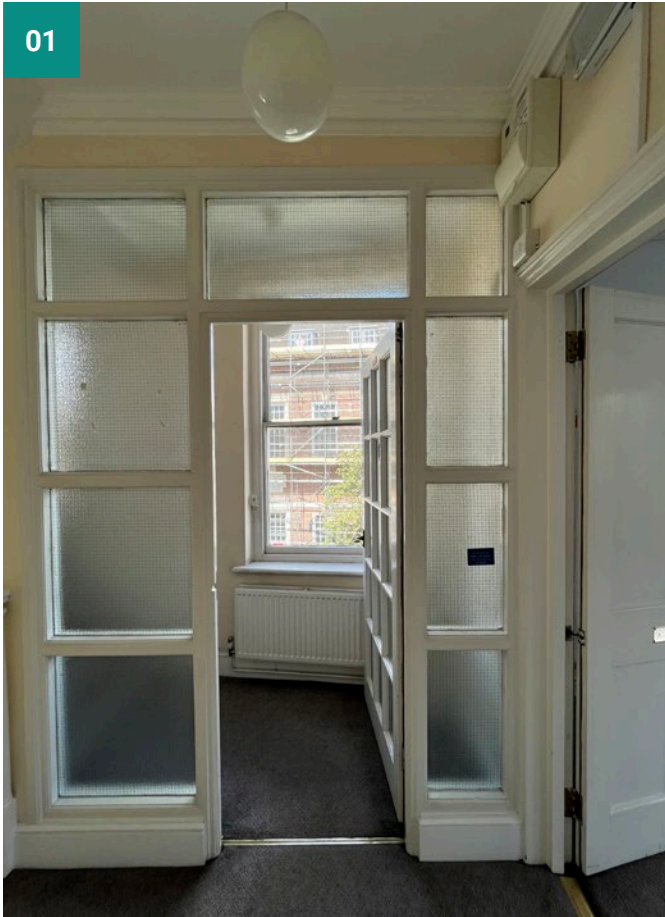
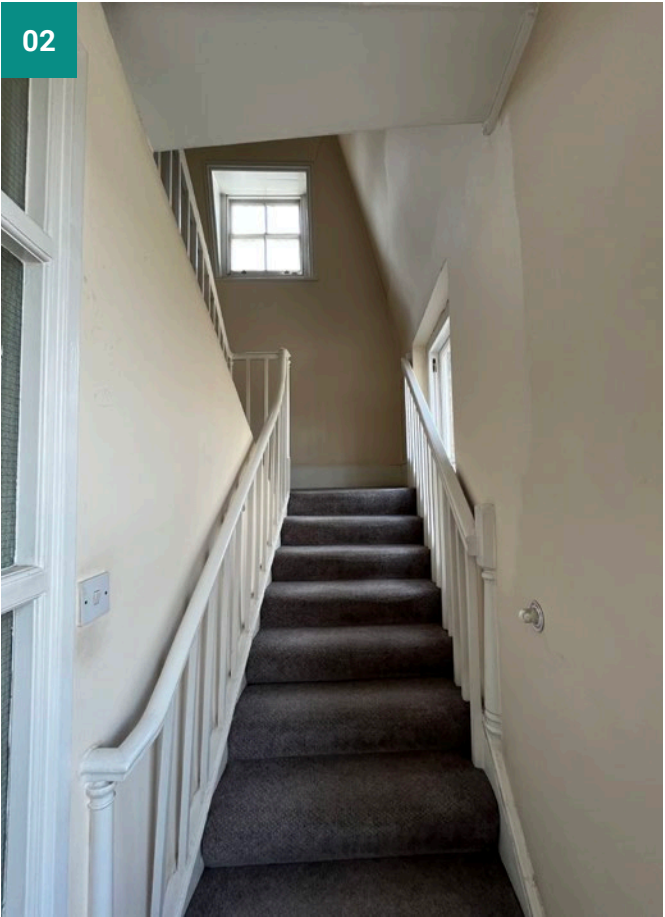
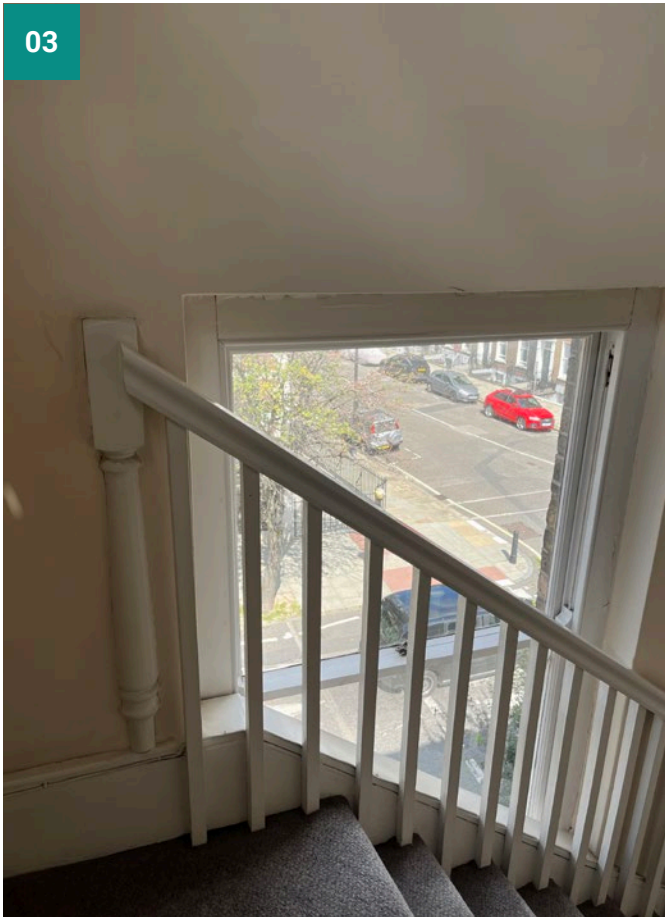
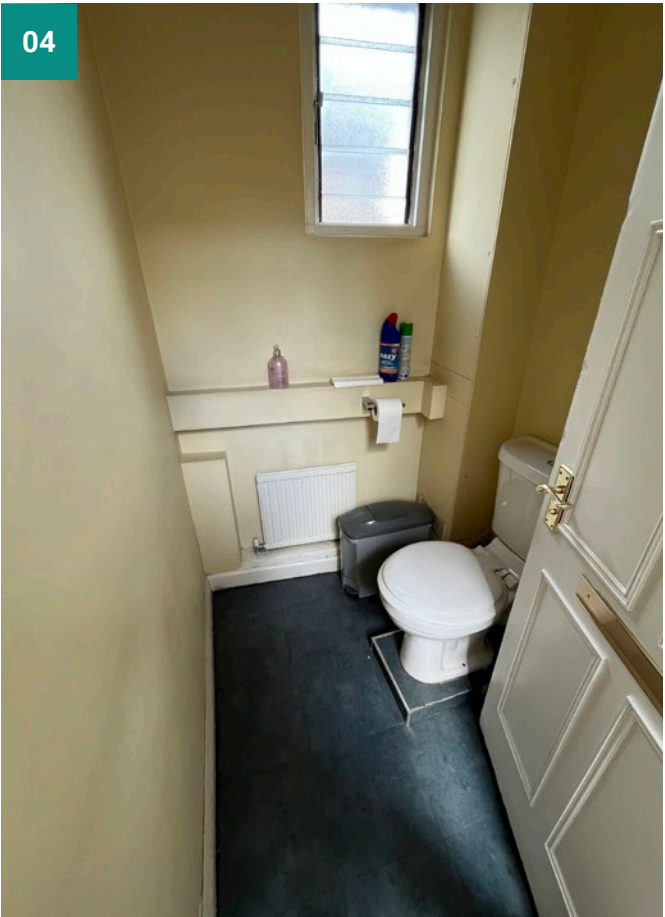
FIGURE 19 ROOM 02.04 / 02.05

LOCATION	DESCRIPTION	CONDITION / SCOPE OF REPAIR	COMMENTS
02.04	Stairs	Steps covered with modern new carpet	Carpet to be removed and replaced
02.04	Railings	Handrail to baluster and newel posts appear to be original elements, but the balusters appear to be modern	All to be retained and refurbished
02.04	Floor	Modern carpet	Carpet to be removed and replaced
02.04	Walls	Painted plaster walls	To be made good and repainted
02.05	Toilet		To be removed
02.04	Glazed Partition	Modern timber framed obscured glass partition	To be removed

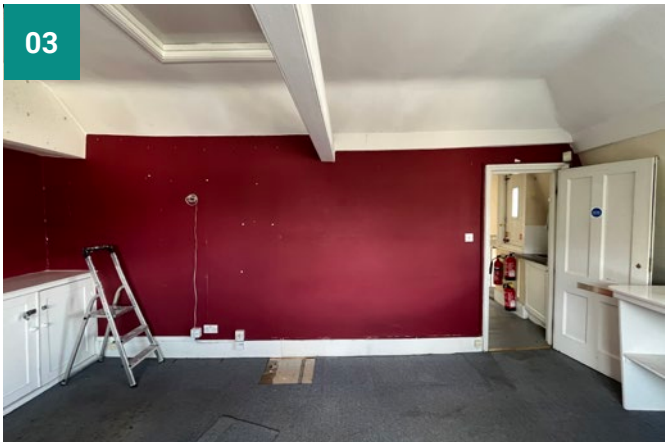
FIGURE 21 ROOM 03.02

LOCATION	DESCRIPTION	CONDITION / SCOPE OF REPAIR	COMMENTS
03.02	Ceiling / Cornice	Ceiling and cornice in poor condition	All to be retained (where possible), refurbished and redecorated

03.02	Floor	Modern carpet covering floor - to be inspected to confirm condition	Depending on floor quality either sand and stain or replace floor with new boards. joists to be inspected

03.02	Walls / Skirting	<ul style="list-style-type: none">• Poor condition• Skirting to be retained	<ul style="list-style-type: none">• All to be retained (where possible), refurbished and redecorated• All surface mounted fixtures, fixings and services to be removed

03.02	Windows	<ul style="list-style-type: none">• Traditional timber sash windows, single glazed to be retained.• Extremely poor condition, stuck and covered in several layers of painting. Most timber forming the bars seems to be rotten and beyond repairable state	Repair where possible, and replace components beyond repair

03.02	Internal Doors	Six panel door to stair retained	Retained and refurbished, ironmongery to be replaced
03.02	Radiators	Double panel metal radiator beneath windows	Replaced and renewed
