Revised
Arboricultural Appraisal Report

Subsidence Damage Investigation at:

138 Haverstock Hill
 London
 NW3 2AY

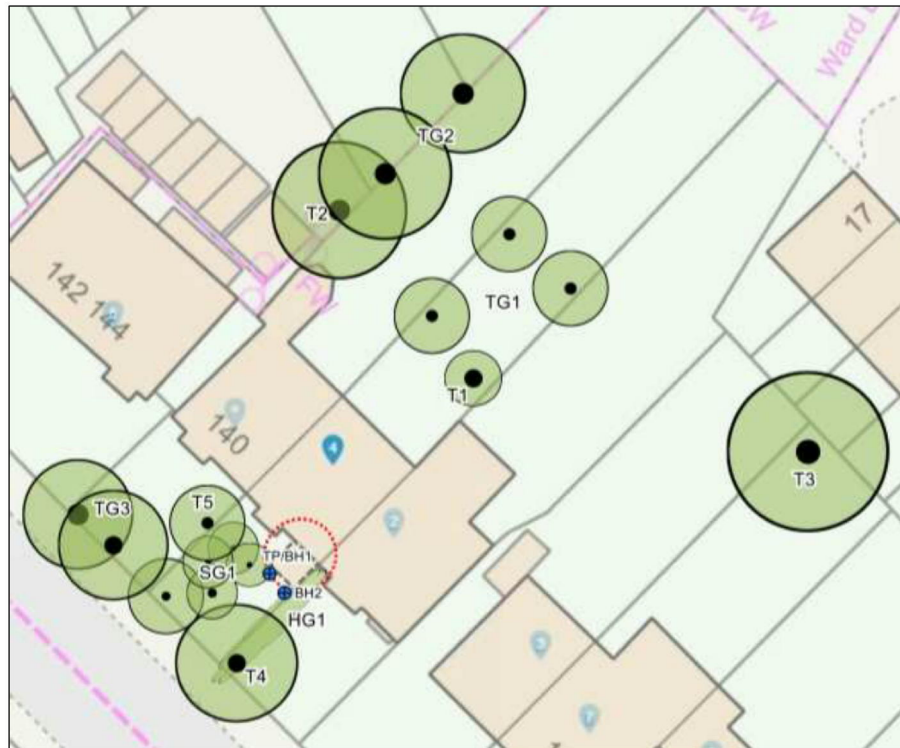
Site Plan

Approximate areas of damage

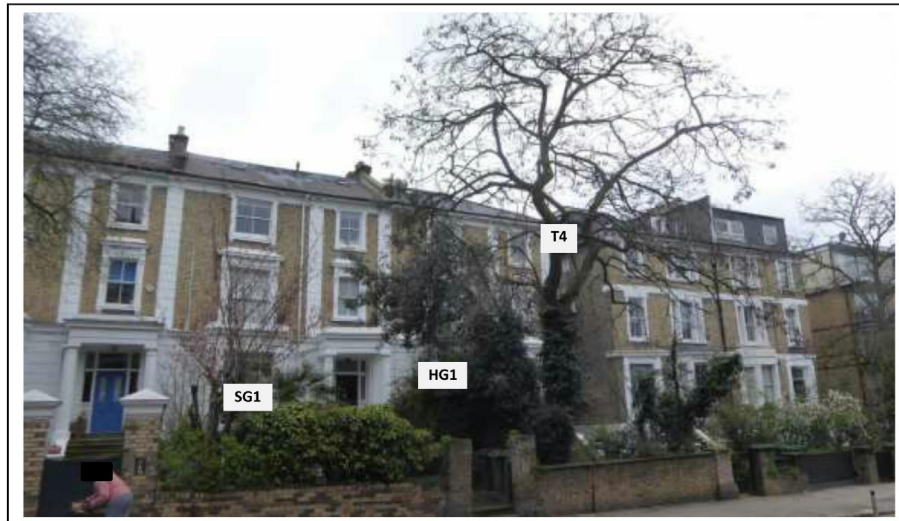
Roots were observed below foundation depth in TP/BH1 and BH2 and recovered samples have been positively identified (using anatomical analysis) as *Pittosporum* spp. and *Leguminosae* spp.; the origins of which will be the *Pittosporum* of HG1 and the False Acacia T4, confirming their influence on the soils below the foundations.

| Tree No. | Species | Ht (m) | Dia (mm) | Crown Spread (m) | Dist. to building (m) | Age Classification | Ownership |
|---|--|---|---|---|---|---|---|
| T4 | False Acacia | 15.5 | 600 * | 13.0 | 7.6 | Younger than Property | Third Party 136 & 136A Haverstock Hill NW3 2AY |

Overview of T4 False Acacia, HG1 hedgerow group and SG1 mixed spp. shrub group

| Tree No. | Species | Ht (m) | Dia (mm) | Crown Spread (m) | Dist. to building (m) | Age Classification | Ownership |
|---|--|---|---|---|---|---|---|
| Recommendation | | Remove (fell) to near ground level and treat stump to inhibit regrowth. | | | | | |
| Recommendation | | Reduce height to 2.0m and cut back sides to leave no wider than 1.0m. Trim thereafter on an annual cycle to maintain at broadly reduced dimensions. | | | | | |

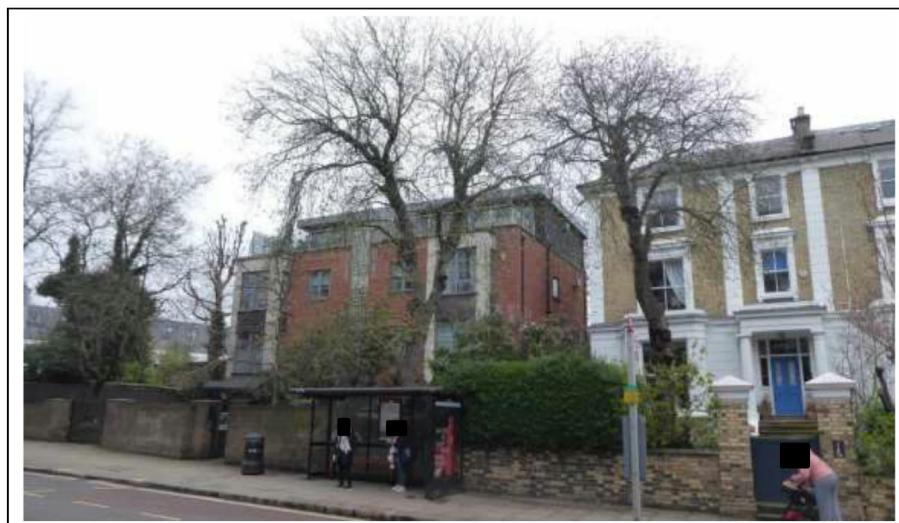
| Tree No. | Species | Ht (m) | Dia (mm) | Crown Spread (m) | Dist. to building (m) | Age Classification | Ownership |
|---|---|--|---|---|---|---|---|
| TG3 | Horse Chestnut group | 12.5 * | 500 Ms * | 7.5 | 10.0 | Younger than Property | Third Party 140 Haverstock Hill NW3 2AY |

View of TG3 Horse Chestnut group

| Tree No. | Species | Ht (m) | Dia (mm) | Crown Spread (m) | Dist. to building (m) | Age Classification | Ownership |
|---|---|--|---|---|---|---|---|
| Recommendation | | Maintain broadly at no more than current dimensions by periodic pruning. | | | | | |

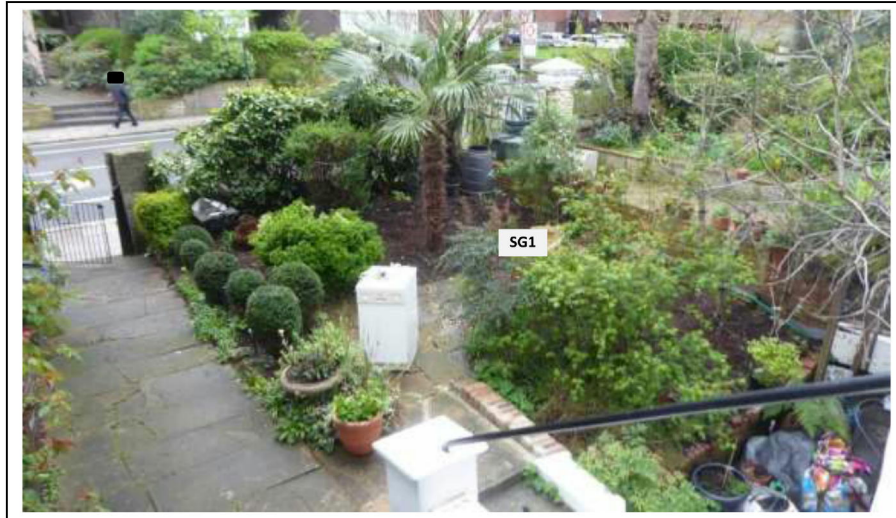
| Tree No. | Species | Ht (m) | Dia (mm) | Crown Spread (m) | Dist. to building (m) | Age Classification | Ownership |
|---|---|--|---|---|---|---|---|
| SG1 | Mixed spp. shrub group of mostly Yew, Aucuba, Rose, Date Palm, Cherry and Elder | 5.0 | 400 Ms * | 5.0 | 3.0 | Younger than Property | Policy Holder |

View of SG1 shrub group

| Tree No. | Species | Ht (m) | Dia (mm) | Crown Spread (m) | Dist. to building (m) | Age Classification | Ownership |
|---|---|--|---|---|---|---|---|
| Recommendation | | Maintain broadly at no more than current dimensions by periodic pruning. | | | | | |

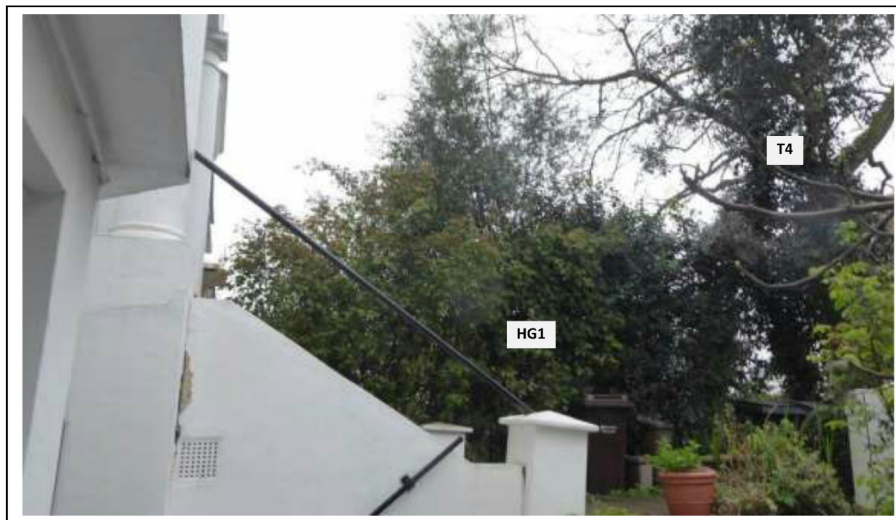
| Tree No. | Species | Ht (m) | Dia (mm) | Crown Spread (m) | Dist. to building (m) | Age Classification | Ownership |
|---|--|---|---|---|---|---|---|
| HG1 | Mixed spp. hedgerow group of mostly Rose, Pittosporum, Holly and Bay | 5.0 | 80 * Ms | 5.0 | 0.2 | Younger than Property | Third Party 136 & 136A Haverstock Hill NW3 2AY |

View of HG1 hedgerow group and T4 False Acacia
