From: Joshua Cheung <Joshua.Cheung@camden.gov.uk>
Sent: Wednesday, May 17, 2023 9:22:23 AM
To: Hassan Howlader <hassan@sohoha.org.uk>
Subject: RE: EN23/0247: DO NOT IGNORE: CAMDEN COUNCIL ENFORCEMENT

22 Montague Street, London, WC1B 5BH Our Ref: EN23/0247 Date: 28th June 2023

Our ref: 2882-r1-230718-Report
18 July 2023
by email (hassan@sohoha.org.uk)

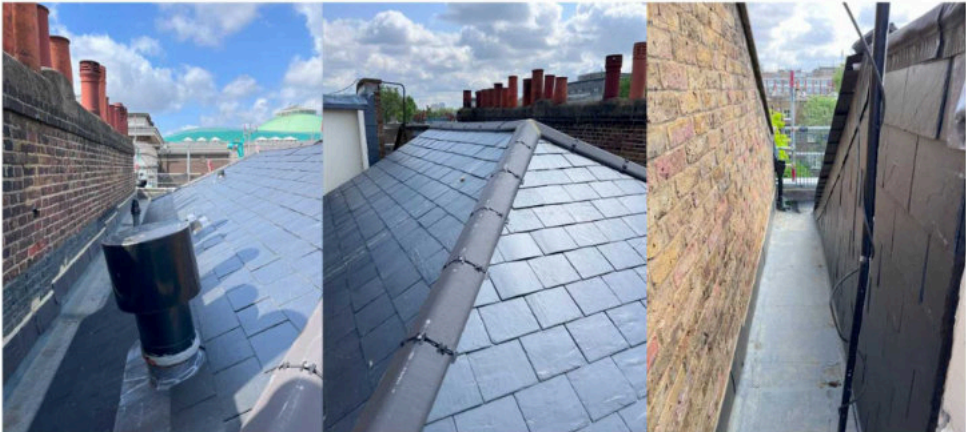
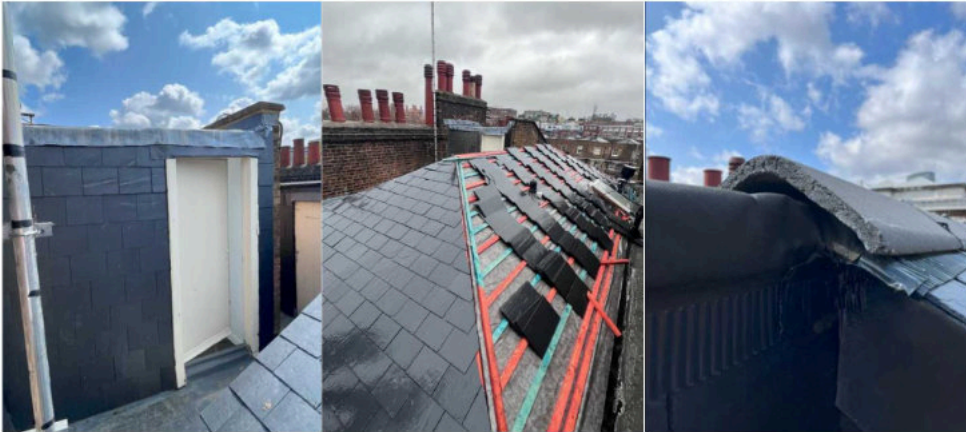
1. Replacement of the Welsh Slates on the pitch roof and staircase cover with Spanish Slates;
2. Replacement of the underlying timber frames of the pitch roof with new;
3. Installation of new Hip and Ridge tiles on the pitch roof;
4. Installation of waterproof membranes/linings to the staircase cover roof, roof landings and the bases of the high chimneys and parapets; and
5. Installation of a new rooflight.

Schedule A Items 1, 2 and 3

- The reinstatement of the Welsh Slates on the pitch roof and staircase cover.
- Your scheme/scope of works to repair the associated damages caused to the below flat.
- *Addressal of the as-built pitch roof's timber frame.
- *Addressal of the as-built Hip and Ridge tiles on the pitch roof.
- *Addressal of the as-built waterproof membranes/linings to the roof landings, high chimneys, and parapets.
- *Addressal of the as-built rooflight.

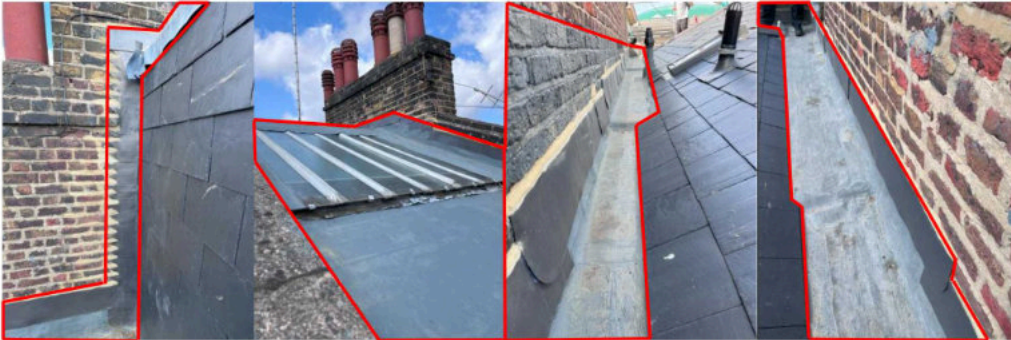
Schedule A Item 4 – Waterproof membranes/linings currently present on the roof are not limited to these photos.

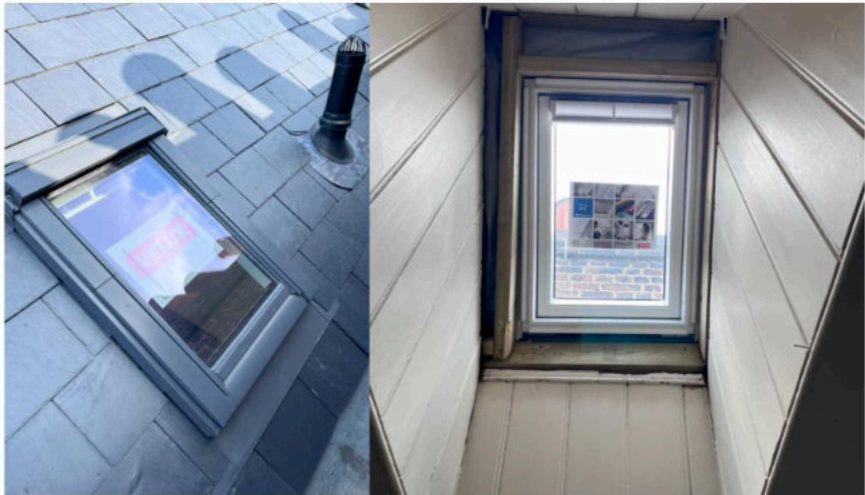
1. Various damp damages to the ceilings and walls across the flat; and
2. Poor quality internal finish of the new rooflight.

Schedule A Item 5 & Schedule B Item 2

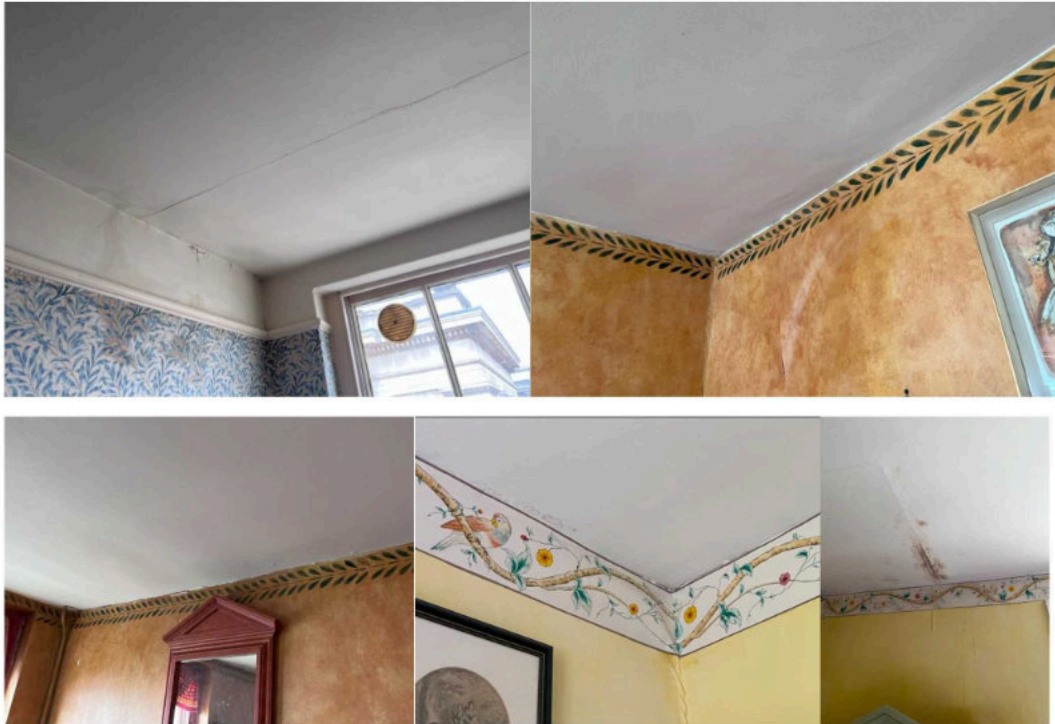
Schedule B Item 1 – Damages present at the below flat (Flat G) are not limited to these photos – the above demonstrates a few of the most notable damages.

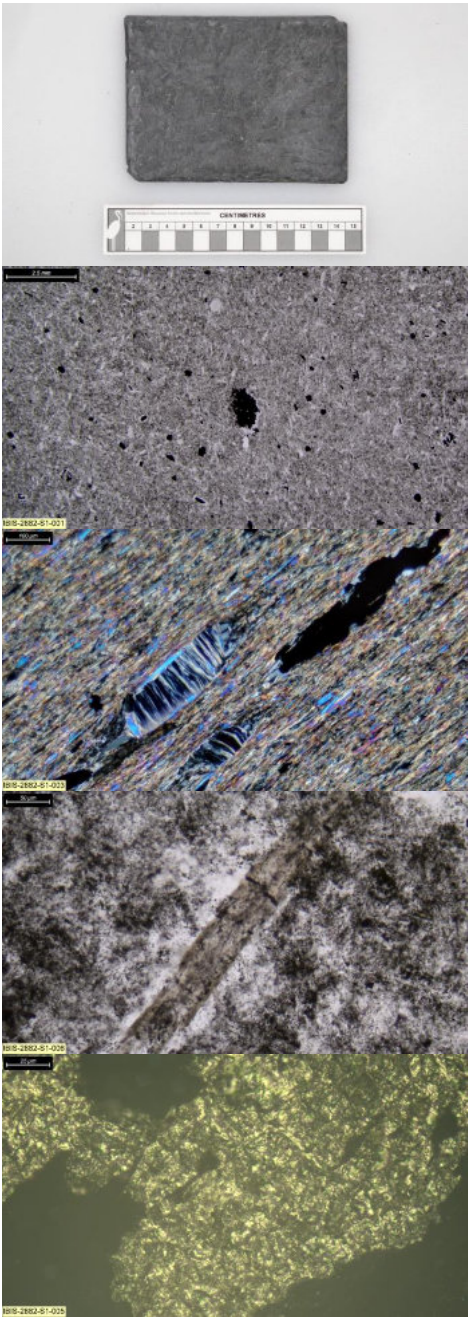
Slate recovered from the roof that was then replaced

Sample taken for thin-sectioning.

Spots of opaque pyrite and other related iron-sulfide minerals scattered throughout the slate fabric, a feature typical of many slates found within Spain.

A mixture of larger chlorite lenses and mixed with opaques and quartz. This is a feature also more typical of many slates found within Spain.

A rod-like crystal of possible sillimanite or other higher-grade metamorphic crystal form that are very typical of a number of slates found in Spain. These are not present in slates found in other countries.

Pyrite is shown here exhibiting a strong yellow bireflectance. Pyrite and related minerals are found in all slates to some level but it generally are more disordered in slates found within Spain.

In summary, the examination of this slate yielded many strong features that are considered to be typical of slates found within Spain, and certainly not of slates from Wales and other UK locations. Resources around the world other than Spain were also ruled out.

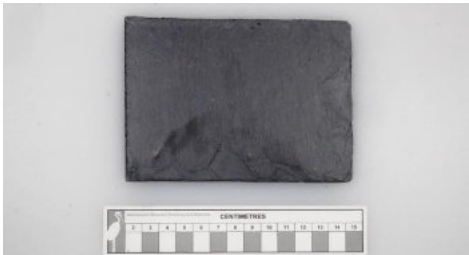
Unused slate that was employed for the recent replacement works

Sample taken for thin-sectioning.

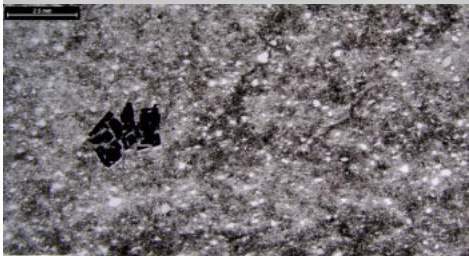
Scattered large irregular spots of opaque pyrite and other related iron-sulfide minerals were present throughout the slate fabric, a feature typical of many slates found within Spain. The background fine darkness is possible graphite, which is another feature typical of certain slates found within Spain.

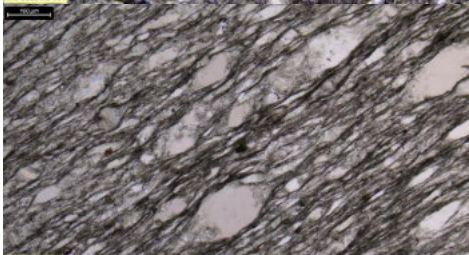
Abundant chlorite micro-lenses were present throughout the slate fabric, a feature typical of many slates found within Spain.

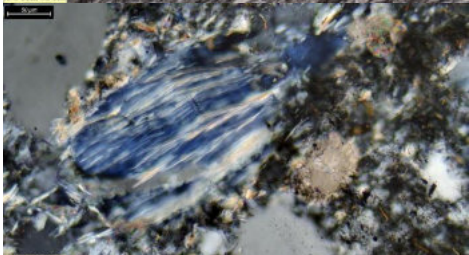
A mixture of chlorite lensing with fuzzy-looking quartz and carbonates is a texture that is almost unique to slates found within Spain.

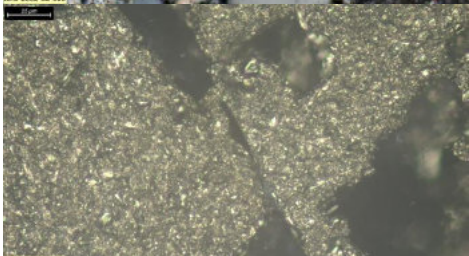
Pyrite is shown here exhibiting a strong yellow bireflectance. Pyrite and related minerals are found in all slates to some level but it generally are more disordered in slates found within Spain.

In summary, the examination of this slate yielded many strong features that are considered to be typical of slates found within Spain, and certainly not of slates from Wales and other UK locations. Resources around the world other than Spain were also ruled out.

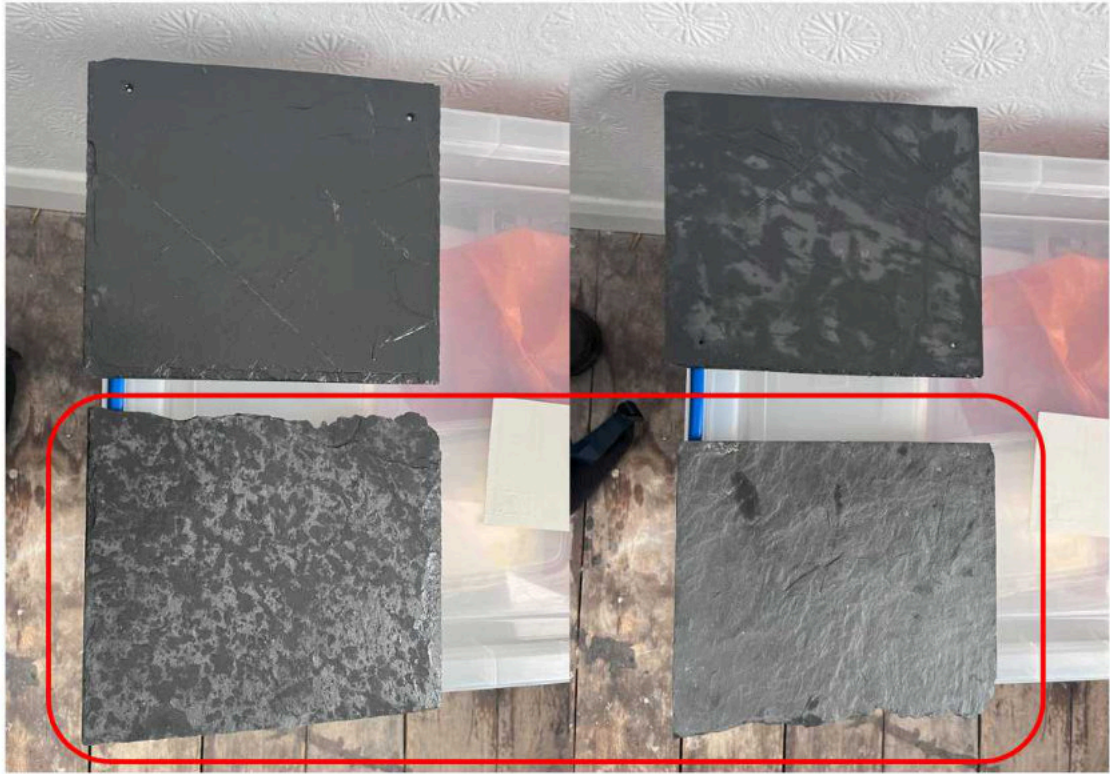
[Top tile - New (Spanish) Slate. Bottom Tile – “Original” Slate that was claimed to be sent to the lab for testing (No evidence that it came from the roof)]

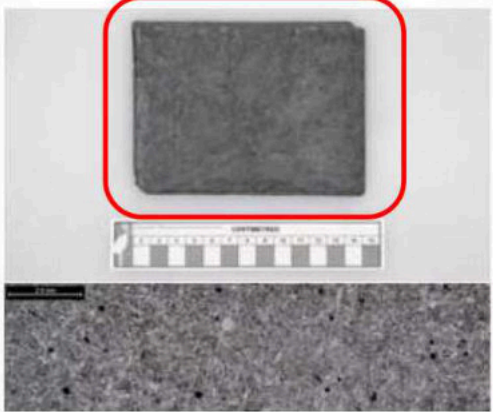
Slate recovered from the roof that was then replaced

Sample taken for thin-sectioning.

Spots of opaque pyrite and other related iron-sulfide minerals scattered throughout the slate fabric, a feature typical of many slates found within Spain.

[Sample tested by IBIS does not match what was claimed to be the “Original” Slate, appears to be a new Spanish Slate that was tested]

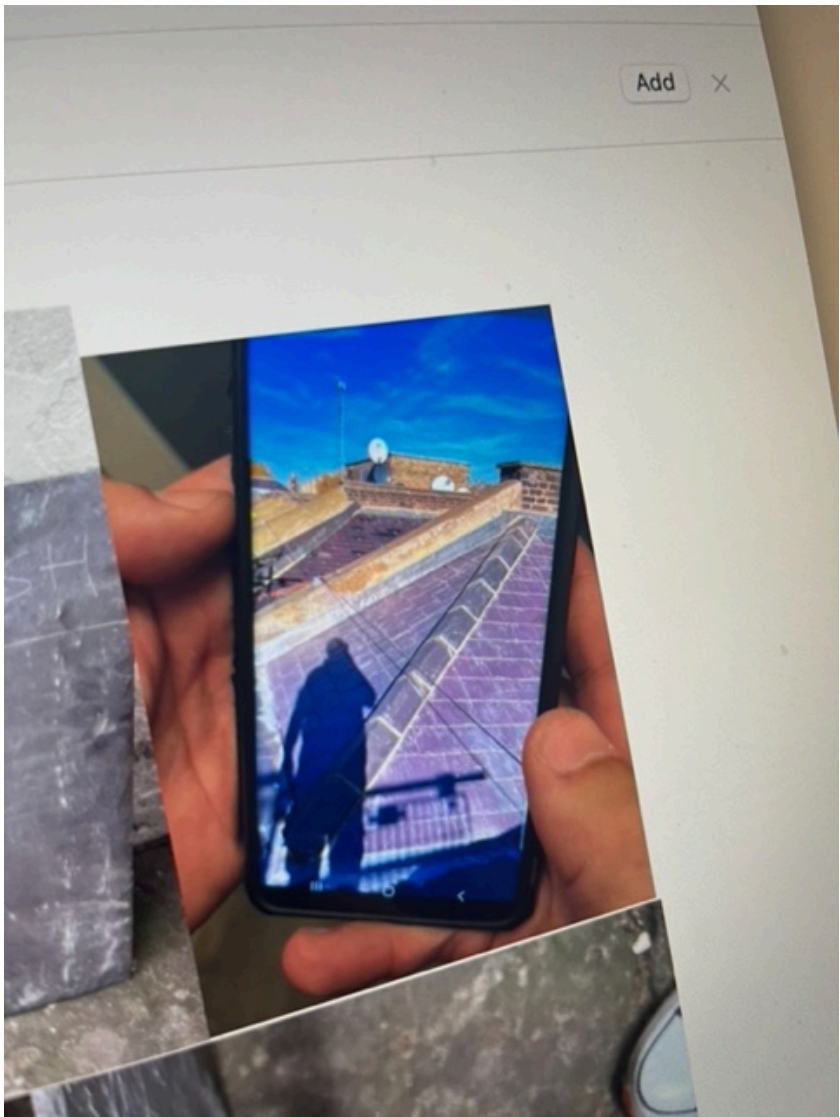
Photo 1

I am not sure who took the photograph (Photo 1) of the adjacent building but it has been processed, there is an unnaturally blue sky, and the slate colours are unnatural. I took this image, albeit at very low resolution and reprocessed it trying to get the sky to be a more natural colour (see Photo 2), the slates now appear to be somewhere between grey and purple, which is not atypical of weathered slates from the Ffestiniog area in Wales. There is no great roughness to the slates so they do not appear to be from Cumbria or other locations in the British Isles.

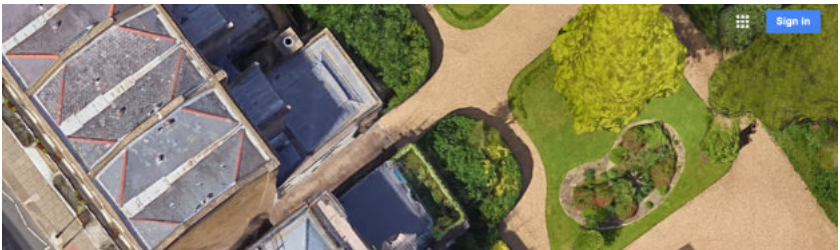
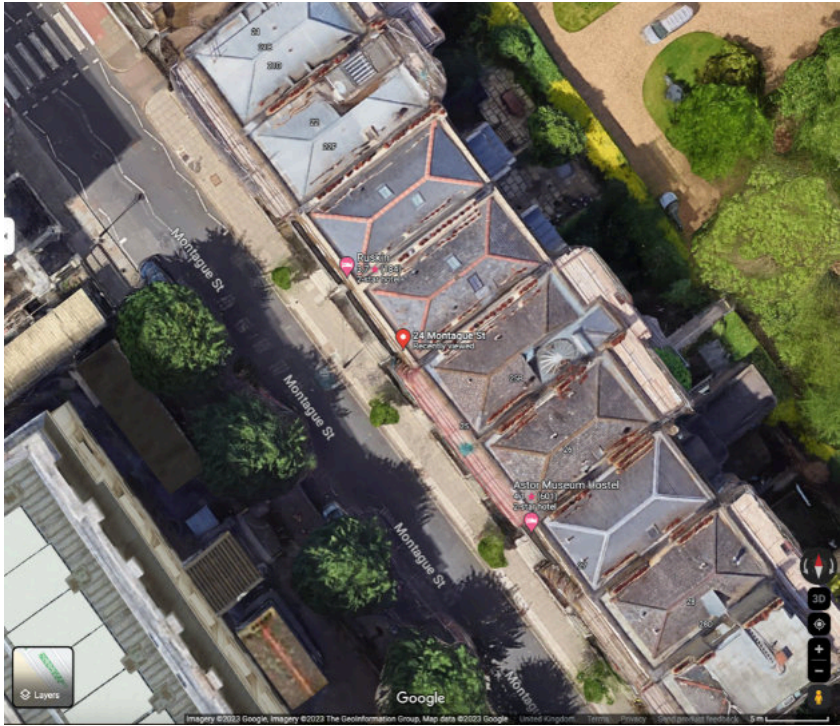
Photo 3

Now look at the attached GoogleEarth image (Photo 3) looking down at the roofs of the area and most are grey, in various shades. There are some that appear to be of a purplish grey colour in locations away from the area but these are few. This image was from September 2022 when the scaffolding was up and the slate very shiny and new and so stands out above and left of centre. Again, the overall suggesting its that the original slates were probably from the Ffestiniog area of Wales.

One thing I notice is the condition of the hips and ridges of many of the roofs, in addition to the general appearance of the slates, and the overall impression is that many of these roofs may have been replaced in the past. The second, fourth and fifth roofs up from the low right corner possibly are original, all others being replacement.

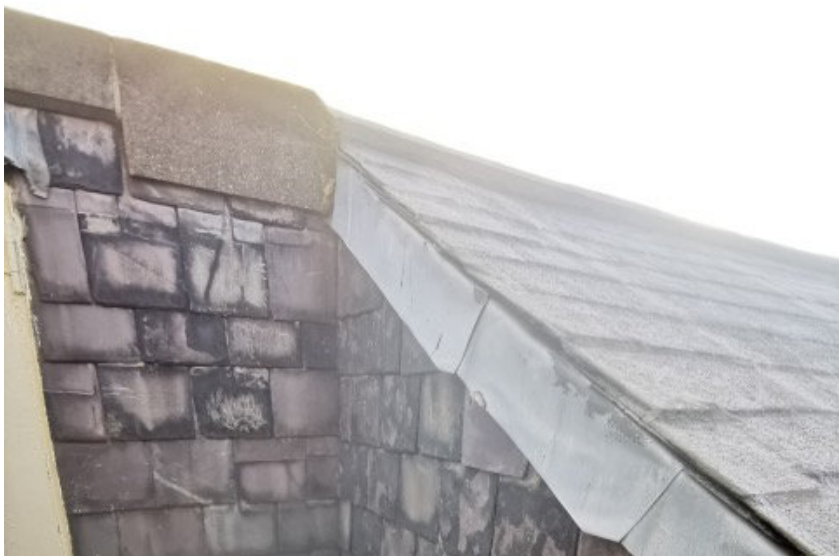
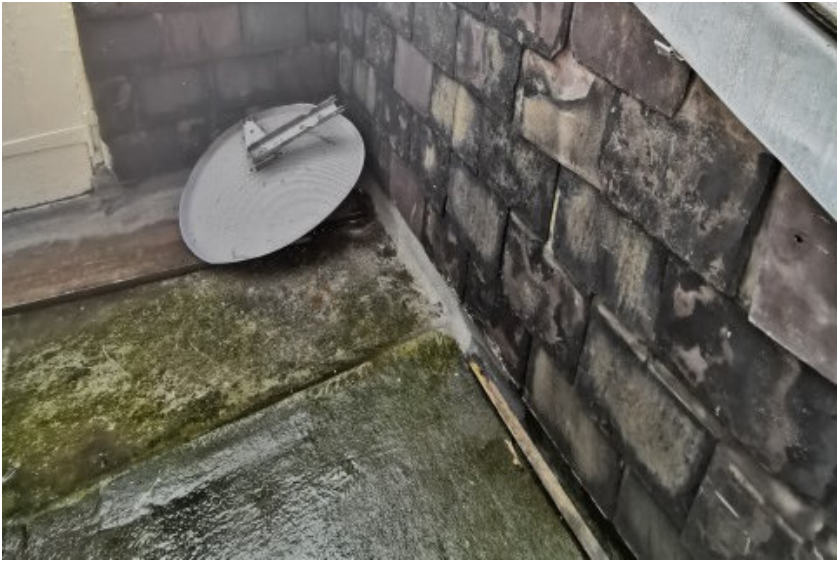
Photo 4

Now I turn to the images taken of the roof taken prior to the works and when it exhibited an applied coating over the non vertical sections. Nothing can be deduced from the covered areas. From the vertical sections it is clear that there has been replacement and re-use of slates. This would certainly fit with the recent advice that there was refurbishment carried out in 1978 that included the requirement to set aside and slates in good enough condition for re-use. Original slates certainly would be those with extremely heavy darkening and surface scaling visible in the photos. I have included one of the photos below as Photo 4.

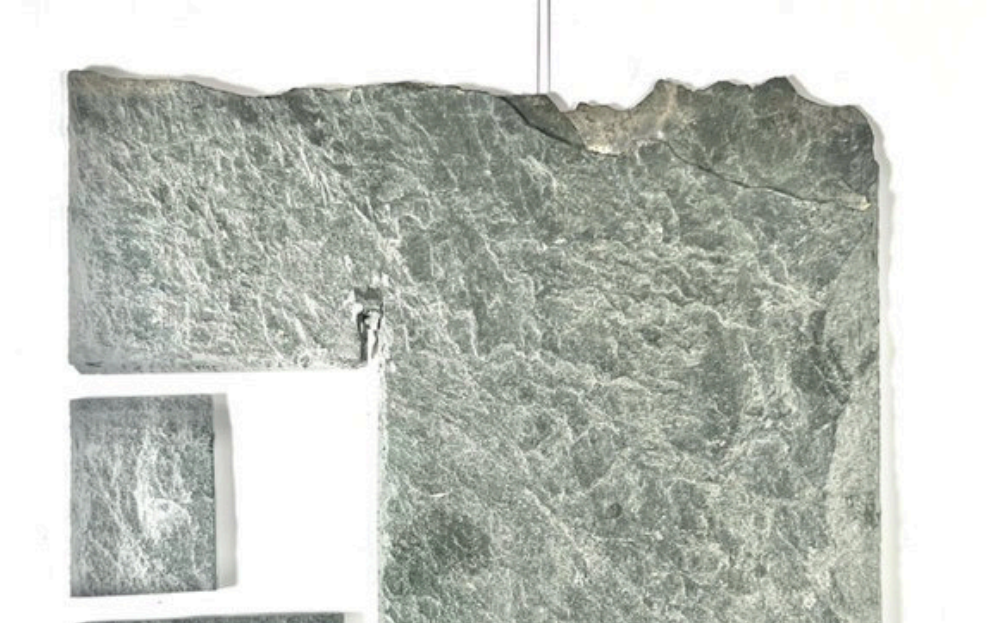
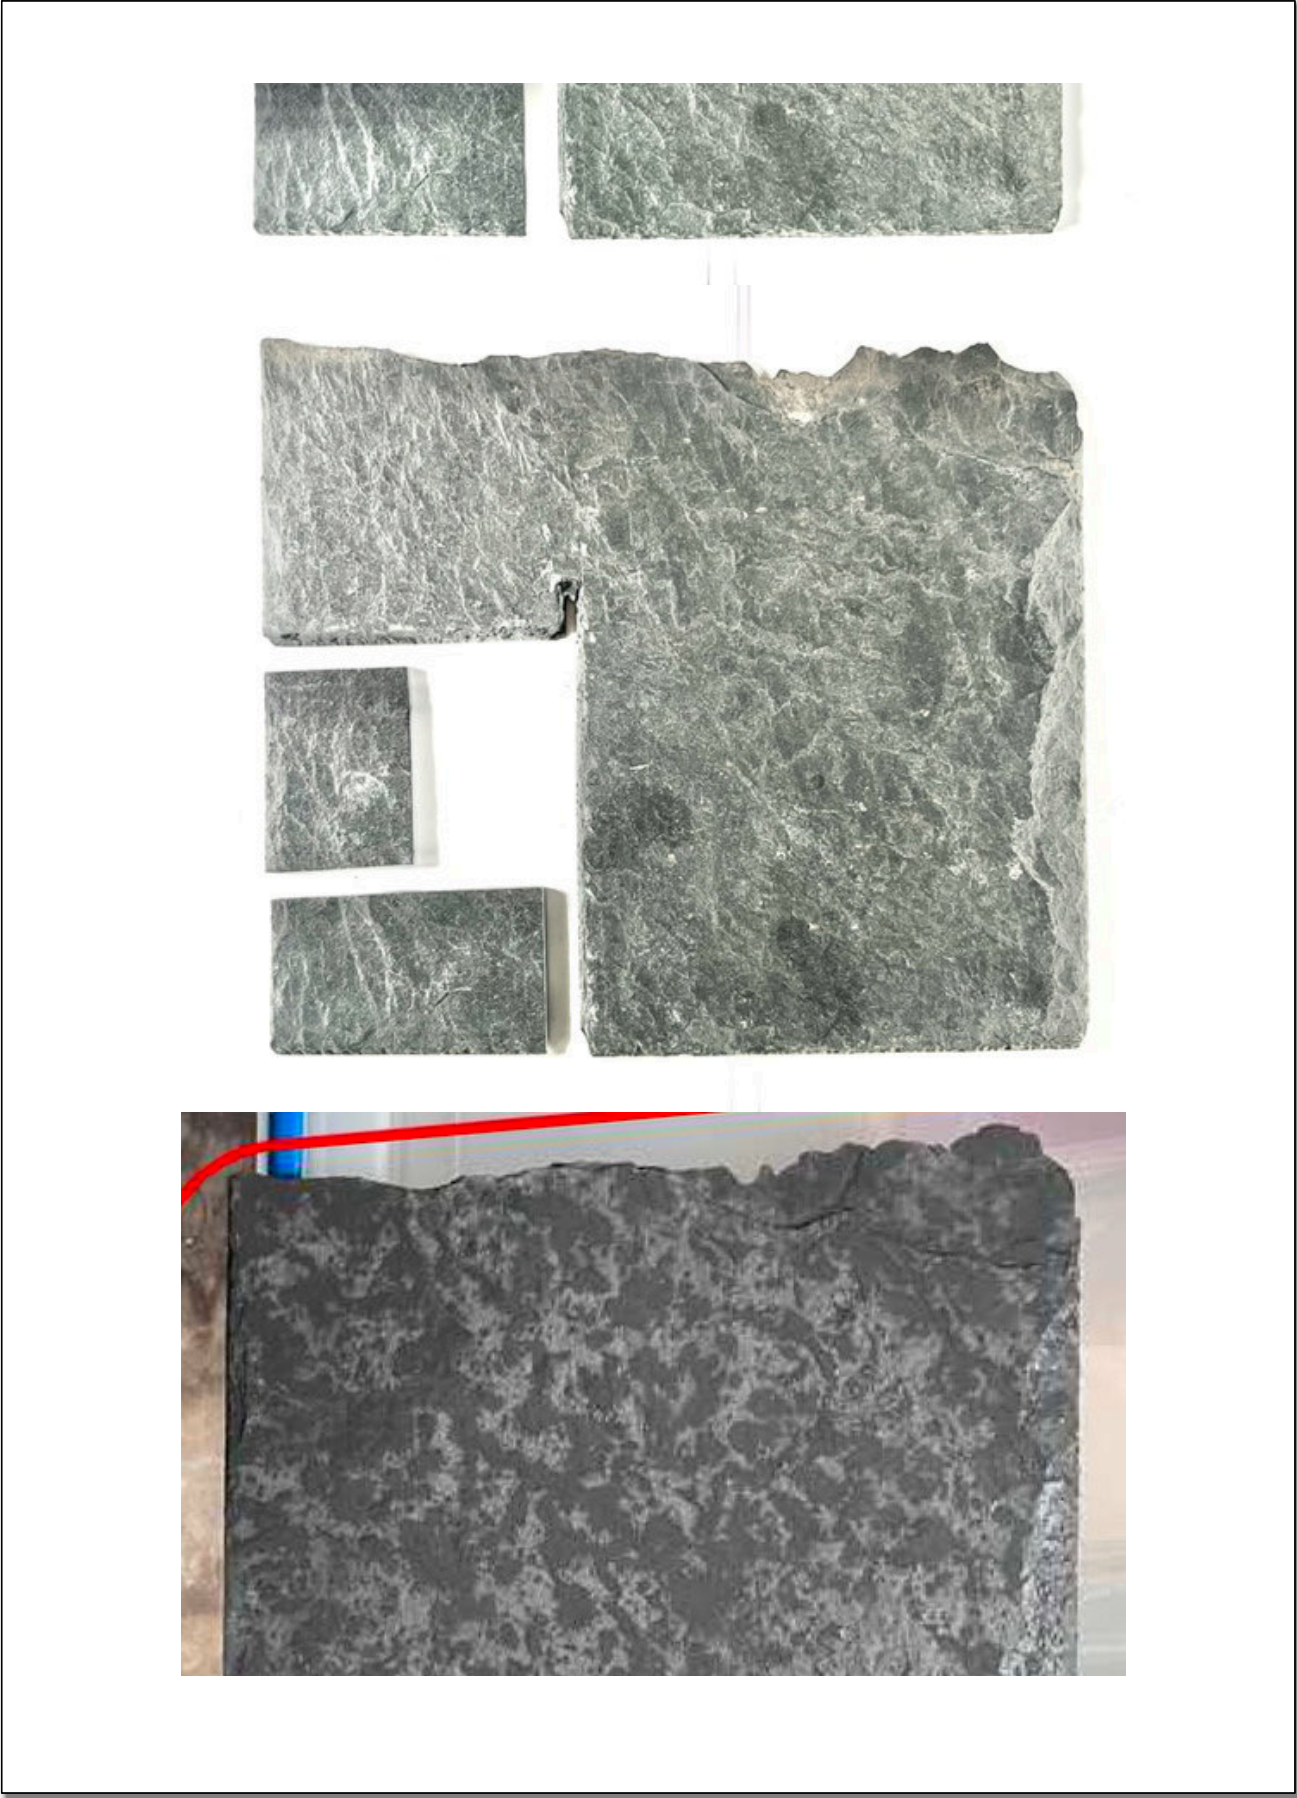
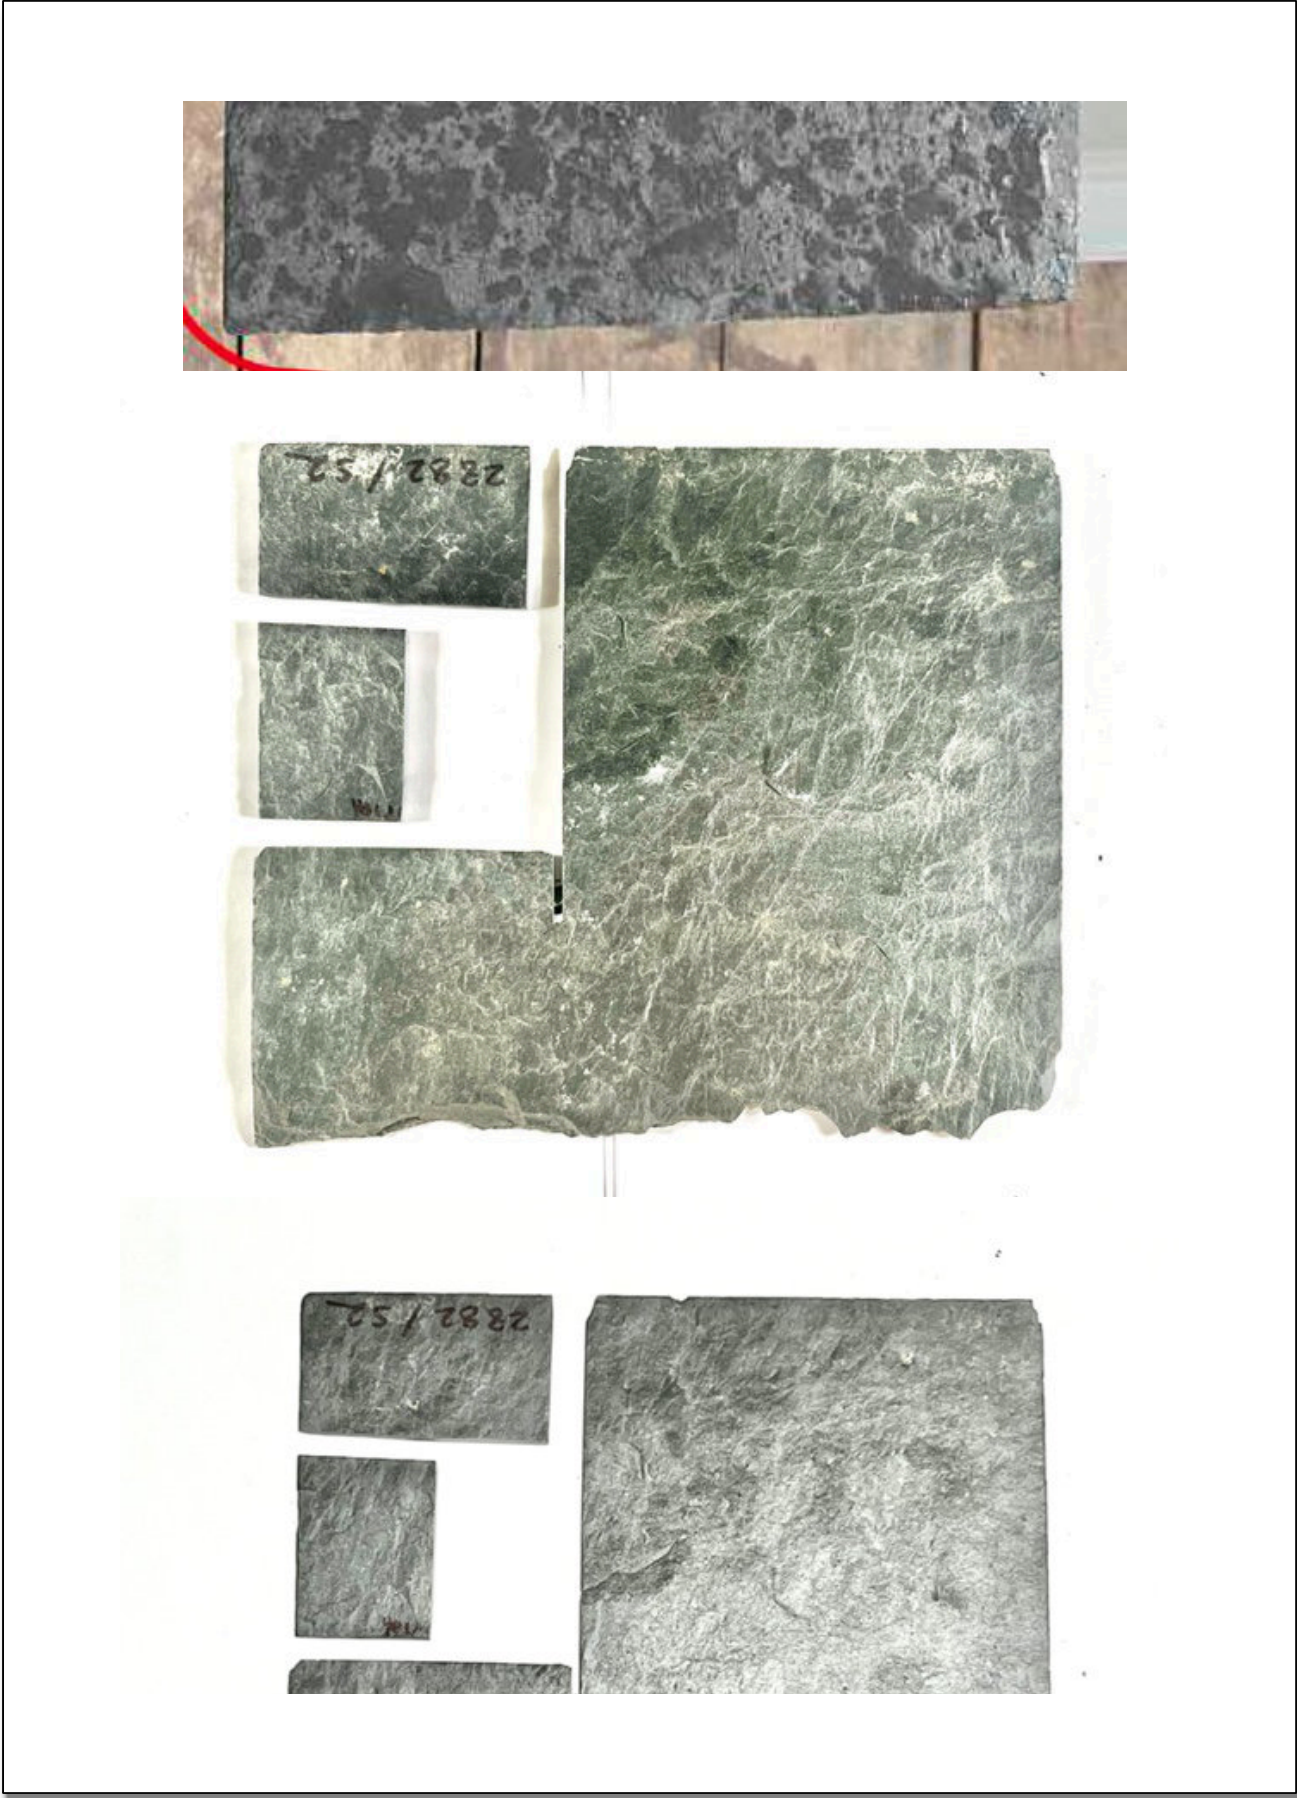
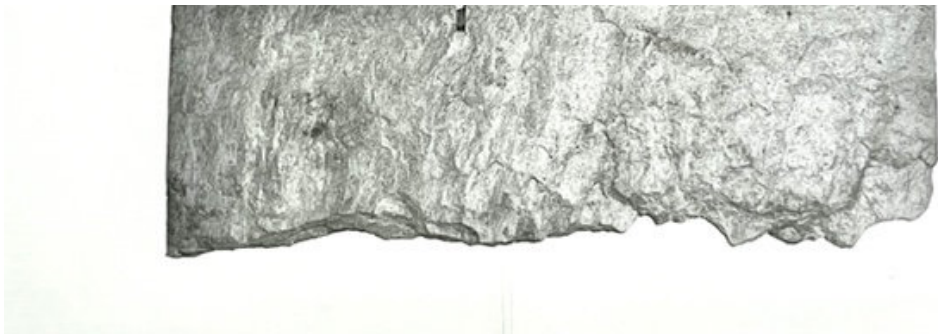
From the images I provide here you can clearly see the exact same broken edge profile and areas where the edge has been eaten away. Some of the slate features are also able to be compared and confirmed to be the same. The problem with the original photograph is it was taken of a partially damp and drying out slate using flash, which is a totally different set of viewing conditions. Those making the comparison have clearly not taken many factors into account. They were lacking in a lot of information, unfortunately.

I have taken two sets of photos, front and back, under different lighting conditions. The sub-sample I took was from one of the corners and the pieces remaining from this have been put back into position. The same peaks and troughs can be traced, even though a small amount of the right side of the broken edge has been lost. The right front edge is an exact match where the edge cuts inwards. This is despite taking the photos at different angles and lighting conditions.
