### **Tree Report**

#### **17 Pond Street London NW3 2PN**

**1.6 Rear Garden Holm Oak,**

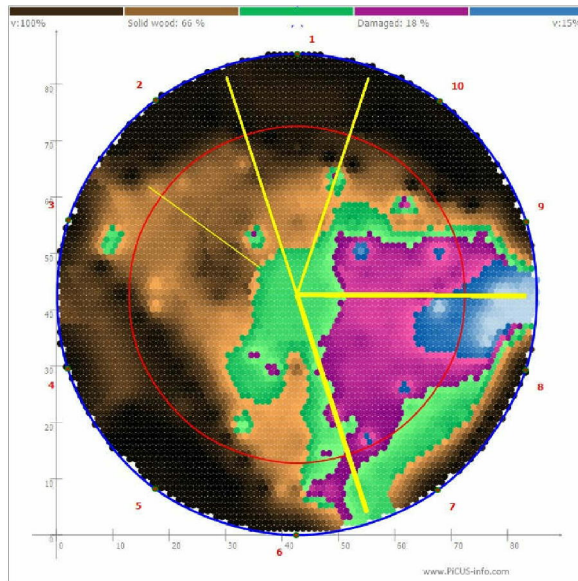
Figure 1- Tomographic image

The measuring point readings give evidence of low velocities overall in the area of test representation showing decayed timber. The tomographic images shown above has a large percentage amount of altered timber. With reference to the 'colour chart see figure 2', the slower sonic speed of sound is represented by three bands of data representation blue/violet/white being the slowest altered/decayed timber, green being faster altered timber, brown being fast sonic-speeds solid timber.

The resulting Picus tests are of unacceptable limits in relation the altered timber. This ratio called a 'trunk ratio' TR (*reference Claus Mattheck*) has been calculated to be a guideline in terms of stability and rigidity of cylindrical structure. Although a debated theory in arboriculture in general terms the TR of 30% is an average.

**The resulting data shows the Holm Oak is decaying at the base and leaning over the rear garden.**

**It is appropriate to recommend that this specimen is completely removed on the grounds of health and safety.**
