**Flat 57 Holly Lodge Mansions
London
N6 6DS**

**Full Circle Compliance
32 Writtle Road
Chelmsford
Essex
CM1 3BX
Email: info@fullcirclecompliance.co.uk
Tel: 01245 690606**

1.0 Executive summary:

Flat 57 Holly Lodge Mansions
London
N6 6DS

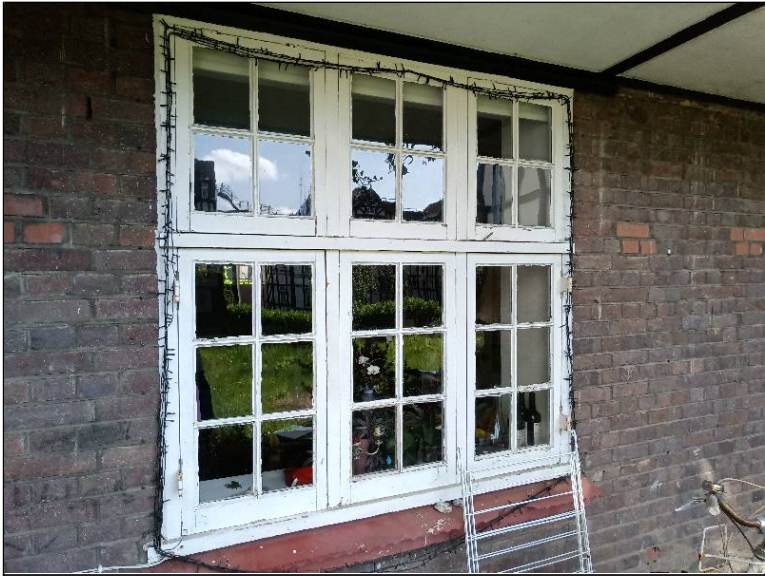
Survey Date:		Lead Surveyor		Survey Type		Floor		Analysis	
	26 May 2023 to 26 May 2023		Luke Atkinson		Management Survey		External		No Asbestos Detected	
	Building			Room		Item			Quantity	
	Flat 57 Holly Lodge Mansions			External		Putty sealant To windows			2no.	
	Sample No (S,SP,P,As)		Product Type		Surface Treatment		Condition		Accessibility	
	FA000100 (S)		N/A		N/A		N/A		N/A	
	Normal Occupancy	Score	Likelihood of disturbance	Score	Exposure Potential	Score	Maintenance Activity	Score		
	Main type of activity	N/A	Location	N/A	Number of occupants	N/A	Type of Maintenance	N/A	N/A	
	Accessibility	N/A	Frequency of use	N/A	Frequency of maintenance	N/A				
	Amount	N/A	Average Time	N/A						
Average Score	N/A	Average Score	N/A	Average Score	N/A	Average Score	N/A			
Average of Priority	N/A									
Material Assessment Score	N/A									
Recommendation	No further action required

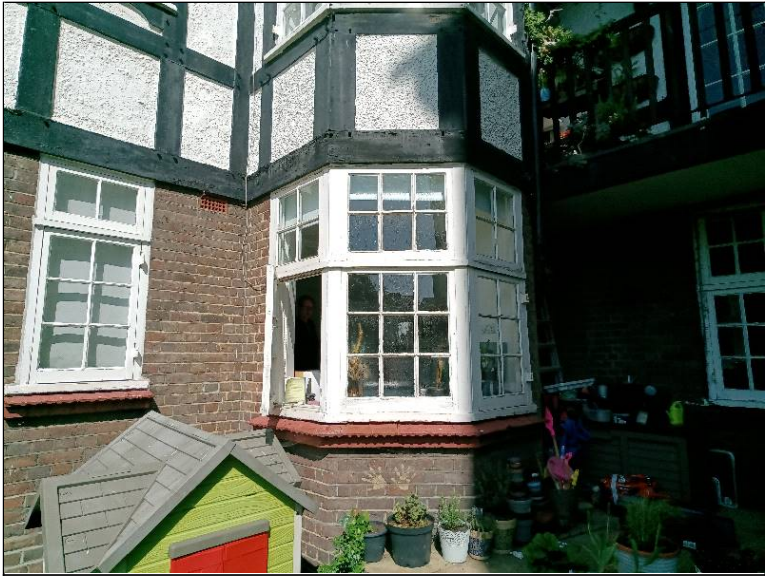
Survey Date:		Lead Surveyor		Survey Type		Floor		Analysis	
	26 May 2023 to 26 May 2023		Luke Atkinson		Management Survey		External		No Asbestos Detected	
	Building			Room		Item			Quantity	
	Flat 57 Holly Lodge Mansions			External		Putty sealant To windows			2no.	
	Sample No (S,SP,P,As)		Product Type		Surface Treatment		Condition		Accessibility	
	FA000101 (S)		N/A		N/A		N/A		N/A	
	Normal Occupancy	Score	Likelihood of disturbance	Score	Exposure Potential	Score	Maintenance Activity	Score		
	Main type of activity	N/A	Location	N/A	Number of occupants	N/A	Type of Maintenance	N/A	N/A	
	Accessibility	N/A	Frequency of use	N/A	Frequency of maintenance	N/A				
	Amount	N/A	Average Time	N/A						
Average Score	N/A	Average Score	N/A	Average Score	N/A	Average Score	N/A			
Average of Priority	N/A									
Material Assessment Score	N/A									
Recommendation	No further action required

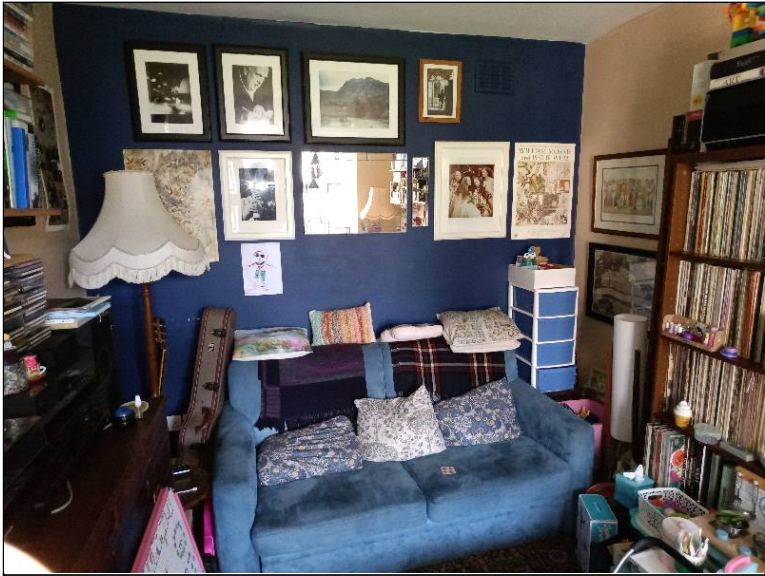
Survey Date:		Lead Surveyor		Survey Type		Floor		Analysis	
	26 May 2023 to 26 May 2023		Luke Atkinson		Management Survey		Ground Floor		N/A	
	Building		Room		Item				Quantity	
	Flat 57 Holly Lodge Mansions		Lounge		No suspect materials found				N/A	
	Sample No (S,SP,P,As)		Product Type		Surface Treatment		Condition		Accessibility	
	Visual (NS)		N/A		N/A		N/A		N/A	
	Normal Occupancy		Score	Likelihood of disturbance	Score	Exposure Potential	Score	Maintenance Activity	Score	
	Main type of activity		N/A	Location	N/A	Number of occupants	N/A	Type of Maintenance	N/A	
	Accessibility		N/A	Frequency of use	N/A	Frequency of maintenance	N/A			
	Amount		N/A	Average Time	N/A					
Average Score		N/A	Average Score	N/A	Average Score	N/A	Average Score	N/A		
Average of Priority		N/A								
Material Assessment Score		N/A								
Recommendation		No further action required

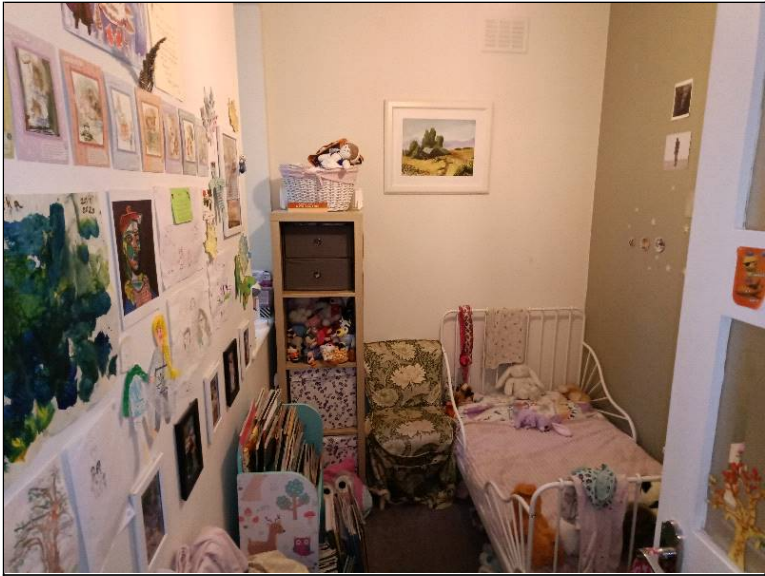
Survey Date:		Lead Surveyor		Survey Type		Floor		Analysis	
	26 May 2023 to 26 May 2023		Luke Atkinson		Management Survey		Ground Floor		N/A	
	Building		Room		Item				Quantity	
	Flat 57 Holly Lodge Mansions		Bedroom 1		No suspect materials found				N/A	
	Sample No (S,SP,P,As)		Product Type		Surface Treatment		Condition		Accessibility	
	Visual (NS)		N/A		N/A		N/A		N/A	
	Normal Occupancy		Score	Likelihood of disturbance	Score	Exposure Potential	Score	Maintenance Activity	Score	
	Main type of activity		N/A	Location	N/A	Number of occupants	N/A	Type of Maintenance	N/A	
	Accessibility		N/A	Frequency of use	N/A	Frequency of maintenance	N/A			
	Amount		N/A	Average Time	N/A					
Average Score		N/A	Average Score	N/A	Average Score	N/A	Average Score	N/A		
Average of Priority		N/A								
Material Assessment Score		N/A								
Recommendation		No further action required

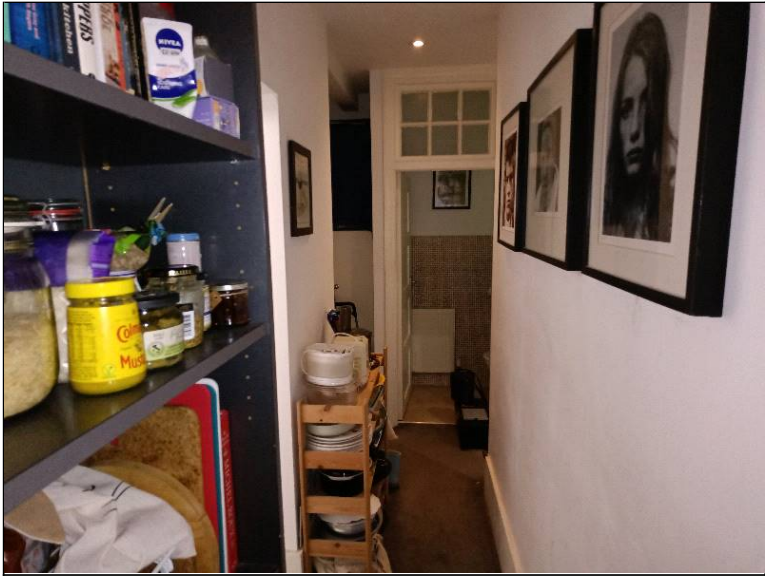
Survey Date:		Lead Surveyor		Survey Type		Floor		Analysis	
	26 May 2023 to 26 May 2023		Luke Atkinson		Management Survey		Ground Floor		N/A	
	Building		Room		Item				Quantity	
	Flat 57 Holly Lodge Mansions		Hallway		No suspect materials found				N/A	
	Sample No (S,SP,P,As)		Product Type		Surface Treatment		Condition		Accessibility	
	Visual (NS)		N/A		N/A		N/A		N/A	
	Normal Occupancy		Score	Likelihood of disturbance	Score	Exposure Potential	Score	Maintenance Activity	Score	
	Main type of activity		N/A	Location	N/A	Number of occupants	N/A	Type of Maintenance	N/A	
	Accessibility		N/A	Frequency of use	N/A	Frequency of maintenance	N/A			
	Amount		N/A	Average Time	N/A					
Average Score		N/A	Average Score	N/A	Average Score	N/A	Average Score	N/A		
Average of Priority		N/A								
Material Assessment Score		N/A								
Recommendation		No further action required

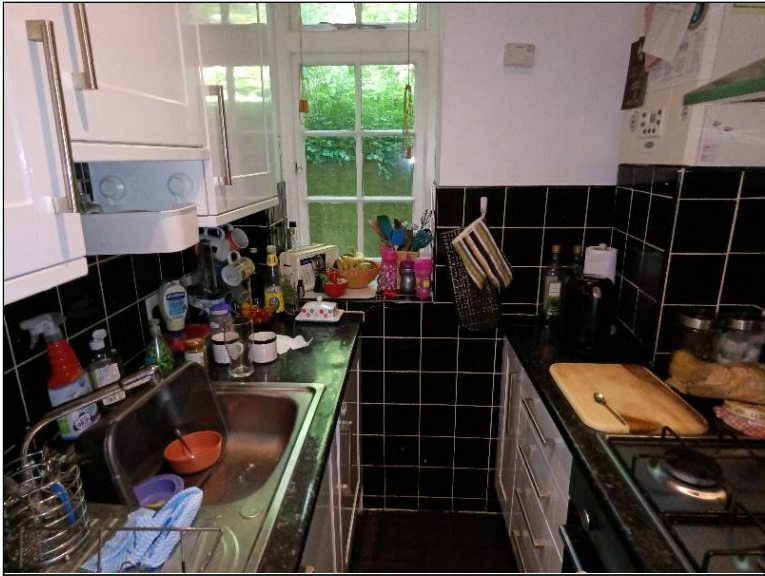
Survey Date:		Lead Surveyor		Survey Type		Floor		Analysis	
	26 May 2023 to 26 May 2023		Luke Atkinson		Management Survey		Ground Floor		N/A	
	Building			Room		Item			Quantity	
	Flat 57 Holly Lodge Mansions			Kitchen		No suspect materials found			N/A	
	Sample No (S,SP,P,As)		Product Type		Surface Treatment		Condition		Accessibility	
	Visual (NS)		N/A		N/A		N/A		N/A	
	Normal Occupancy	Score	Likelihood of disturbance	Score	Exposure Potential	Score	Maintenance Activity	Score		
	Main type of activity	N/A	Location	N/A	Number of occupants	N/A	Type of Maintenance	N/A	N/A	
	Accessibility	N/A	Frequency of use	N/A	Frequency of maintenance	N/A				
	Amount	N/A	Average Time	N/A						
Average Score	N/A	Average Score	N/A	Average Score	N/A	Average Score	N/A			
Average of Priority	N/A									
Material Assessment Score	N/A									
Recommendation	No further action required

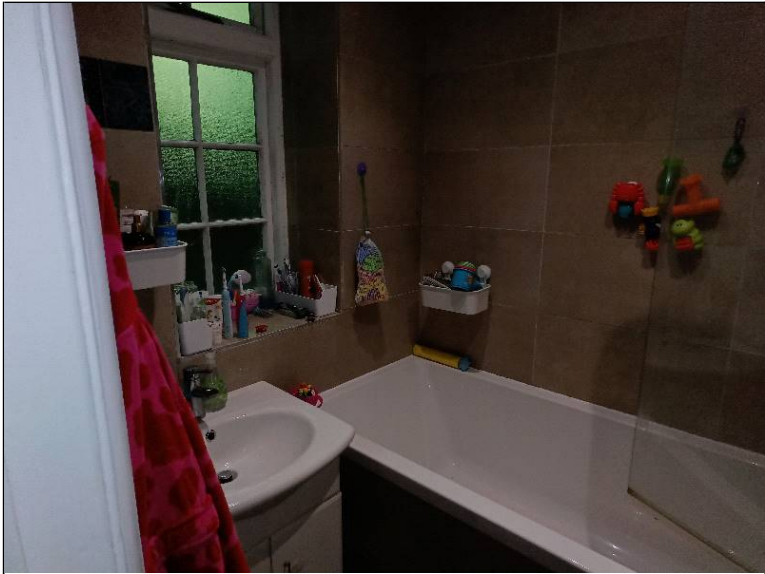
Survey Date:		Lead Surveyor		Survey Type		Floor		Analysis	
	26 May 2023 to 26 May 2023		Luke Atkinson		Management Survey		Ground Floor		N/A	
	Building			Room		Item			Quantity	
	Flat 57 Holly Lodge Mansions			Bathroom		No suspect materials found			N/A	
	Sample No (S,SP,P,As)		Product Type		Surface Treatment		Condition		Accessibility	
	Visual (NS)		N/A		N/A		N/A		N/A	
	Normal Occupancy		Score	Likelihood of disturbance	Score	Exposure Potential	Score	Maintenance Activity	Score	
	Main type of activity		N/A	Location	N/A	Number of occupants	N/A	Type of Maintenance	N/A	
	Accessibility		N/A	Frequency of use	N/A	Frequency of maintenance	N/A			
	Amount		N/A	Average Time	N/A					
Average Score		N/A	Average Score	N/A	Average Score	N/A	Average Score	N/A		
Average of Priority		N/A								
Material Assessment Score		N/A								
Recommendation		No further action required

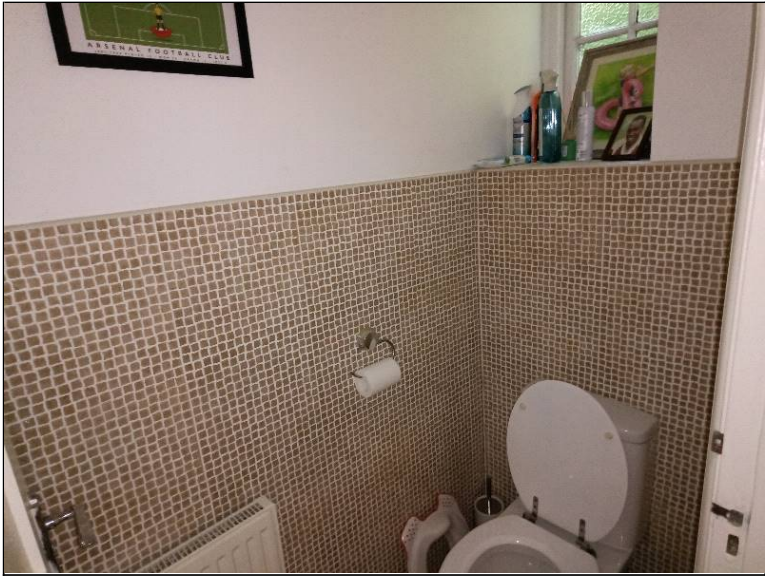
Survey Date:		Lead Surveyor		Survey Type		Floor		Analysis	
	26 May 2023 to 26 May 2023		Luke Atkinson		Management Survey		Ground Floor		N/A	
	Building		Room		Item				Quantity	
	Flat 57 Holly Lodge Mansions		Toilet		No suspect materials found				N/A	
	Sample No (S,SP,P,As)		Product Type		Surface Treatment		Condition		Accessibility	
	Visual (NS)		N/A		N/A		N/A		N/A	
	Normal Occupancy		Score	Likelihood of disturbance	Score	Exposure Potential	Score	Maintenance Activity	Score	
	Main type of activity		N/A	Location	N/A	Number of occupants	N/A	Type of Maintenance	N/A	
	Accessibility		N/A	Frequency of use	N/A	Frequency of maintenance	N/A			
	Amount		N/A	Average Time	N/A					
Average Score		N/A	Average Score	N/A	Average Score	N/A	Average Score	N/A		
Average of Priority		N/A								
Material Assessment Score		N/A								
Recommendation		No further action required

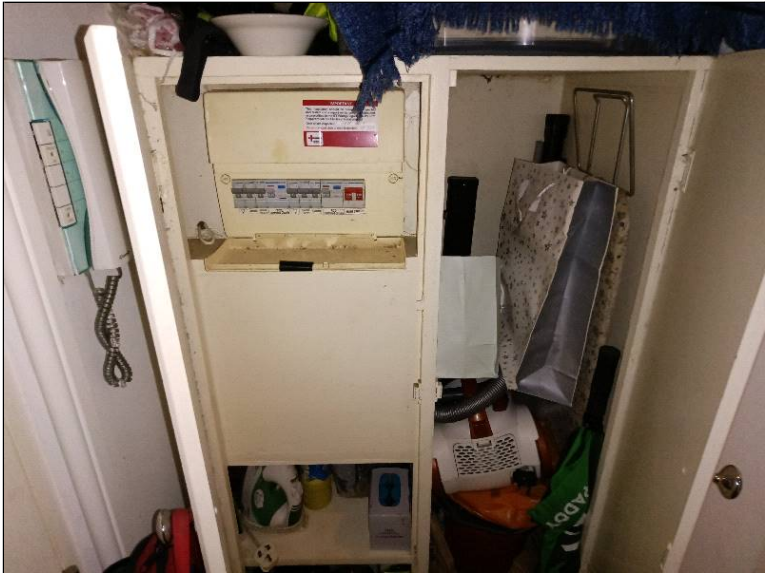
Survey Date:		Lead Surveyor		Survey Type		Floor		Analysis	
	26 May 2023 to 26 May 2023		Luke Atkinson		Management Survey		Ground Floor		N/A	
	Building		Room		Item				Quantity	
	Flat 57 Holly Lodge Mansions		Electrical Cupboard		No suspect materials found				N/A	
	Sample No (S,SP,P,As)		Product Type		Surface Treatment		Condition		Accessibility	
	Visual (NS)		N/A		N/A		N/A		N/A	
	Normal Occupancy	Score	Likelihood of disturbance	Score	Exposure Potential	Score	Maintenance Activity	Score		
	Main type of activity	N/A	Location	N/A	Number of occupants	N/A	Type of Maintenance	N/A	N/A	
	Accessibility	N/A	Frequency of use	N/A	Frequency of maintenance	N/A				
	Amount	N/A	Average Time	N/A						
Average Score	N/A	Average Score	N/A	Average Score	N/A	Average Score	N/A			
Average of Priority	N/A									
Material Assessment Score	N/A									
Recommendation	No further action required

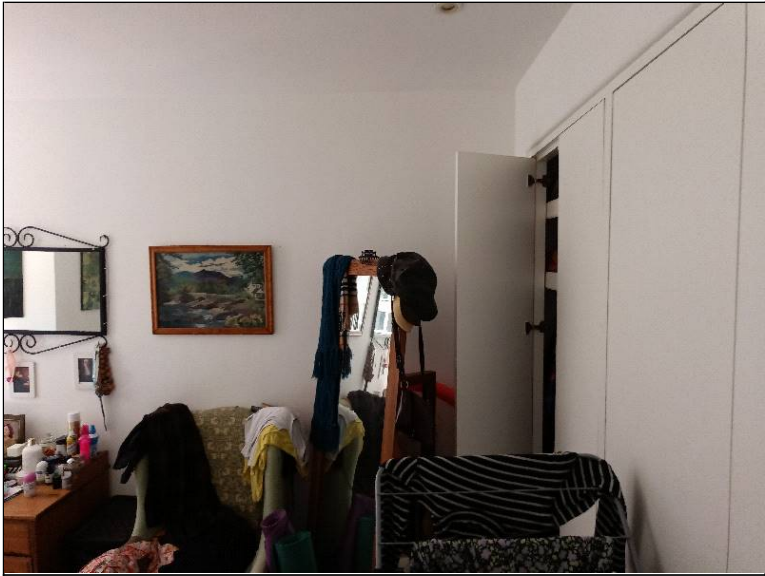
Survey Date:		Lead Surveyor		Survey Type		Floor		Analysis	
	26 May 2023 to 26 May 2023		Luke Atkinson		Management Survey		Ground Floor		N/A	
	Building			Room		Item			Quantity	
	Flat 57 Holly Lodge Mansions			Bedroom 2		No suspect materials found			N/A	
	Sample No (S,SP,P,As)		Product Type		Surface Treatment		Condition		Accessibility	
	Visual (NS)		N/A		N/A		N/A		N/A	
	Normal Occupancy		Score	Likelihood of disturbance	Score	Exposure Potential	Score	Maintenance Activity	Score	
	Main type of activity		N/A	Location	N/A	Number of occupants	N/A	Type of Maintenance	N/A	
	Accessibility		N/A	Frequency of use	N/A	Frequency of maintenance	N/A			
	Amount		N/A	Average Time	N/A					
Average Score		N/A	Average Score	N/A	Average Score	N/A	Average Score	N/A		
Average of Priority		N/A								
Material Assessment Score		N/A								
Recommendation		No further action required

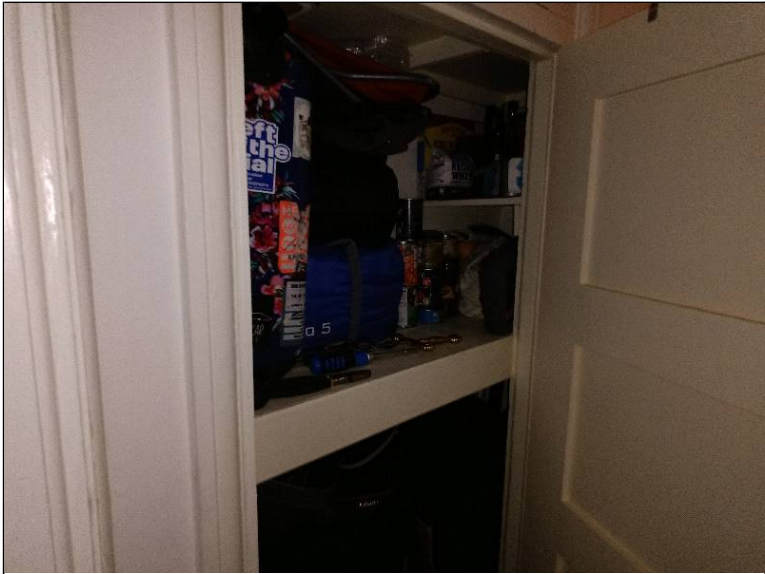
Survey Date:		Lead Surveyor		Survey Type		Floor		Analysis	
	26 May 2023 to 26 May 2023		Luke Atkinson		Management Survey		Ground Floor		N/A	
	Building		Room		Item				Quantity	
	Flat 57 Holly Lodge Mansions		Cupboard		No suspect materials found				N/A	
	Sample No (S,SP,P,As)		Product Type		Surface Treatment		Condition		Accessibility	
	Visual (NS)		N/A		N/A		N/A		N/A	
	Normal Occupancy		Score	Likelihood of disturbance	Score	Exposure Potential	Score	Maintenance Activity	Score	
	Main type of activity		N/A	Location	N/A	Number of occupants	N/A	Type of Maintenance	N/A	
	Accessibility		N/A	Frequency of use	N/A	Frequency of maintenance	N/A			
	Amount		N/A	Average Time	N/A					
Average Score		N/A	Average Score	N/A	Average Score	N/A	Average Score	N/A		
Average of Priority		N/A								
Material Assessment Score		N/A								
Recommendation		No further action required

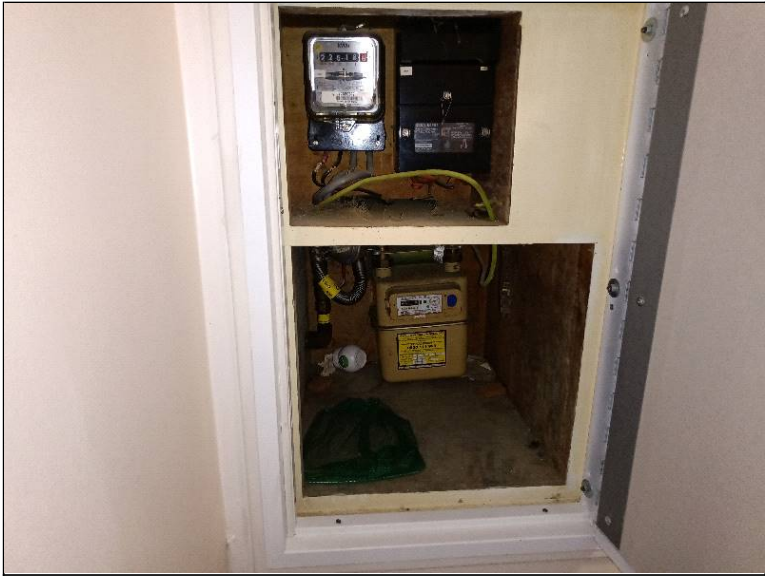
Survey Date:		Lead Surveyor		Survey Type		Floor		Analysis	
	26 May 2023 to 26 May 2023		Luke Atkinson		Management Survey		Ground Floor		N/A	
	Building		Room		Item				Quantity	
	Flat 57 Holly Lodge Mansions		Meter Cupboard		No suspect materials found				N/A	
	Sample No (S,SP,P,As)		Product Type		Surface Treatment		Condition		Accessibility	
	Visual (NS)		N/A		N/A		N/A		N/A	
	Normal Occupancy		Score	Likelihood of disturbance	Score	Exposure Potential	Score	Maintenance Activity	Score	
	Main type of activity		N/A	Location	N/A	Number of occupants	N/A	Type of Maintenance	N/A	
	Accessibility		N/A	Frequency of use	N/A	Frequency of maintenance	N/A			
	Amount		N/A	Average Time	N/A					
Average Score		N/A	Average Score	N/A	Average Score	N/A	Average Score	N/A		
Average of Priority		N/A								
Material Assessment Score		N/A								
Recommendation		No further action required
