University College London (UCL) Bidborough House primary entrance accessibility works – justification statement

Appendix A: photographic evidence of current accessibility non-compliances

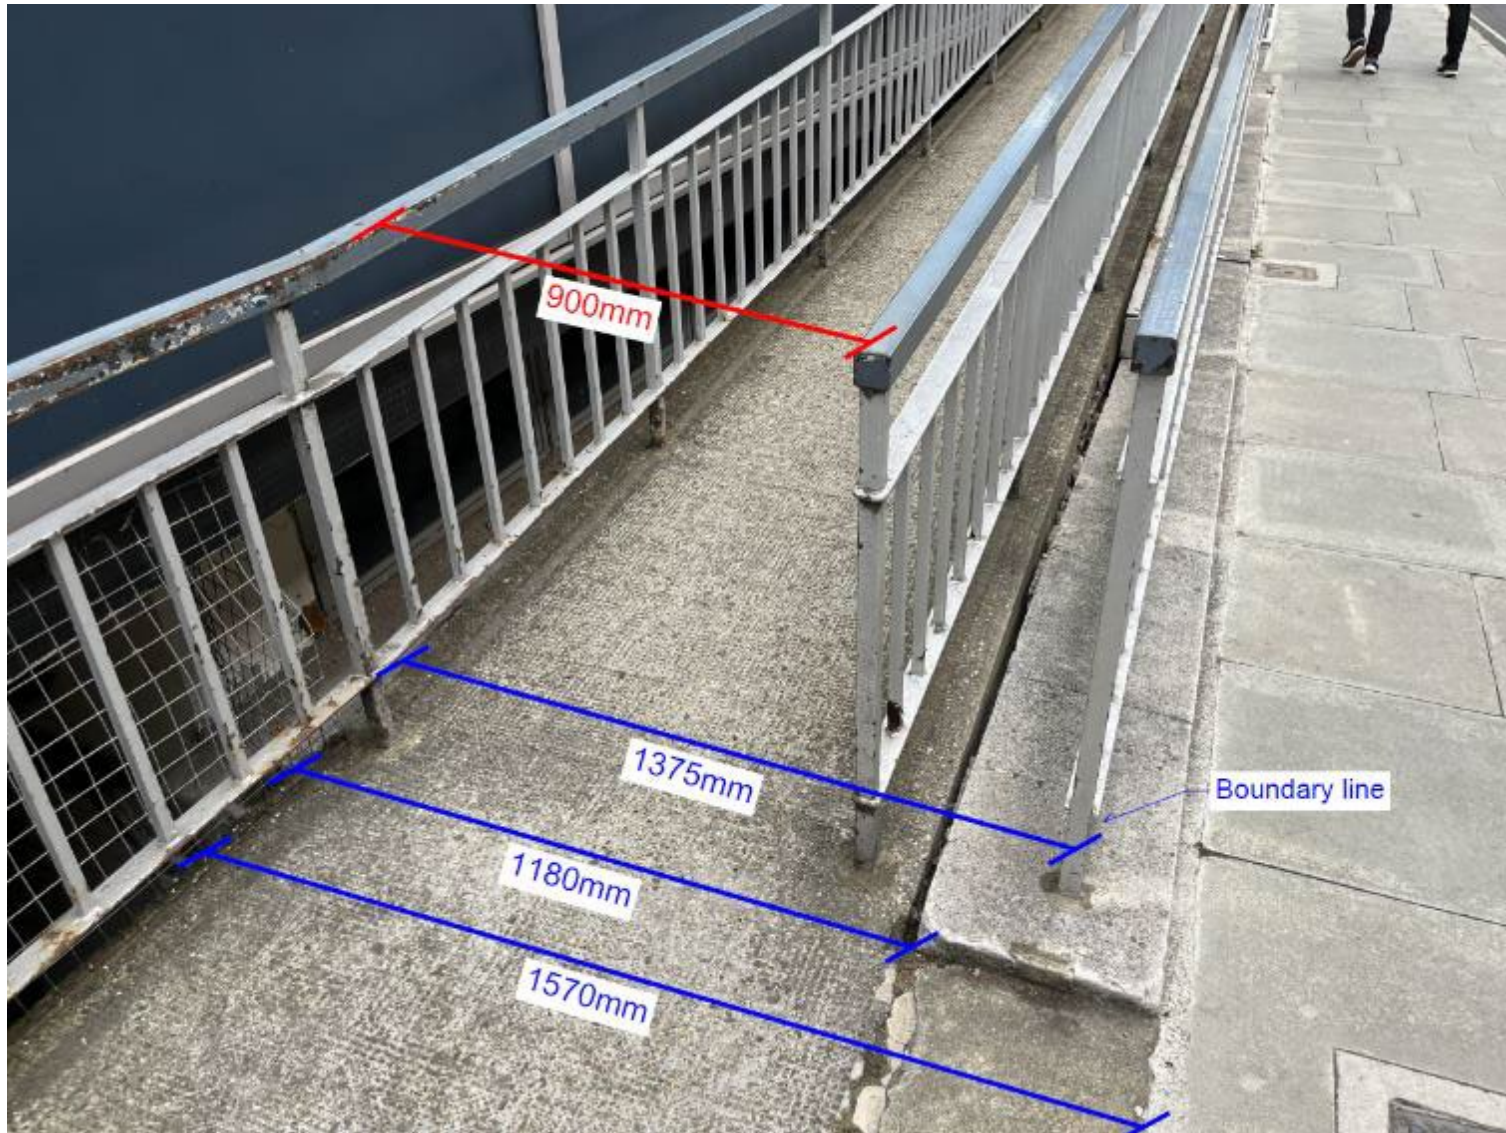
- Insufficient clear width of the ramp (currently 900mm), not achieving the required 1500mm clear surface width (see dimension highlighted in red, within Figure 1 in Appendix A).

Figure 1. Indication of the current clear width of the ramp (in red) at the bottom of the ramp, and indication of the project boundary line.

- Ramp:
 - Widening of the clear surface width to 1500mm (from the current 900mm) or, at least as far as practicable within the boundary line (as shown in Figure 1 in Appendix A).
 - Widening the top landing of the ramp to 1500mm (from the current 1220mm) or, at least, as wide as the revised ramp width.
 - Resurfacing the ramp going and both the landing at the bottom and at the top of the ramp, in order to provide sufficient visual contrast between these two

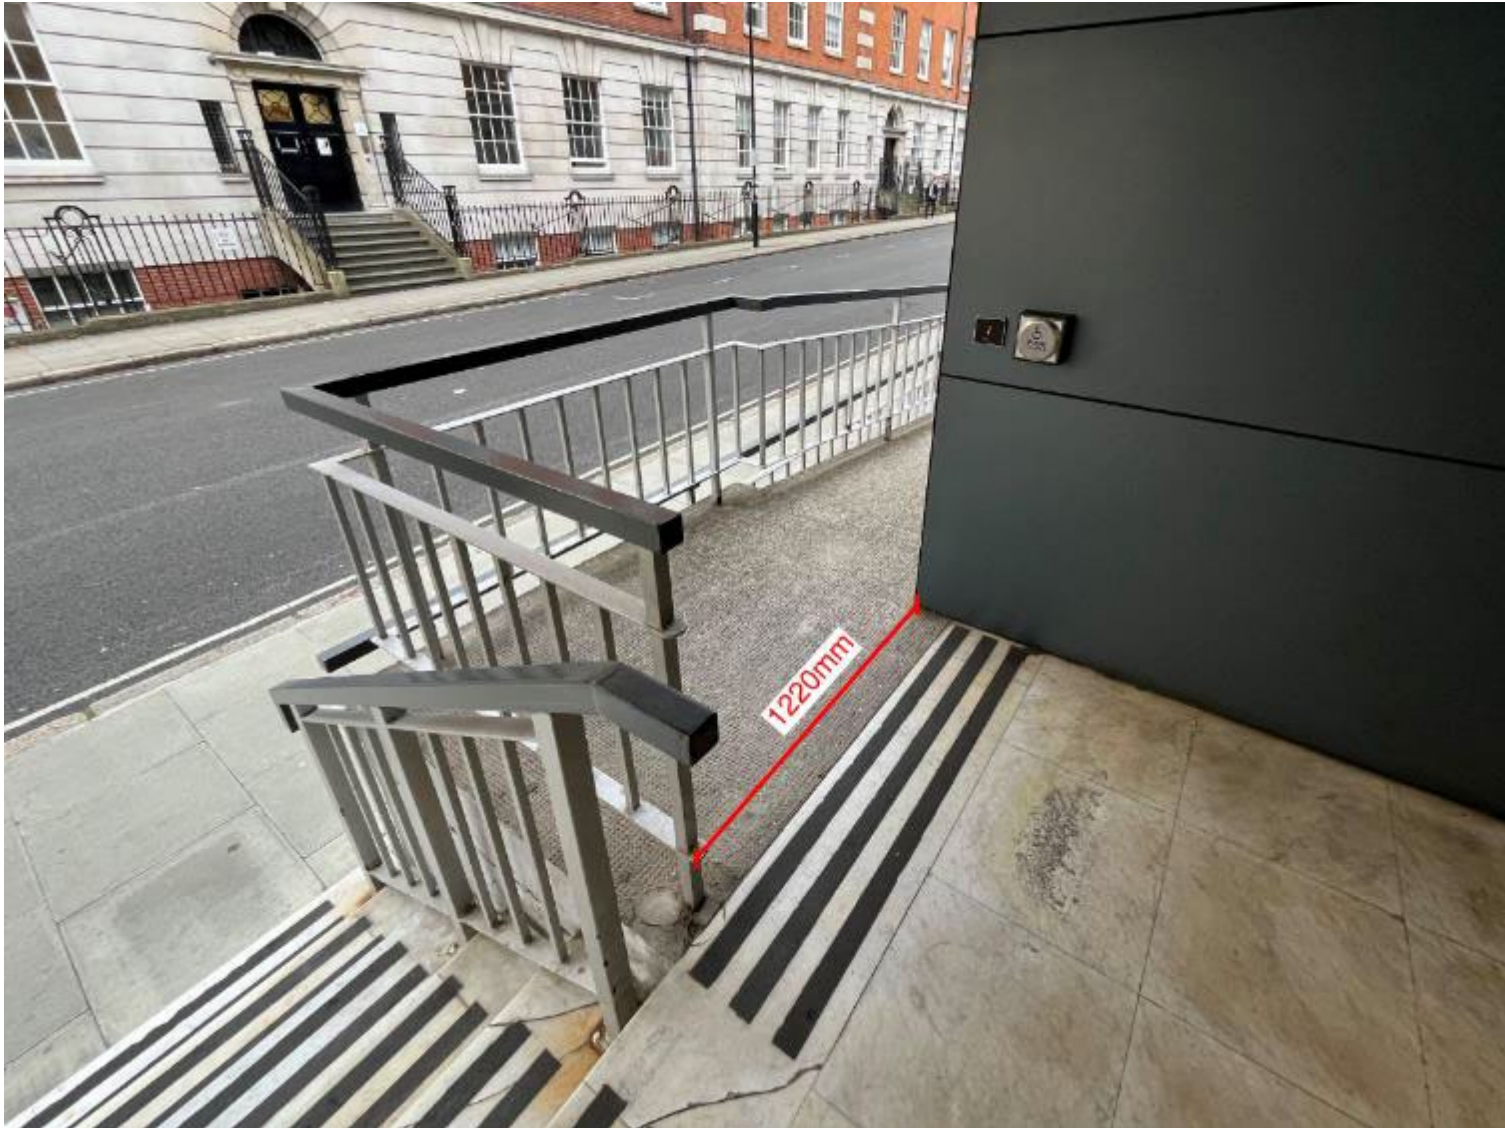
- Lack of sufficiently deep landing at the top of the ramp (currently 1220mm), as the top landing should have a clear depth of least 1500mm or be at least as wide as the ramp (see Figure 2 in Appendix A).

Figure 2. Indication of the current clear width of the top landing of the ramp (in red).

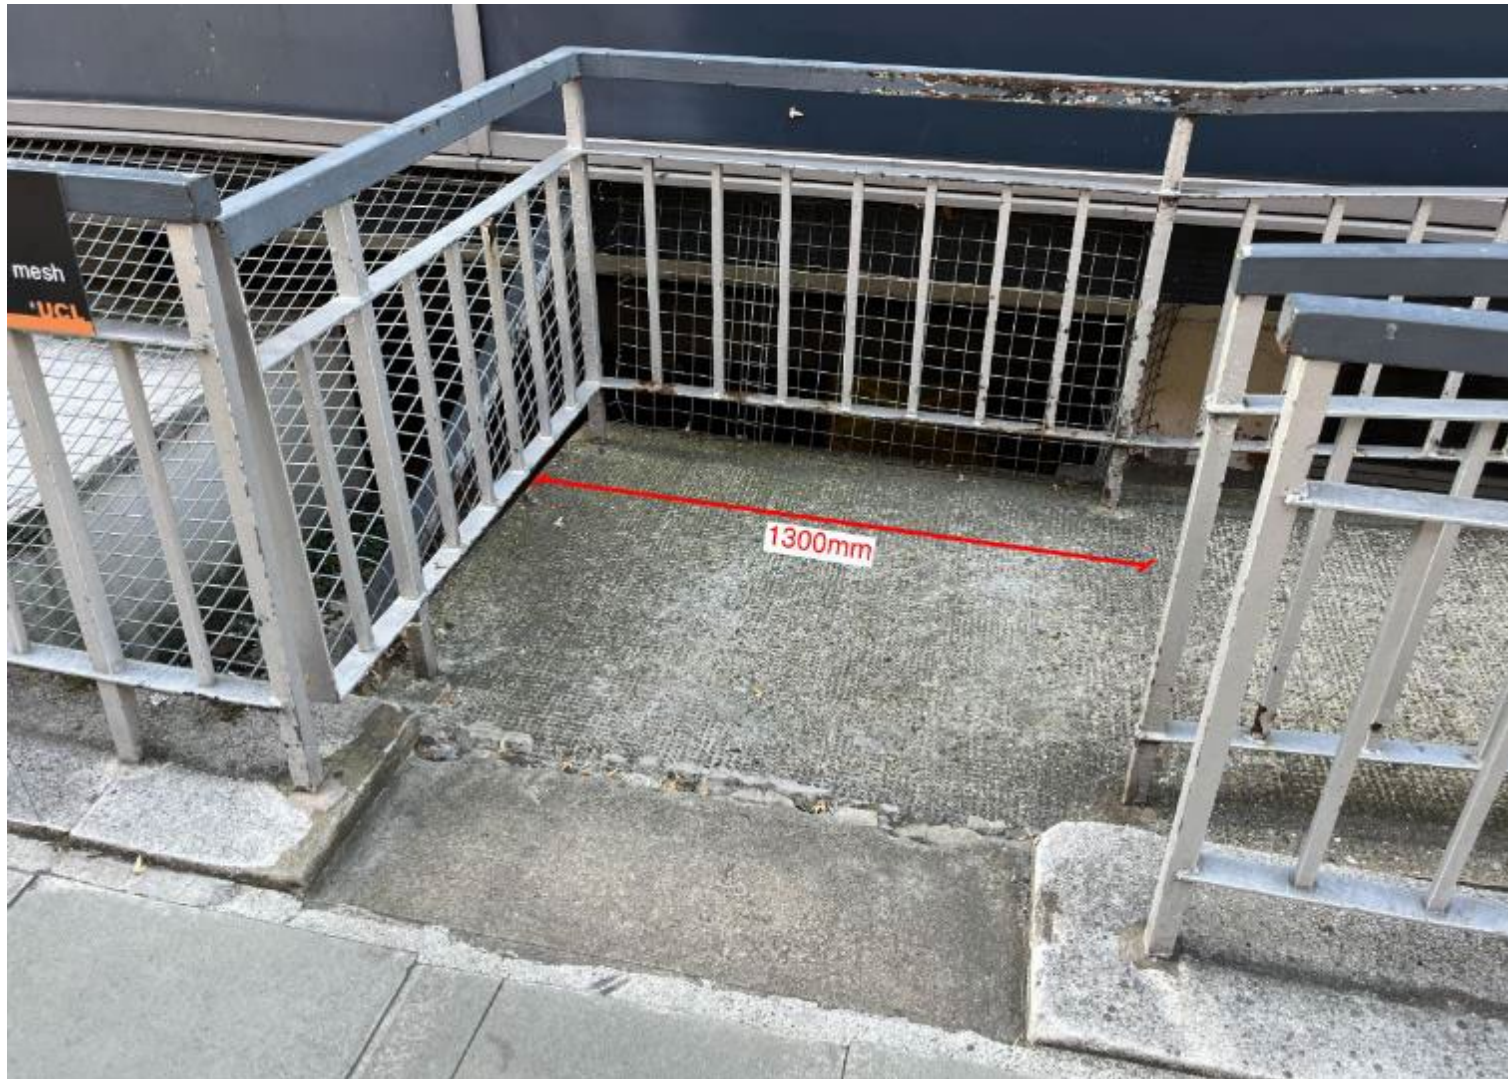
- Lack of sufficiently deep landing at the bottom of the ramp (currently 1300mm), as the bottom landing should have a clear depth of least 1500mm or be at least as wide as the ramp (see Figure 3 in Appendix A).

Figure 3. Indication of the current clear width of the bottom landing of the ramp (in red).

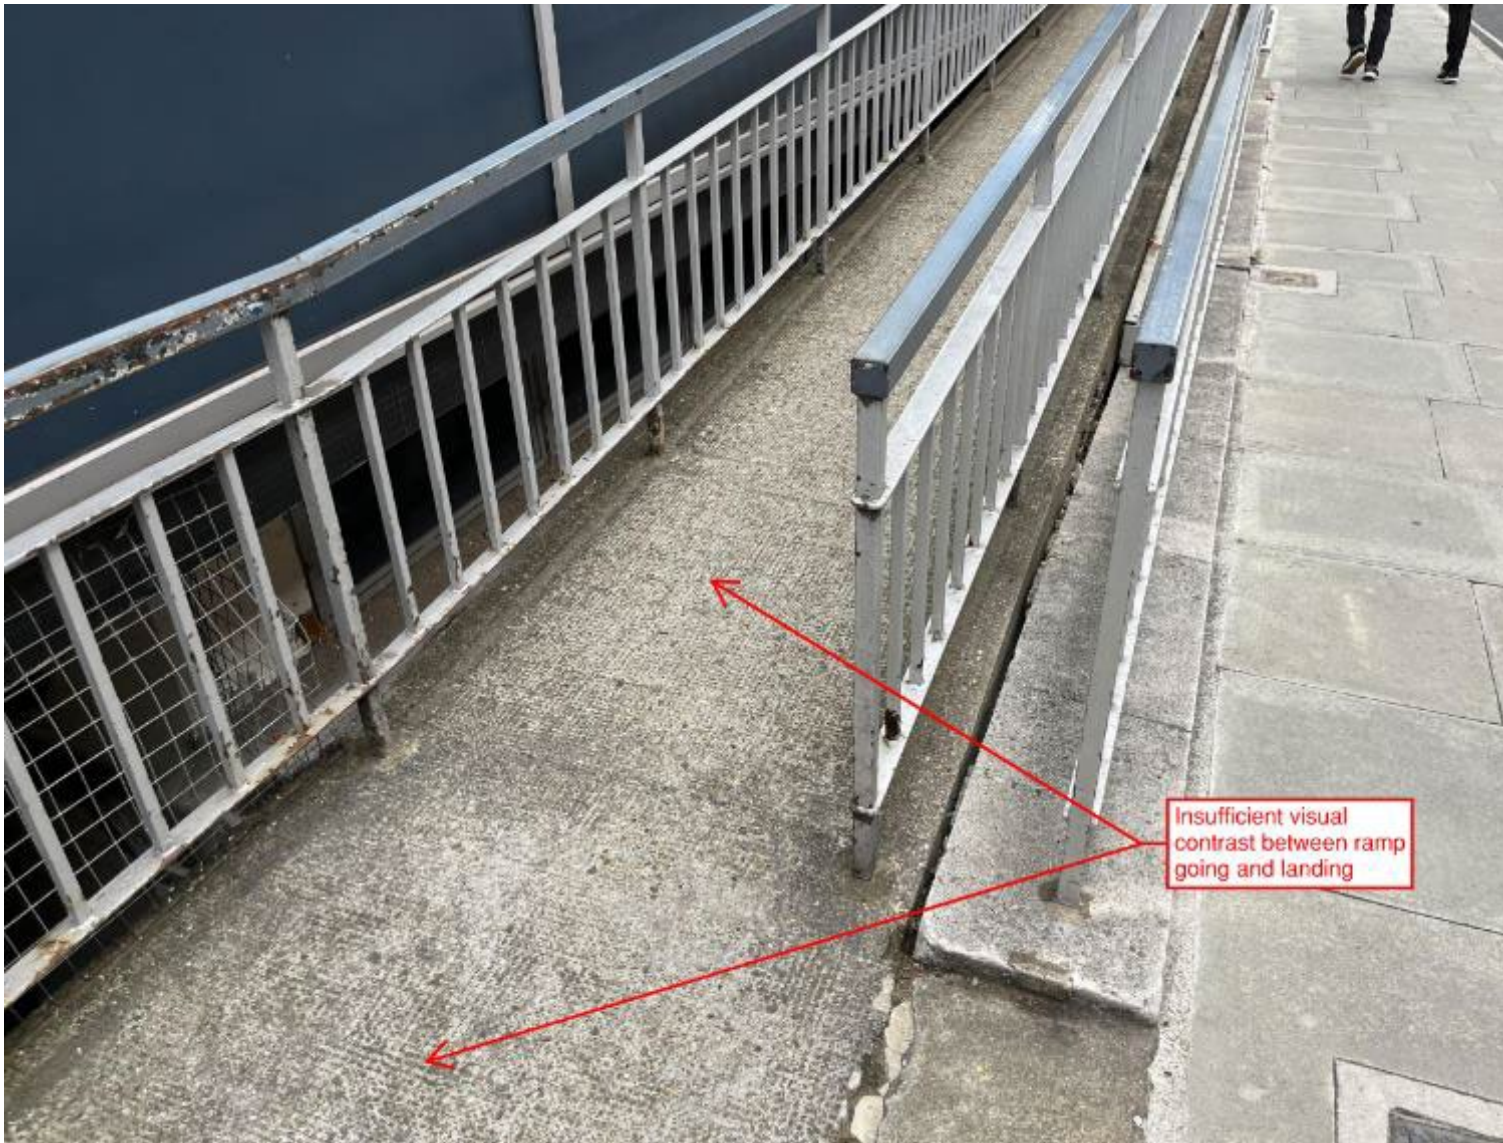
- No sufficient visual contrast (i.e. at least 30 Light Reflectance Value points of difference) between the landings and the going of the ramp; in addition, the intersection between the top landing of the ramp and the flooring material in front of the entrance to Bidborough House is paved in such a way that it can be mistaken as a step (see Figure 4 and Figure 5 in Appendix A).

Figure 4. Photo showing lack of sufficient visual contrast between the ramp going and the bottom landing.

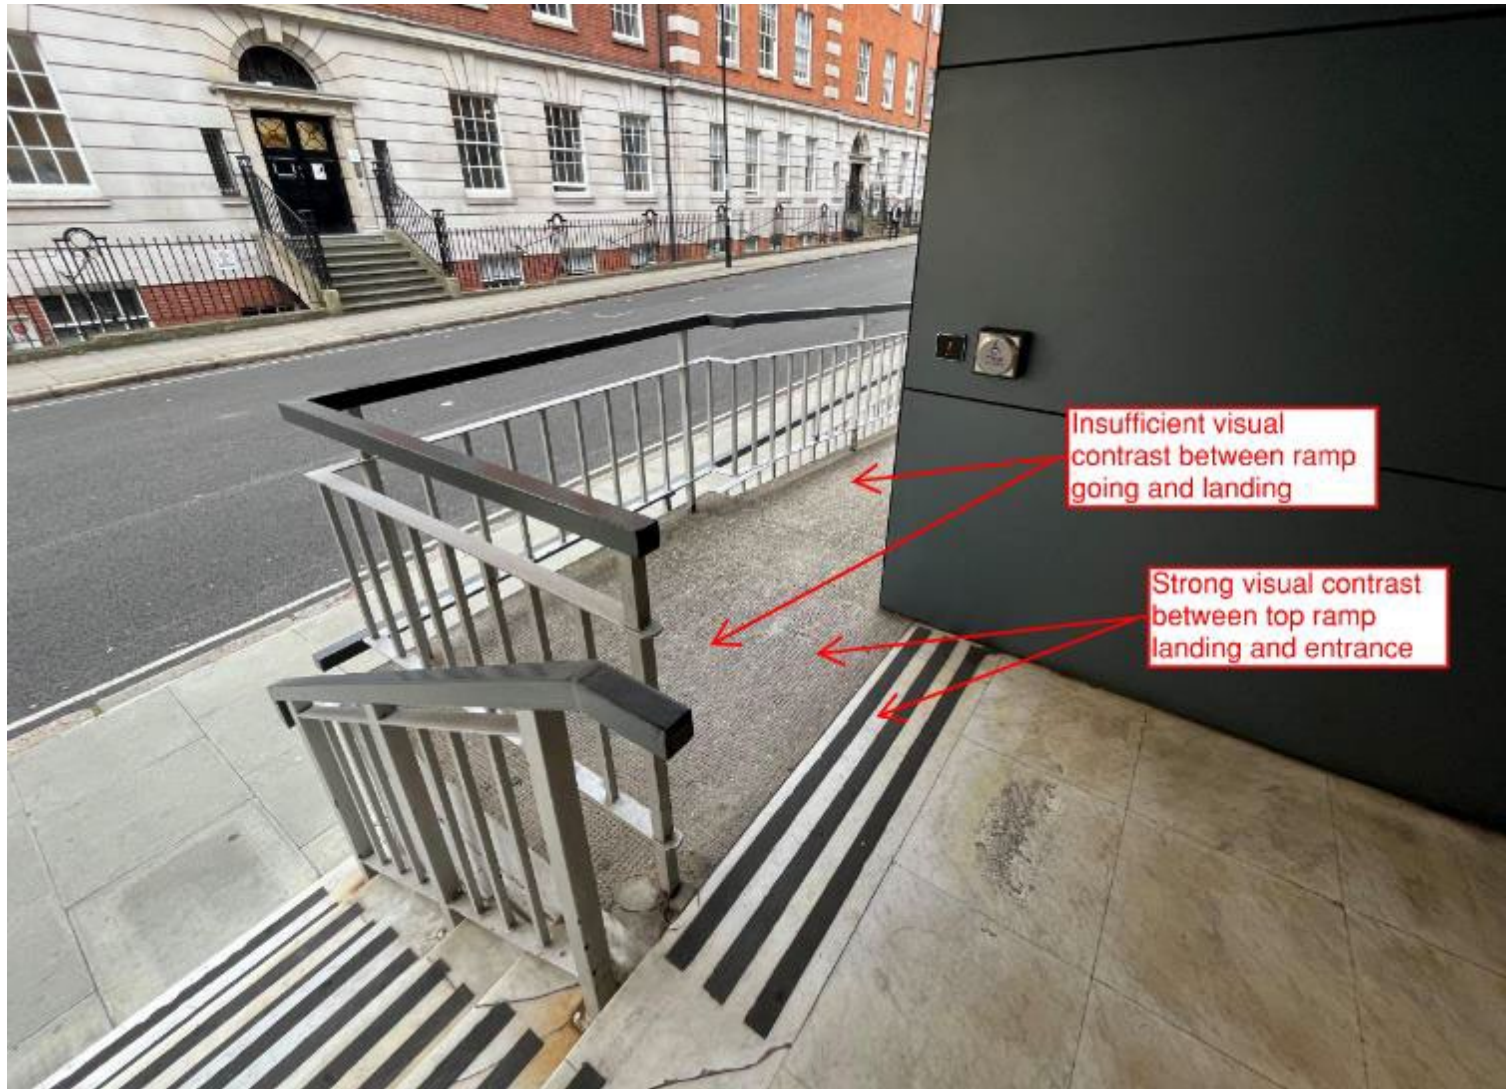
Figure 5. Photo showing lack of sufficient visual contrast between the ramp going and the top landing, in addition of strong visual contrast in the intersection between top ramp landing and entrance.

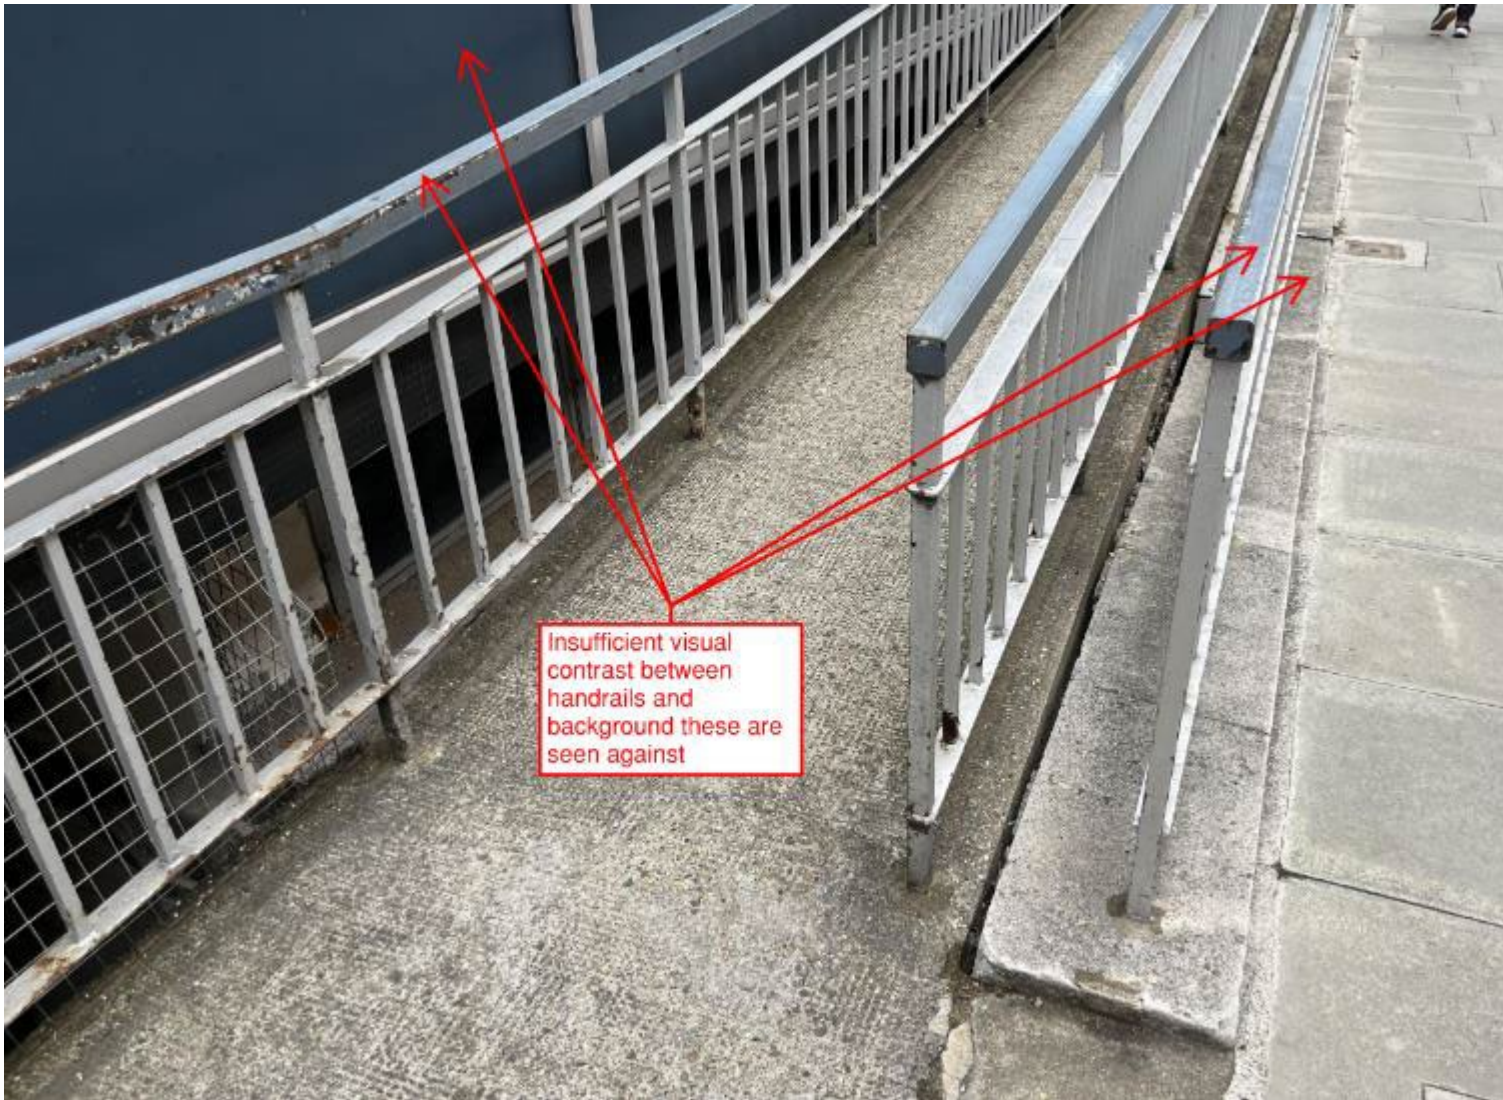
- Lack of sufficient visual contrast between the handrails and the background these are seen against (see Figure 6 in Appendix A).
- Handrailing not being provided with a circular or oval profile, as Required by Approved Document M vol 2 2015 (see Figure 7 in Appendix A).

Figure 6. Photo showing lack of sufficient visual contrast between handrails and background these are seen against.

- Providing visually contrasting handrails (i.e. at least 30 Light Reflectance Value points of difference with the background these are seen against).
- Providing circular handrails with a diameter of between 32 mm and 50 mm, and a clearance of between 50 mm and 75 mm between the adjacent wall / balustrade surface.

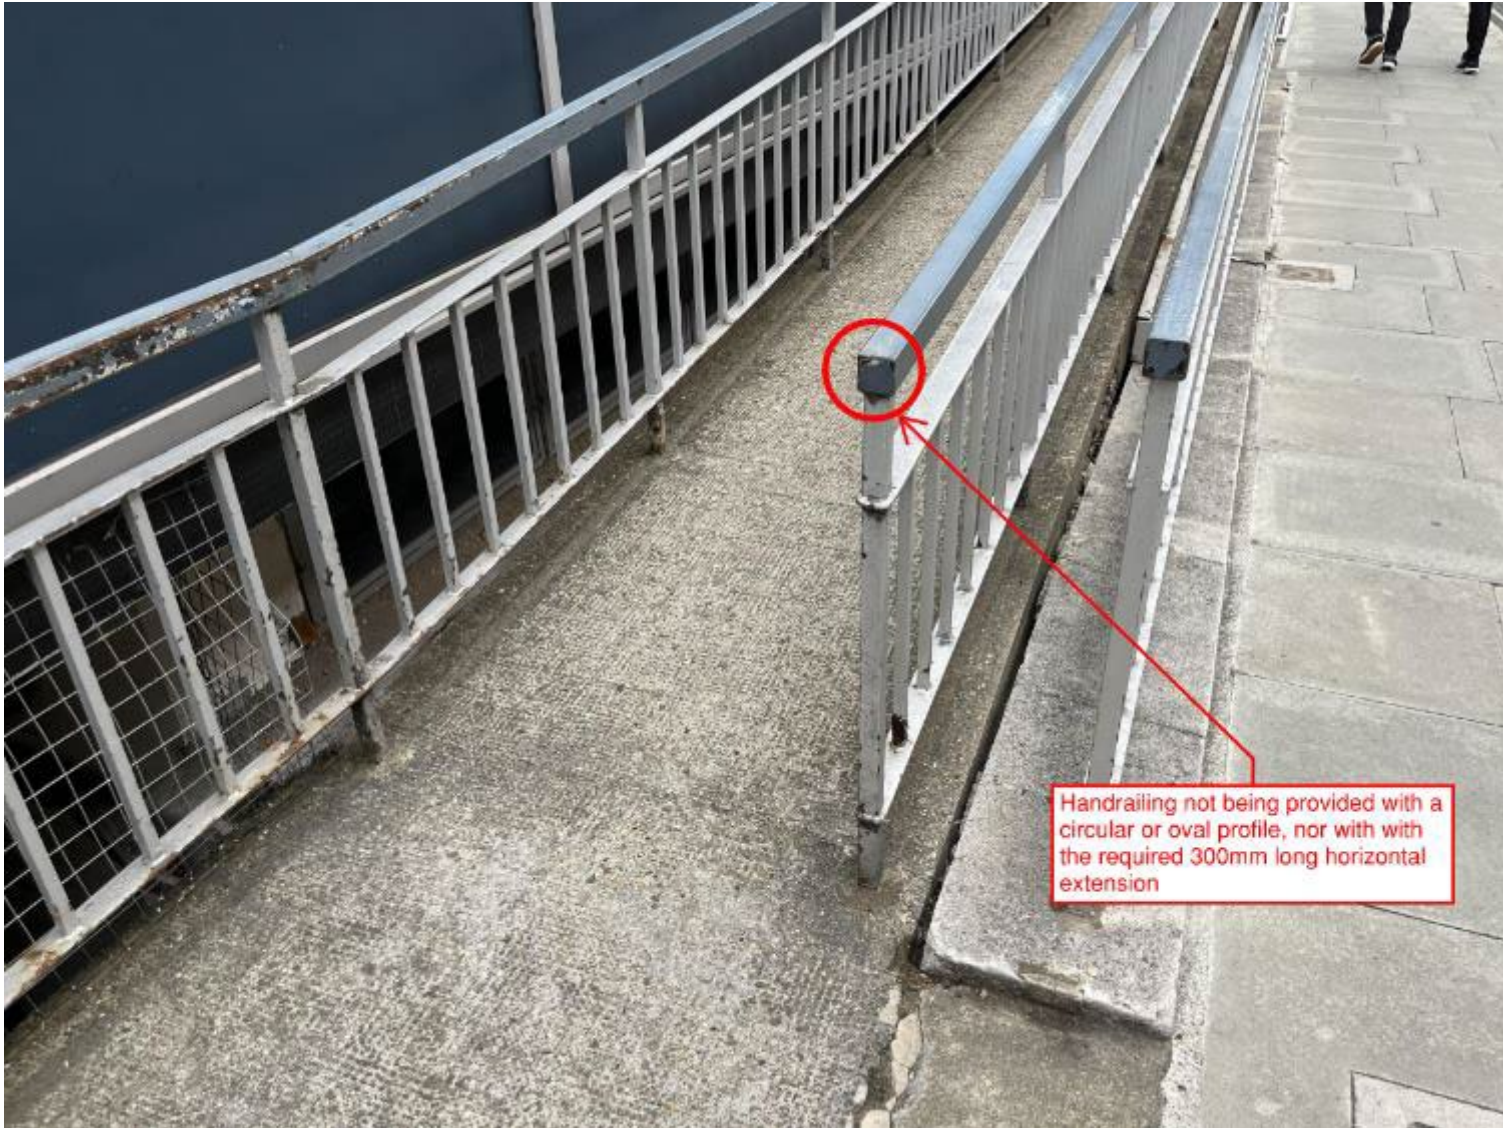
- Handrails, both at the top and at the bottom of the ramp, not being provided with the required 300mm long horizontal extension (see Figure 7 in Appendix A).

Figure 7. Photo showing lack of circular or oval handrailing profile, and lack of 300mm long handrail horizontal extension.

- Extending the handrails 300mm horizontally both at the top and at the bottom of the ramp. Handrails to be terminated in a way that reduces the risk of clothing being caught, and that can be detected by a person walking with a cane.

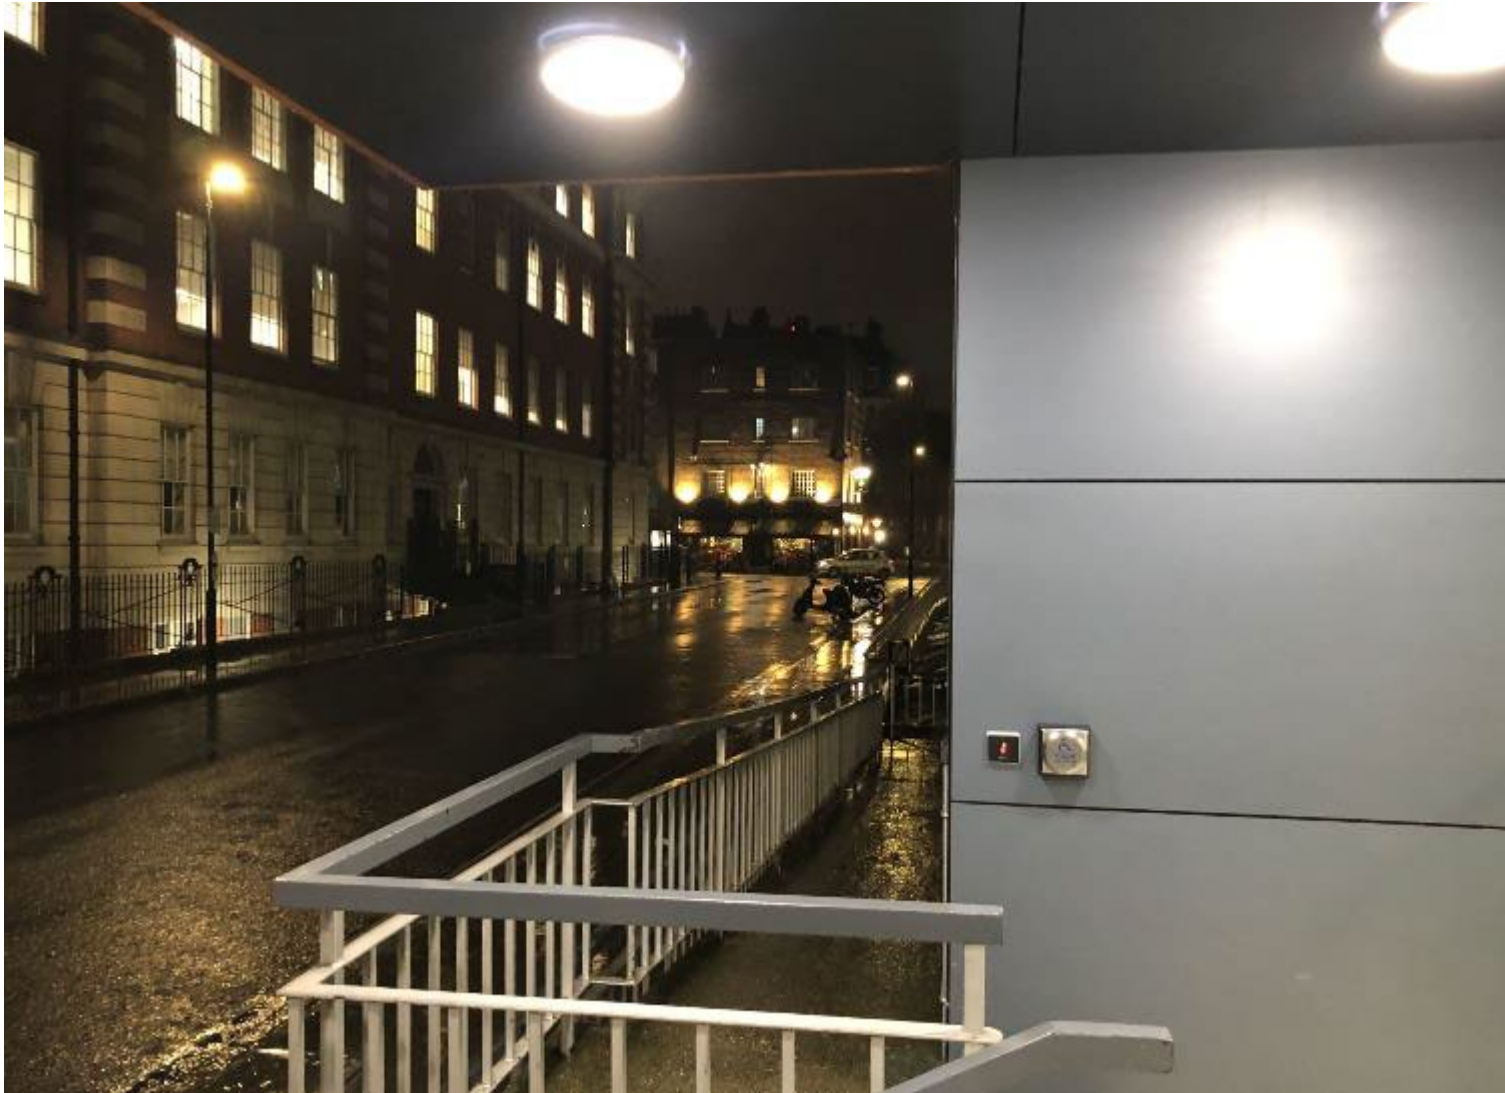
- Lack of evenly distributed artificial lighting along the ramp, creating both visual and personal safety discomfort (see Figure 8 in Appendix A).

Figure 8. Photo showing the lack of sufficient illumination, along the ramp, during nighttime conditions.

- Integrating artificial lighting along the whole development of the ramp in order for it to be evenly distributed, with an illuminance at ramp and landing level of at least 100 lux.

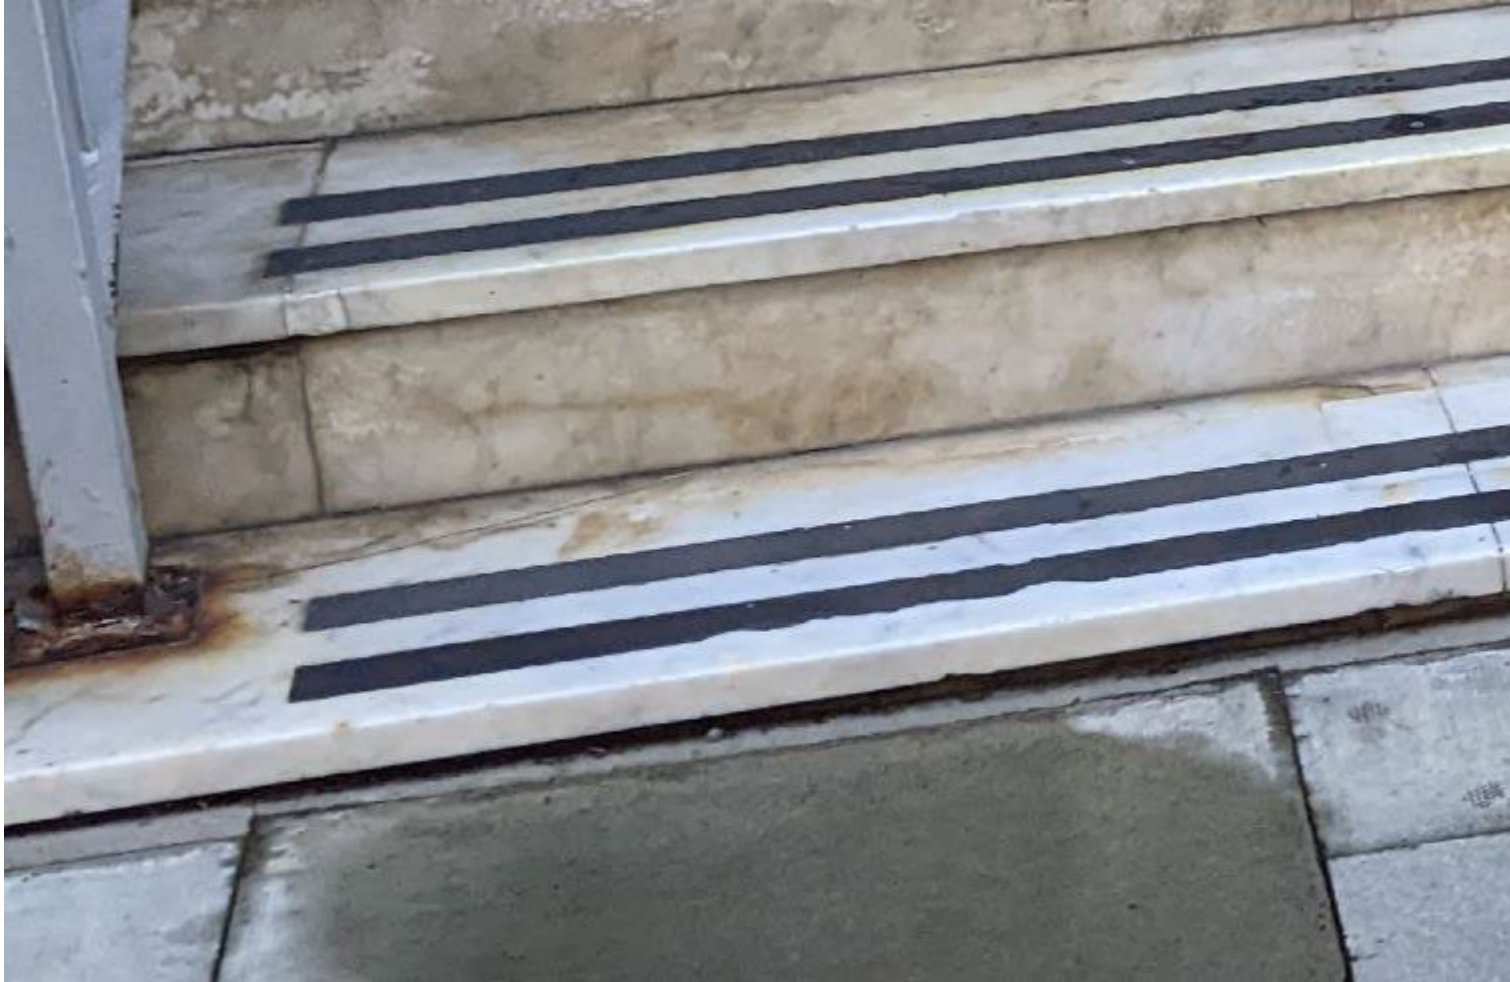
- Unsafe stair nosings, due to wear (see Figure 9 in Appendix A).
- Main entrance doors opening onto the landing, obstructing the required 1500x1500mm clear landing that is to be provided in front of the doors.
- Lack of sufficient visual contrast (i.e. at least 30 Light Reflectance Value points of difference) between the handrails and the background these are seen against (see Figure 10 in Appendix A).
- Handrailing not being provided with a circular or oval profile, as Required by Approved Document M vol 2 2015 (see Figure 11 in Appendix A).
- Handrails, both at the top and at the bottom of the stair, not being provided with the required 300mm long horizontal extension (see Figure 12 in Appendix A).
- Due to the existing gradient of the pavement, the bottom step of the stair is slightly tapered, resulting in the risk of trips and falls (see Figure 13 in Appendix A).

Figure 9. Detail of the stair nosing deterioration.

- Stair:
 - Re-installing the currently torn nosings with new slip resistant, continuous nosings that extends 50-65mm width from the front edge of the tread to and 30-55mm from the top of the rise, ensuring a visual contrast of at least 30 LRV points of difference with the remainder of the stair.

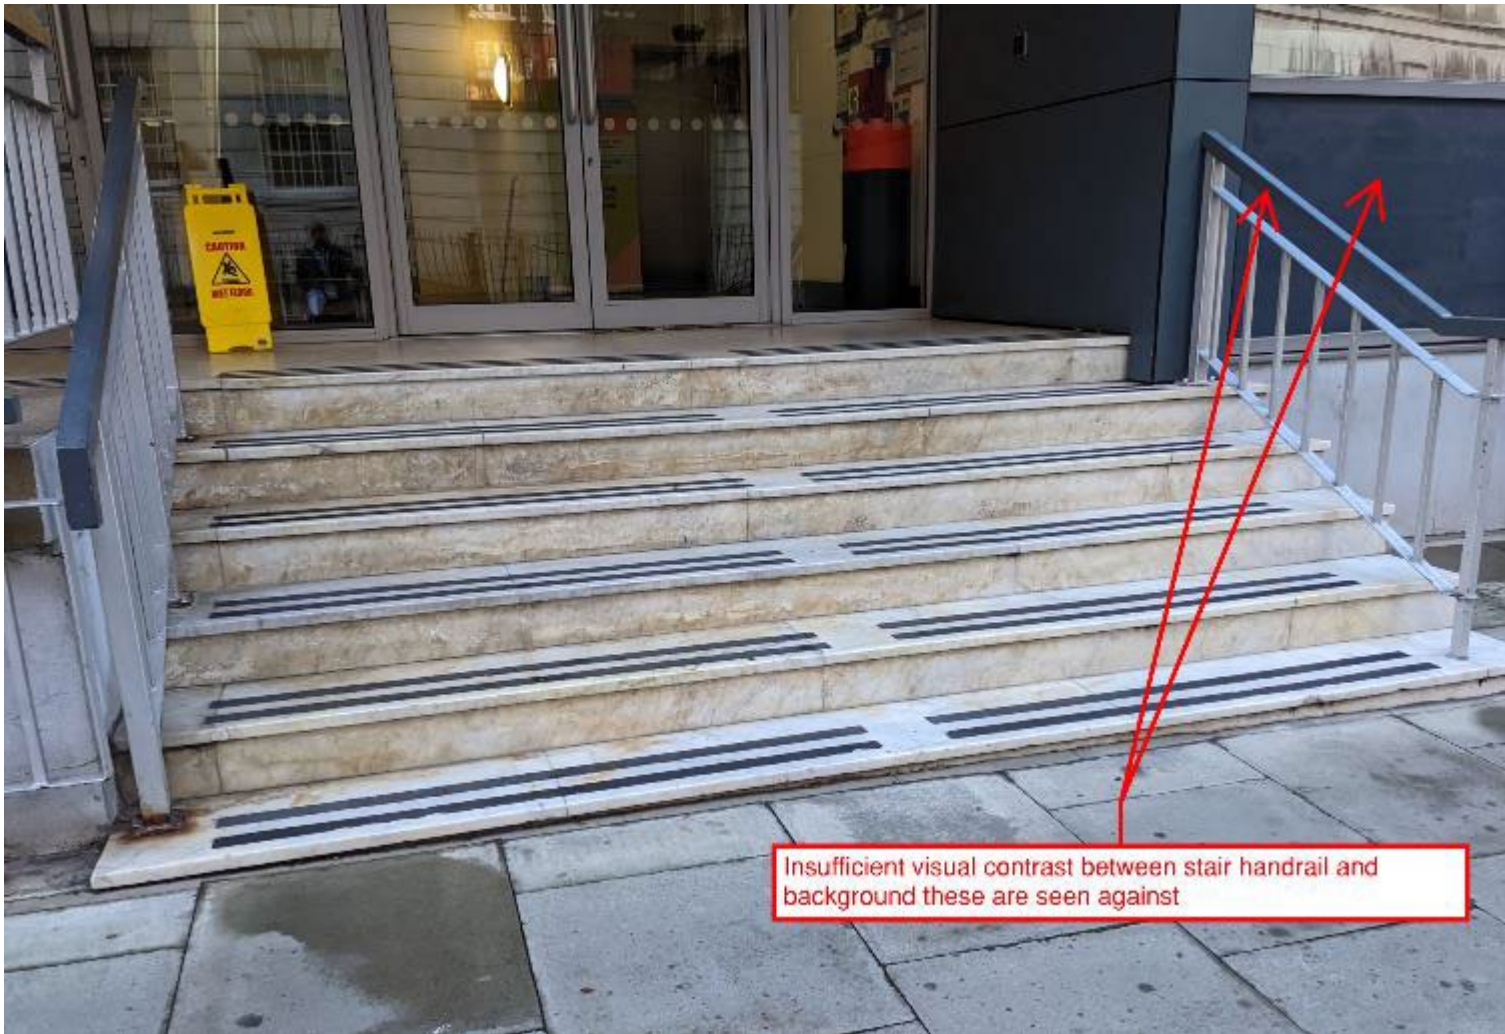
Figure 10. Photo showing lack of sufficient visual contrast between handrails and background these are seen against.

- Providing a lower handrail at 600mm to cater for children and people of shorter stature.
 - Providing visually contrasting handrails (i.e. at least 30 Light Reflectance Value points of difference with the background these are seen against).

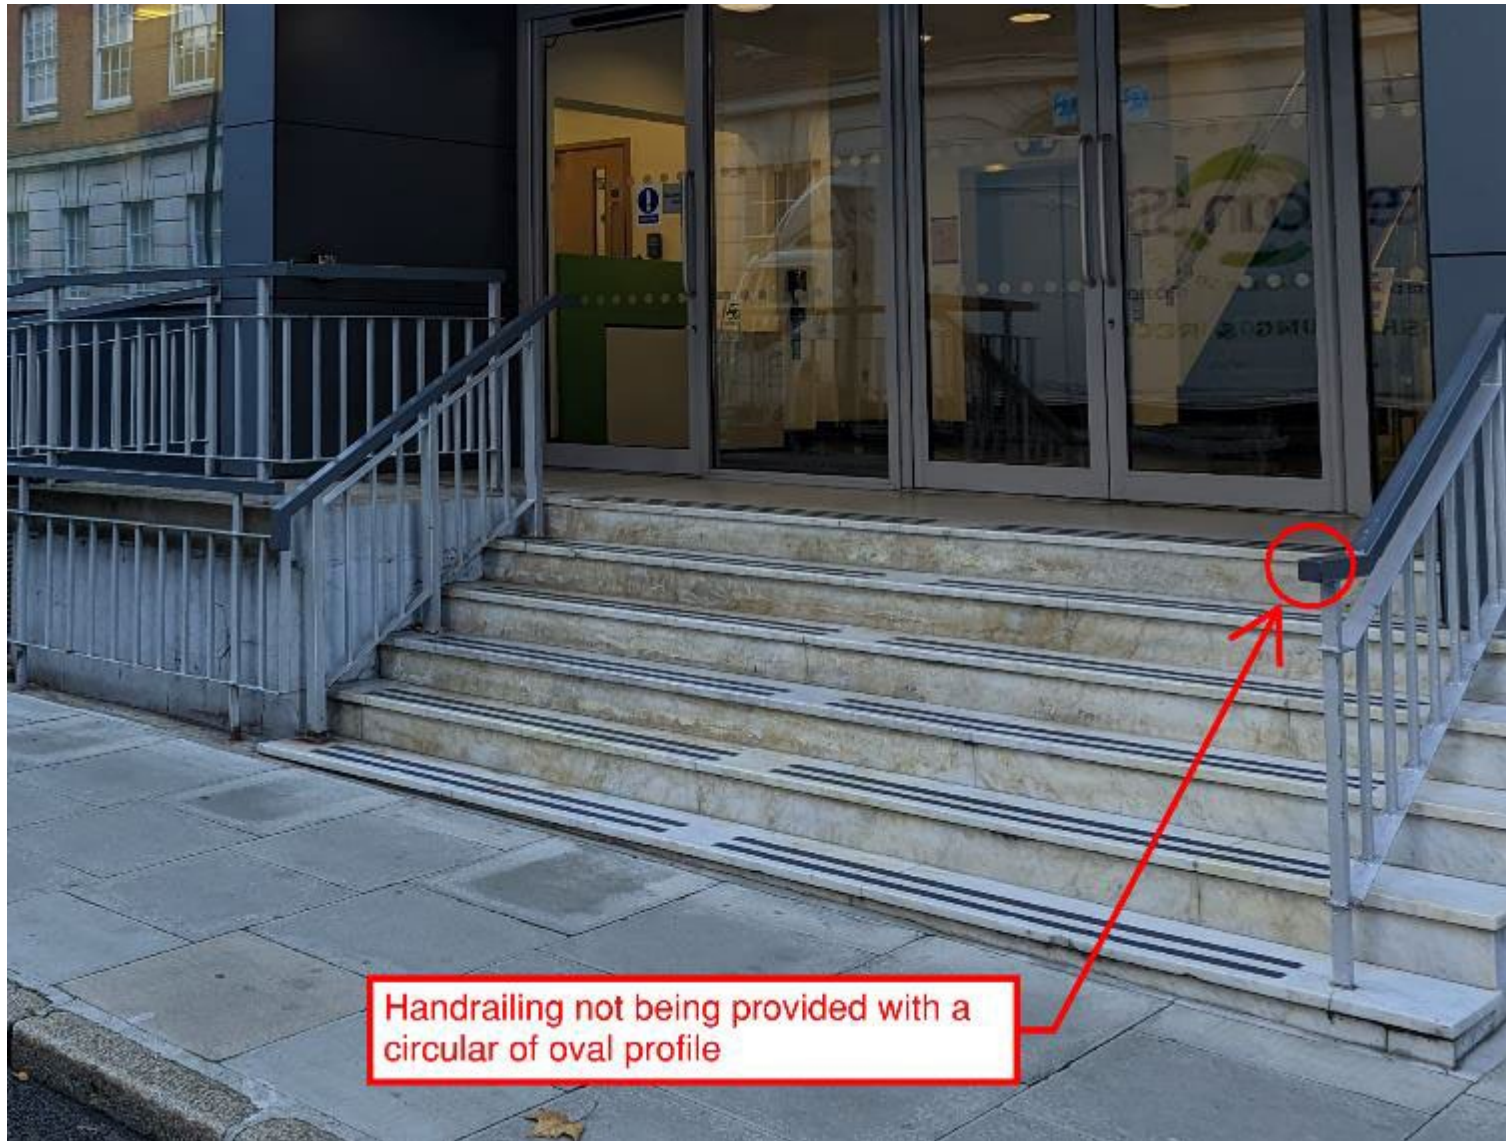
Figure 11. Photo showing stair handrailing profile.

- Providing circular handrails with a diameter of between 32 mm and 50 mm, and a clearance of between 50 mm and 75 mm between the adjacent wall / balustrade surface.

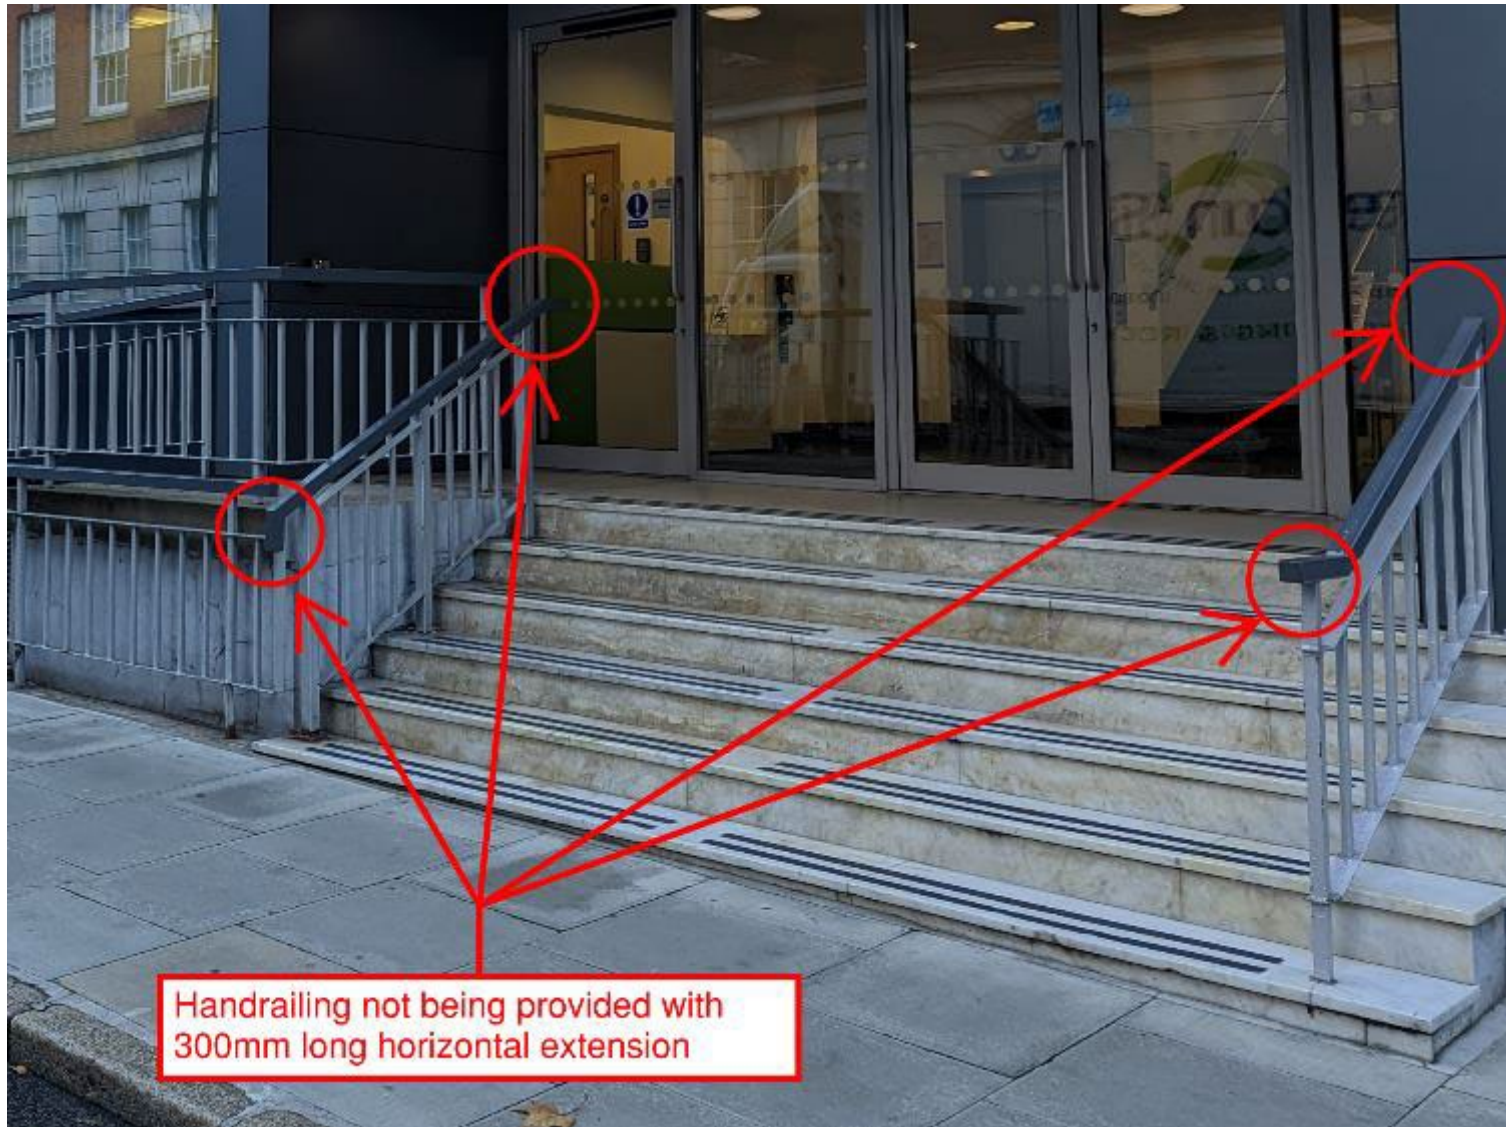
Figure 12. Photo showing lack of 300mm long horizontal extension to the stair handrails.

- Extending handrails 300mm horizontally, on the top and one the bottom of the stair. Handrails to be terminated in a way that reduces the risk of clothing being caught, and that can be detected by a person walking with a cane (coordination needed, with Camden Council, to determine whether the 300mm horizontal handrail extension can be provided to the bottom of the stair as this would encroach with the public pavement).
