University College London (UCL) Bidborough House primary entrance accessibility works – justification statement

Appendix A: photographic evidence of current accessibility non-compliances

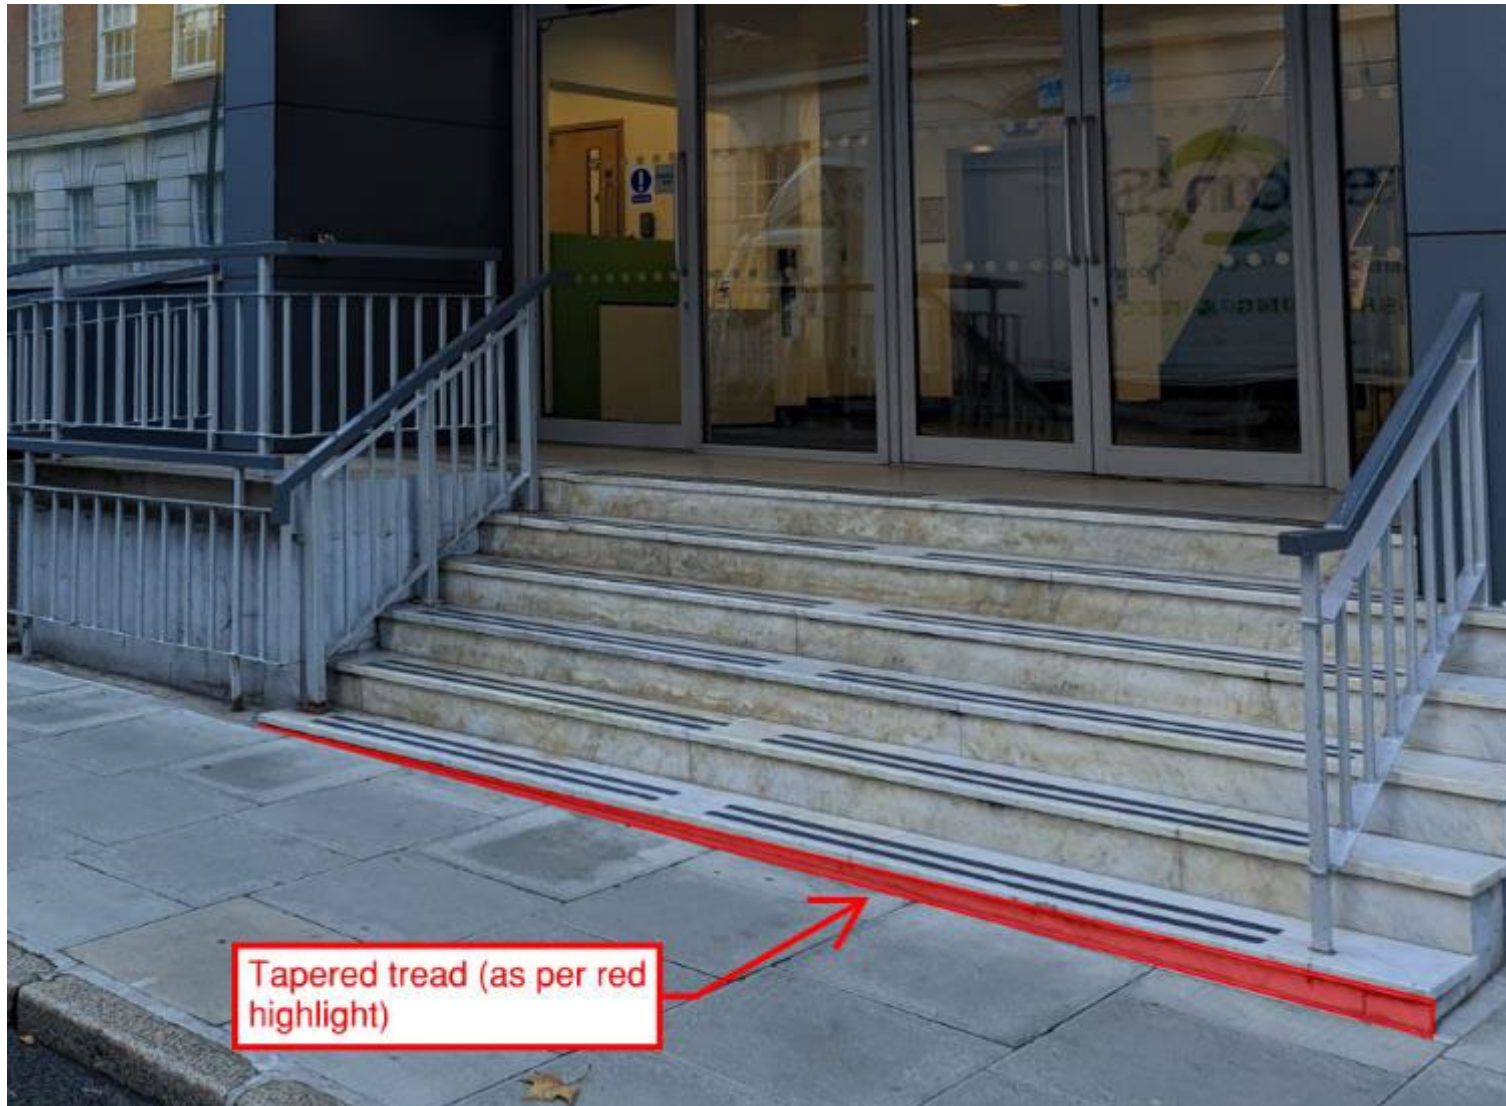
- Unsafe stair nosings, due to wear (see Figure 9 in Appendix A).
- Main entrance doors opening onto the landing, obstructing the required 1500x1500mm clear landing that is to be provided in front of the doors.
- Lack of sufficient visual contrast (i.e. at least 30 Light Reflectance Value points of difference) between the handrails and the background these are seen against (see Figure 10 in Appendix A).
- Handrailing not being provided with a circular or oval profile, as Required by Approved Document M vol 2 2015 (see Figure 11 in Appendix A).
- Handrails, both at the top and at the bottom of the stair, not being provided with the required 300mm long horizontal extension (see Figure 12 in Appendix A).
- Due to the existing gradient of the pavement, the bottom step of the stair is slightly tapered, resulting in the risk of trips and falls (see Figure 13 in Appendix A).

Figure 13. Photo showing the tapered tread, at the bottom of the main entrance.

- If feasible, adjust the gradient of the pavement in order to remove the tapered tread, at the bottom of the stair.
- Entrance doors:
 - Providing an entry-phone, both to the power-operated pass-door and to the adjacent swing doors, to request assistance if needed.
 - Changing the opening direction of the accessible pass door, to swing inwards.
 - Replacing two doors adjacent the accessible pass door with new doors that don't require more than 30N to be opened, and that also allow the possibility to swing both inwards and outwards.
