Revised
Addendum Arboricultural Report

Subsidence Damage Investigation at:

73 Aberdare Gardens
 London
 NW6 3AN

CLIENT:	Davies Group Ltd
CLIENT REF:	[REDACTED]
MWA REF:	[REDACTED]
MWA CONSULTANT:	Andy Clark
REPORT DATE:	03/02/2021

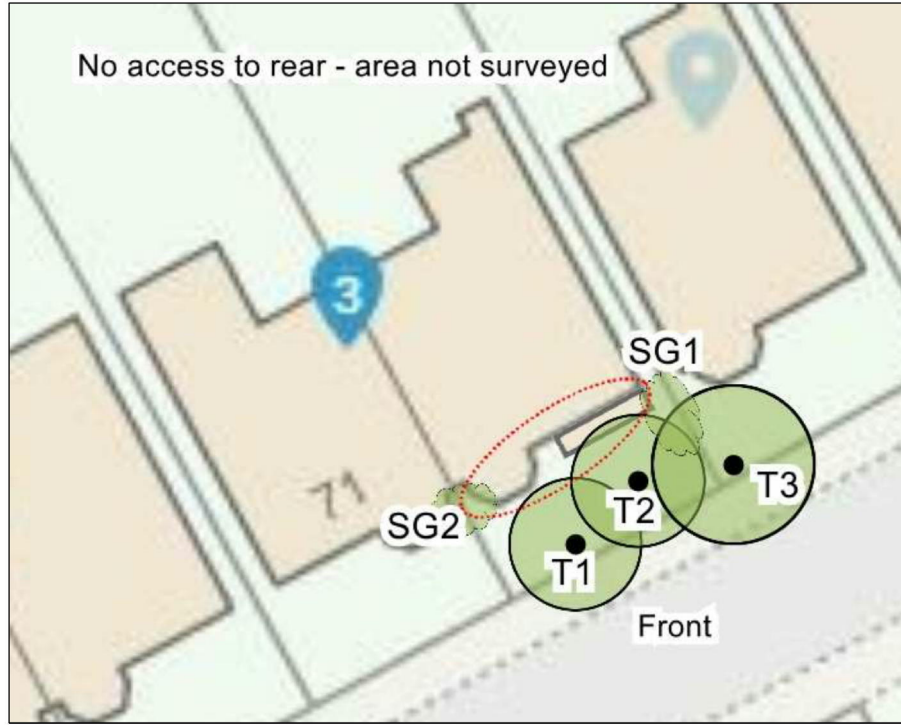
Site Plan

Approximate areas of damage

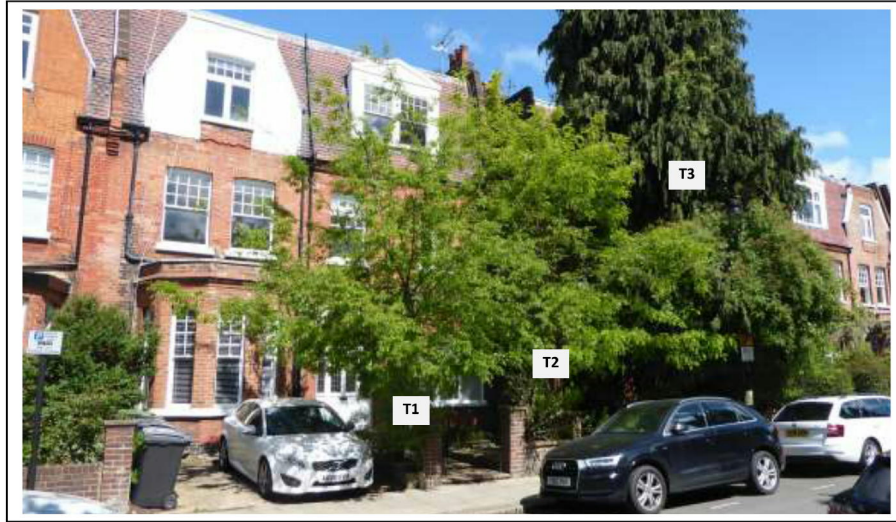
Our survey has previously identified vegetation within influencing distance of the building with a current potential to influence soil volumes below foundation level, the most significant of which in relation to the current damage were identified as T1 Oak [Quercus spp.], T2 False Acacia [Leguminoseae spp.] and T3 Cypress [Cupressaceae spp.]. A potential for localised influence from SG1 and SG2 Privet groups [Oleaceae spp.] was also identified. The presence of corresponding roots samples retrieved from below the property foundations now confirms the influence of the related vegetation.

Overview of T1 Oak, T2 False Acacia and T3 Cypress

If an arboricultural solution is to be implemented to mitigate the influence of the trees/shrubs considered to be responsible for the damage we recommend that T1 Oak, T2 False Acacia, T3 Cypress are removed and that SG1 and SG2 Privet groups are reduced.

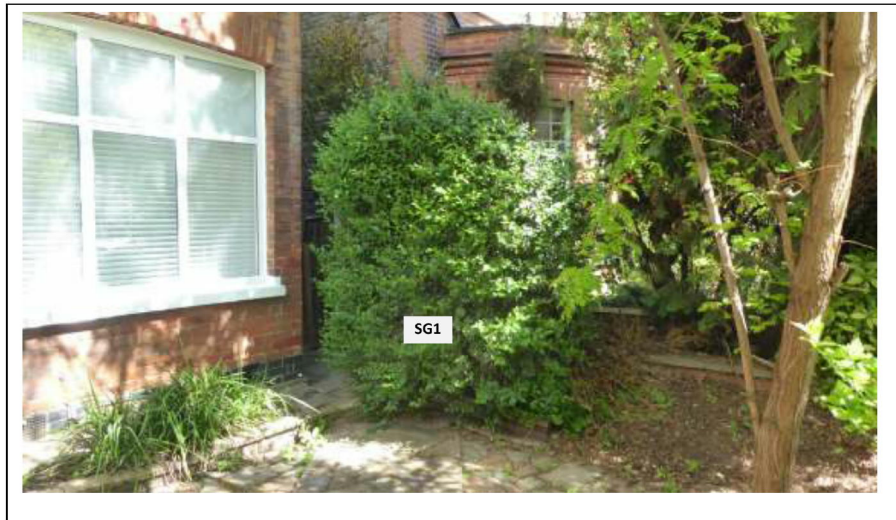
View of SG1 Privet

Recommendation		Reduce to ~2.0m height and prune annually to maintain at reduced size.					
SG2	Privet	3.5	30	2.5	0.8 *	Younger than Property	Policy Holder
Management history		No significant past management noted.					
Recommendation		Reduce to ~2.0m height and prune annually to maintain at reduced size.

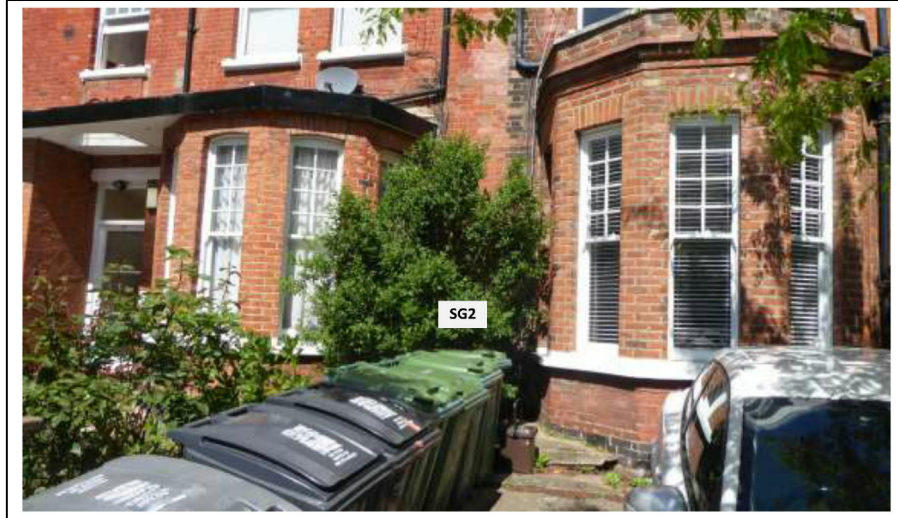
View of SG2 Privet
