UPDATE REPORT
Retained

DATE OF ISSUE:	12/10/2023
OUR REFERENCE NO:	71922159
INSURERS REFERENCE NO:	
JR Clare c/o Davies	Contover Trading Co Ltd 73 Aberdare Gardens London NW6 3AN

General view of property

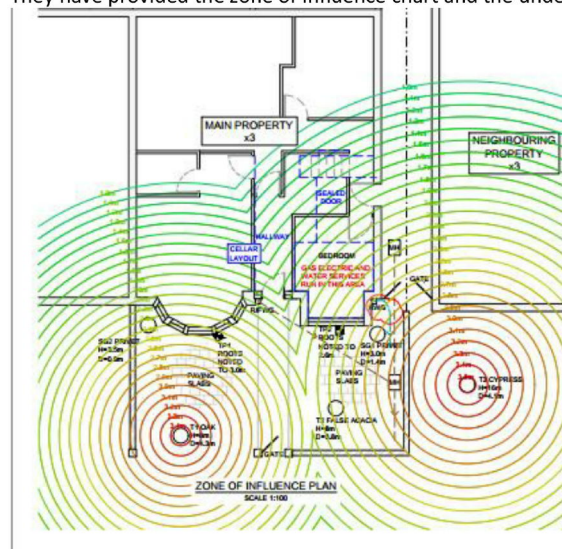
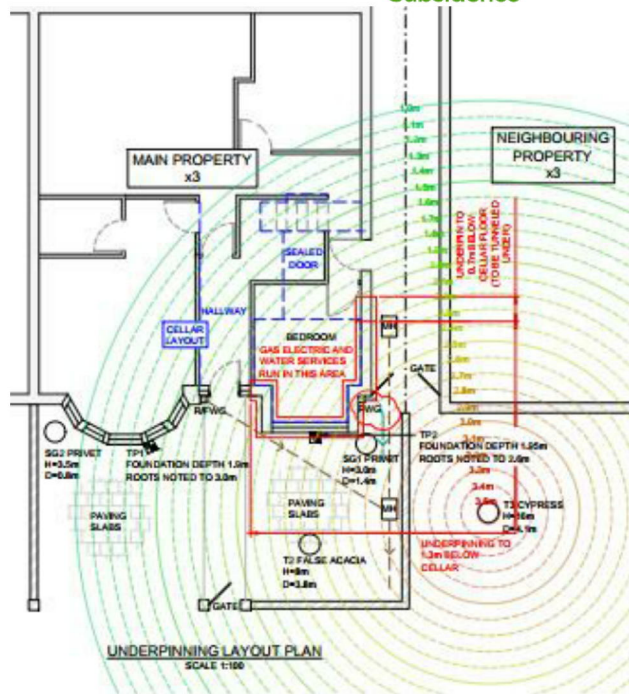
We have obtained costs for underpinning of the property following the unsuccessful mitigation re T3 and T1. The cost for the underpinning is circa £43,000.00. However the contractor has expressed concerns regarding the roots of the vegetation and potential destabilising of the trees during their works.

This also raises the potential issue of the TPO tree roots being potentially being severed.

They have provided the zone of influence chart and the underpinning is planned within the area.
