INITIAL TECHNICAL REPORT
Retained

| DATE OF ISSUE: | 20th March 2020 |
| OUR REFERENCE NO: | 71922159 |

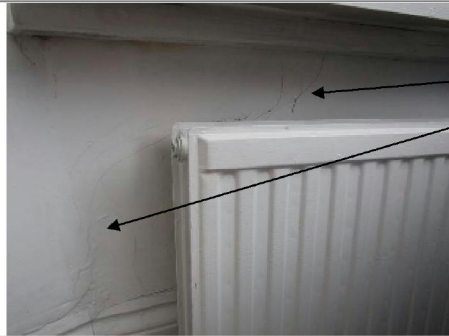
Internally crack damage measuring up to 3mm in width is located within the ground floor front bedrooms to either side of the left hand bedroom bay and to the return within the right hand bedroom.

Photograph 13 Front LHS bedroom – below bay window

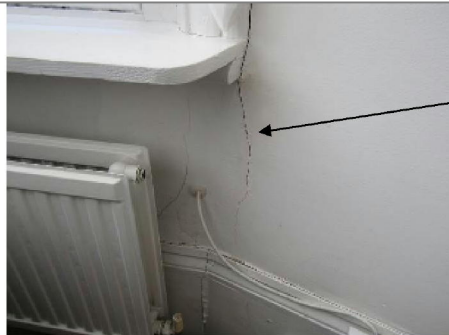
Photograph 14 Front LHS bedroom – below bay window

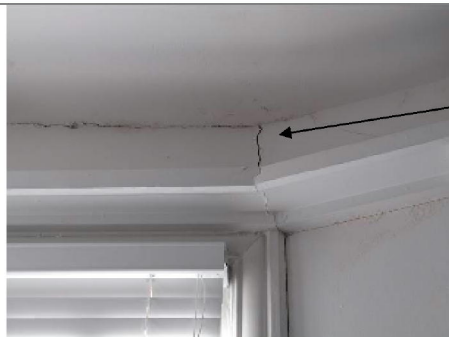
Photograph 15 Front LHS bedroom – above bay window

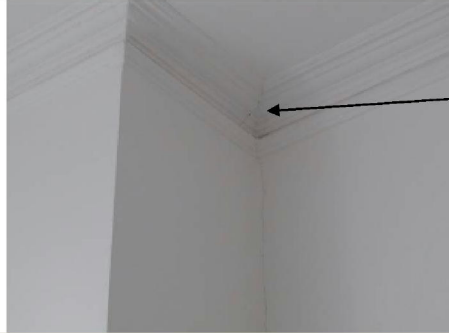
Photograph 17 Front RHS bedroom – high level at bay return

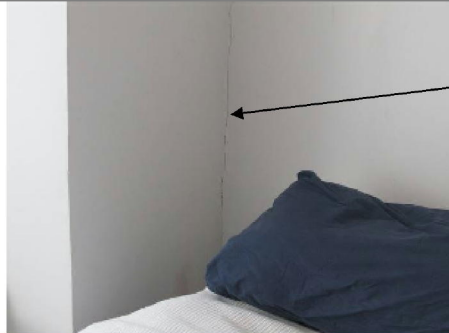
Photograph 18 Front RHS bedroom – lower level at bay return
