Revised  
**Addendum Arboricultural Report**

**Subsidence Damage Investigation at:**

73 Aberdare Gardens  
 London  
 NW6 3AN

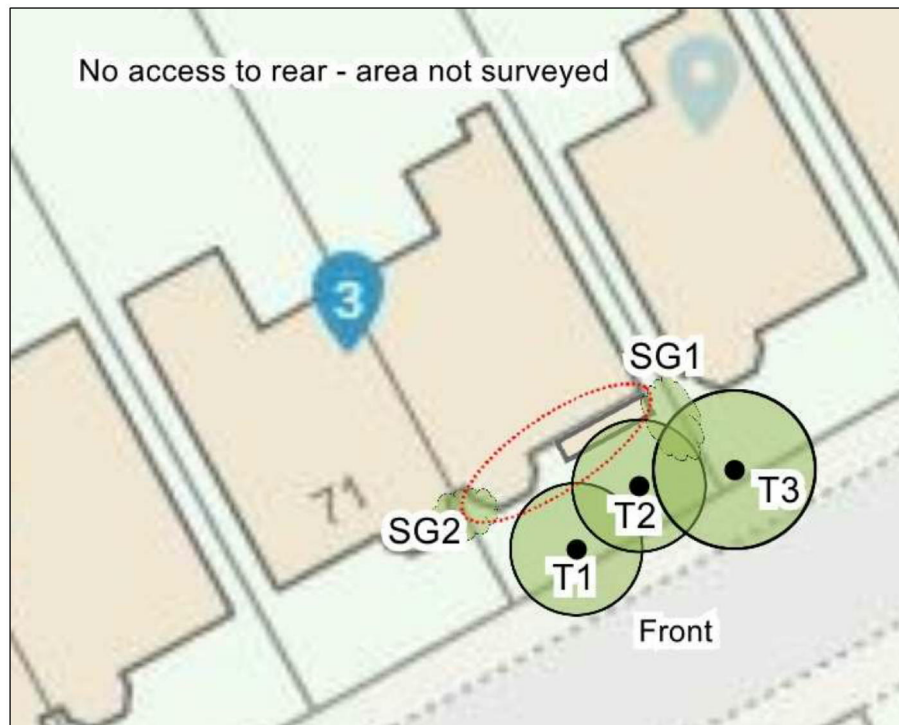
Site Plan

Approximate areas of damage

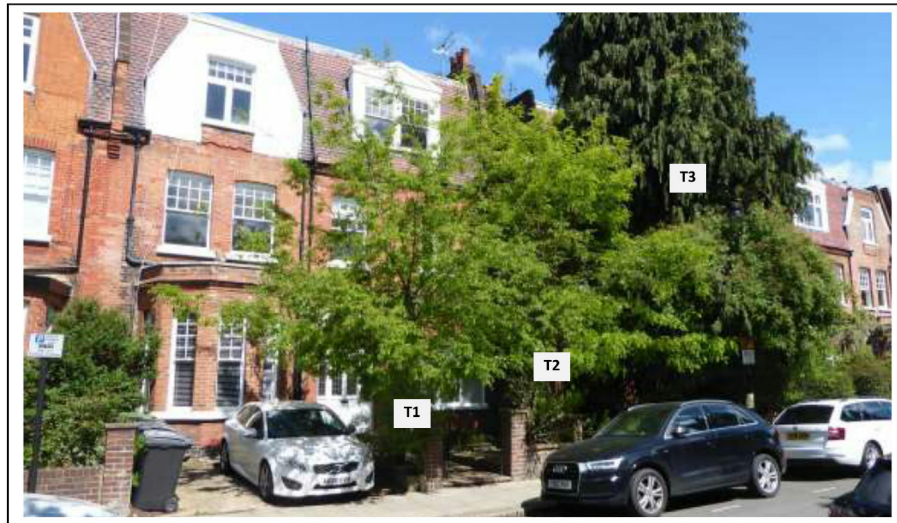
Our survey has previously identified vegetation within influencing distance of the building with a current potential to influence soil volumes below foundation level, the most significant of which in relation to the current damage were identified as T1 Oak [Quercus spp.], T2 False Acacia [Leguminosae spp.] and T3 Cypress [Cupressaceae spp.]. A potential for localised influence from SG1 and SG2 Privet groups [Oleaceae spp.] was also identified. The presence of corresponding roots samples retrieved from below the property foundations now confirms the influence of the related vegetation.

| Tree No. | Species | Ht (m) | Dia (mm) | Crown Spread (m) | Dist. to building (m) | Age Classification | Ownership |
|---|---|---|---|---|---|---|---|
| T1 | Oak | 8.0 | 150 | 7.0 | 4.3 | Younger than Property | Policy Holder |
| T2 | False Acacia | 8.0 | 160 | 5.5 | 3.8 | Younger than Property | Policy Holder |
| T3 | Cypress with climbing shrub throughout | 16.0 | 420 * | 5.0 | 4.1 | Younger than Property | Third Party:<br>75 Aberdare Gdns,<br>NW6 3AN |

Overview of T1 Oak, T2 False Acacia and T3 Cypress

| Tree No. | Species | Ht (m) | Dia (mm) | Crown Spread (m) | Dist. to building (m) | Age Classification | Ownership |
|---|---|---|---|---|---|---|---|
| Recommendation | | Remove (fell) to near ground level and treat stump to inhibit regrowth. | | | | | |

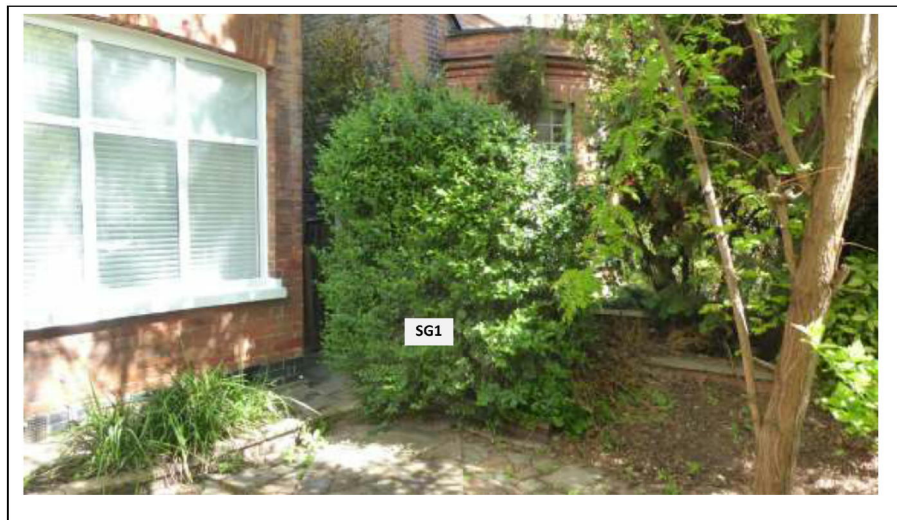
| Tree No. | Species | Ht (m) | Dia (mm) | Crown Spread (m) | Dist. to building (m) | Age Classification | Ownership |
|---|---|---|---|---|---|---|---|
| SG1 | Privet | 3.0 | 30 Ms * | 2.5 | 1.4 | Younger than Property | Policy Holder |

View of SG1 Privet

| Tree No. | Species | Ht (m) | Dia (mm) | Crown Spread (m) | Dist. to building (m) | Age Classification | Ownership |
|---|---|---|---|---|---|---|---|
| Recommendation | | Reduce to ~2.0m height and prune annually to maintain at reduced size. | | | | | |

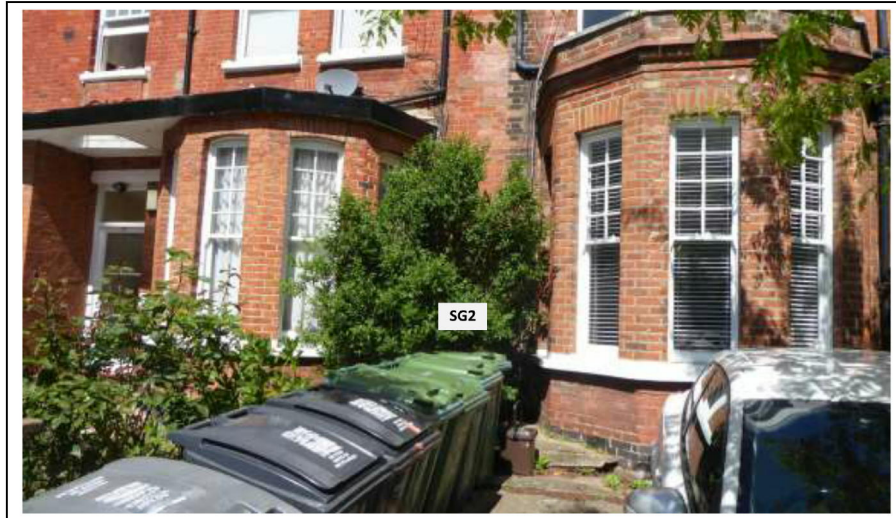
| Tree No. | Species | Ht (m) | Dia (mm) | Crown Spread (m) | Dist. to building (m) | Age Classification | Ownership |
|---|---|---|---|---|---|---|---|
| SG2 | Privet | 3.5 | 30 | 2.5 | 0.8 * | Younger than Property | Policy Holder |

View of SG2 Privet

| Tree No. | Species | Ht (m) | Dia (mm) | Crown Spread (m) | Dist. to building (m) | Age Classification | Ownership |
|---|---|---|---|---|---|---|---|
| Recommendation | | Reduce to ~2.0m height and prune annually to maintain at reduced size. | | | | | |
