**INITIAL TECHNICAL REPORT**  
**Retained**

| JR Clare<br>MS Amlin<br>Davies Group Ltd (Stoke)<br>[REDACTED] | 73 Aberdare Gardens<br>London<br>NW6 3AN |

| POLICYHOLDER DETAILS | |
|---|---|
| Supposed cause: | Subsidence |

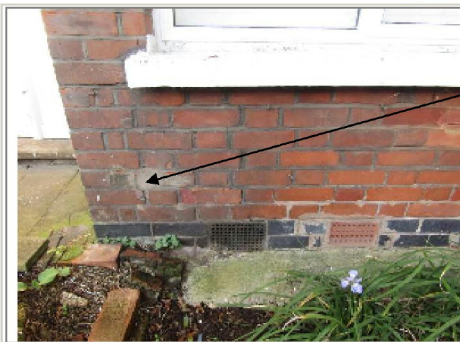
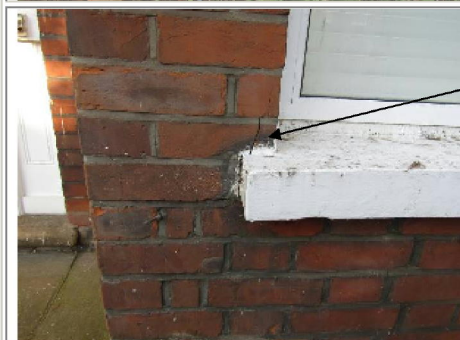
Diagonal and vertical tapering crack damage is evident within the face brickwork to the right and left front bay windows measuring up to 3mm in width.

Photograph 4 front RHS bay

Photograph 5 front RHS bay

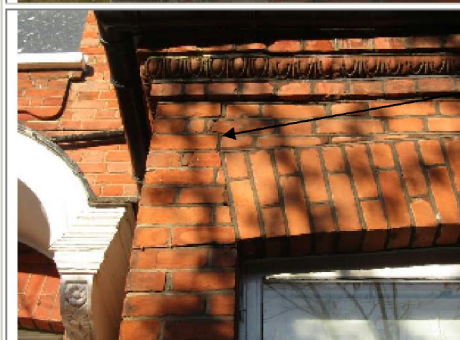
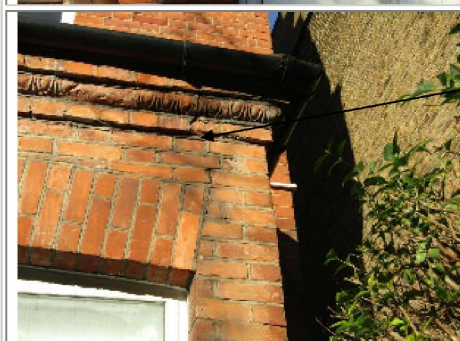
Photograph 6 front RHS bay – above window

Photograph 7 front RHS bay – above window

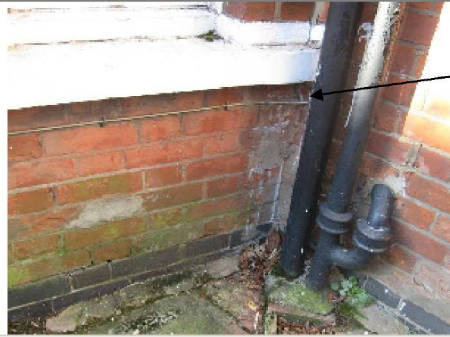
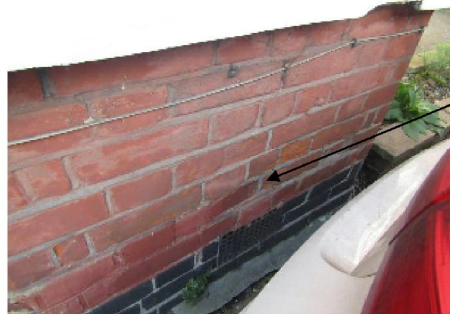
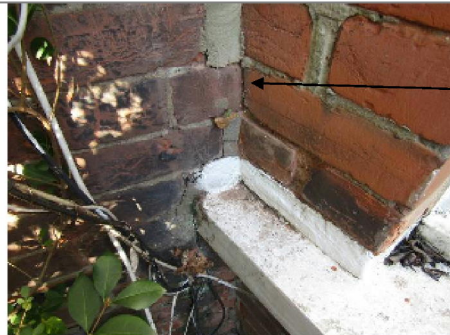
Photograph 8 front LHS bay – below window

Photograph 9 front LHS bay – below window

Photograph 10 front LHS bay – below window

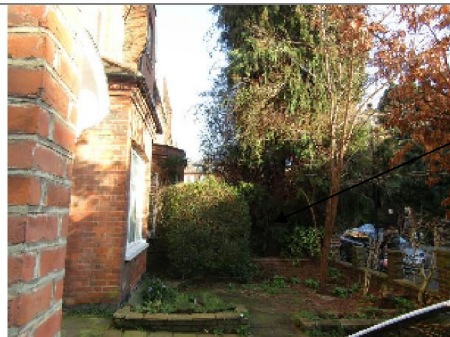
We suspect the underlying subsoil are being adversely affected by the presence of the trees growing within the boundaries of the front garden and the nearby tree vegetation located outside the boundaries of the garden to the right hand side.

Photograph 11 front PH and TP vegetation

- Two Trial pit / boreholes adjacent to the front bays of the property to confirm the depths of the foundations and condition of the bearing soils beneath the foundations.
- A CCTV survey of the drainage runs within close proximity of the area of concern.
- Level monitoring exercise for an initial period of 6 months.
- To obtain an arboriculturalist report to obtain advice on the vegetation management works required, and also confirm if there are any restrictions in place, regarding the removal of the implicated vegetation.

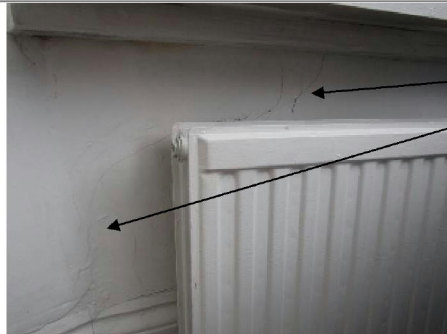
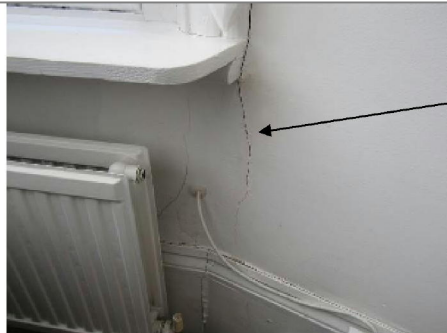
Internally crack damage measuring up to 3mm in width is located within the ground floor front bedrooms to either side of the left hand bedroom bay and to the return within the right hand bedroom.

Photograph 13 Front LHS bedroom – below bay window

Photograph 14 Front LHS bedroom – below bay window

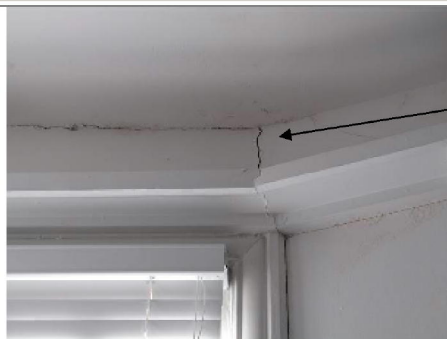
Photograph 15 Front LHS bedroom – above bay window

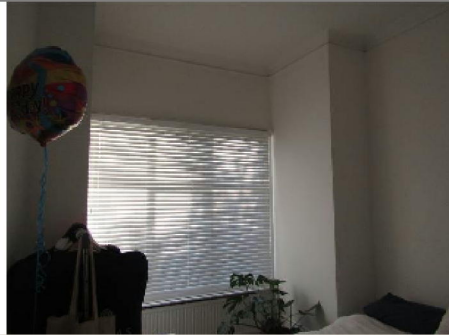
Photograph 16 Front RHS bedroom
