**UPDATE REPORT**  
Retained

| JR Clare<br>c/o Davies | 73 Aberdare Gardens<br>London<br>NW6 3AN |

| POLICYHOLDER DETAILS | |
|---|---|
| Policy wording: | Subsidence |
| Supposed cause: | Subsidence |

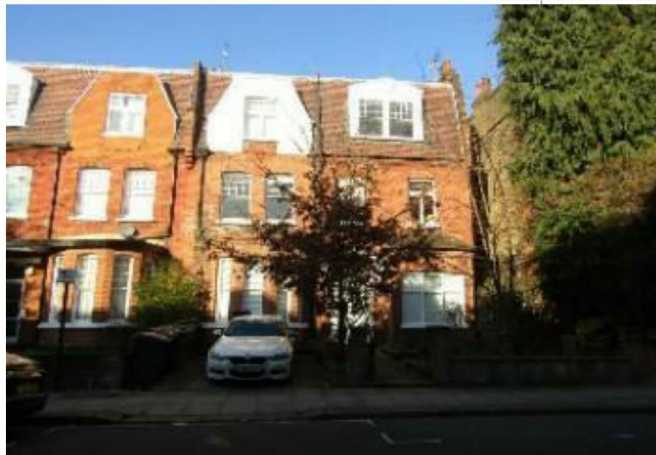
General view of property

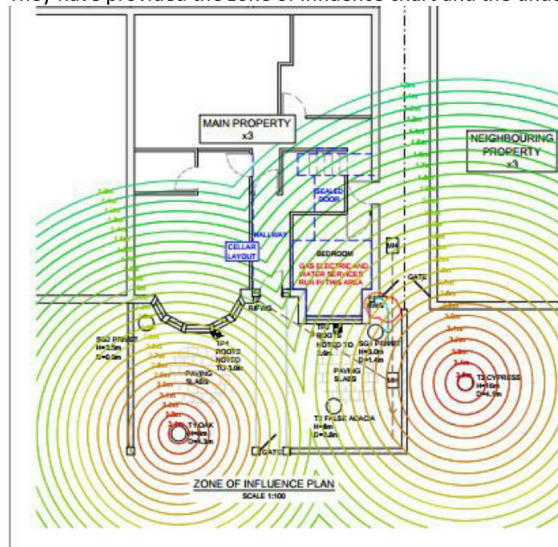
We have obtained costs for underpinning of the property following the unsuccessful mitigation re T3 and T1. The cost for the underpinning is circa £43,000.00. However the contractor has expressed concerns regarding the roots of the vegetation and potential destabilising of the trees during their works.

This also raises the potential issue of the TPO tree roots being potentially being severed.

They have provided the zone of influence chart and the underpinning is planned within the area.
