## Arboricultural Appraisal Report

### Subsidence Damage Investigation at:

16 Fairhazel Gardens  
London  
NW6 3SJ

CLIENT: Crawford & Company  
 CLIENT REF: [REDACTED]  
 MWA REF: [REDACTED]  
 MWA CONSULTANT: Andy Clark  
 REPORT DATE: 16/10/2023

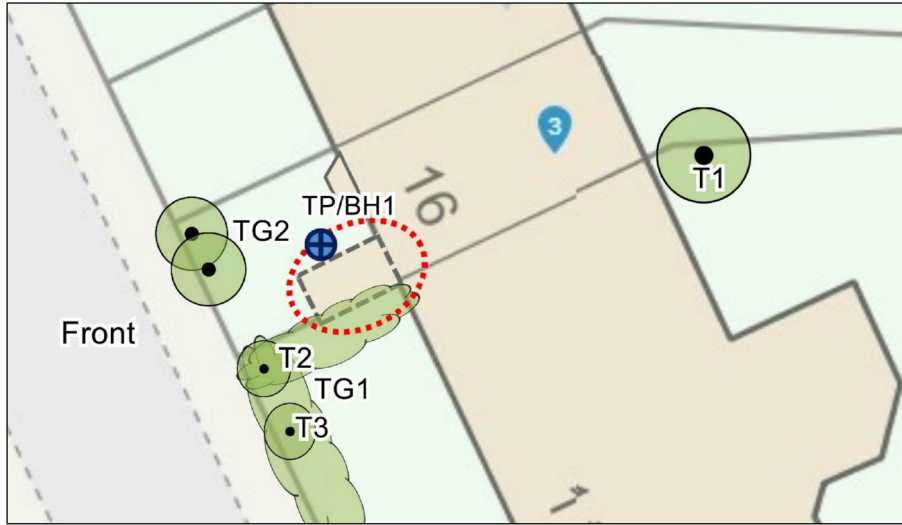
Site Plan

Approximate areas of damage

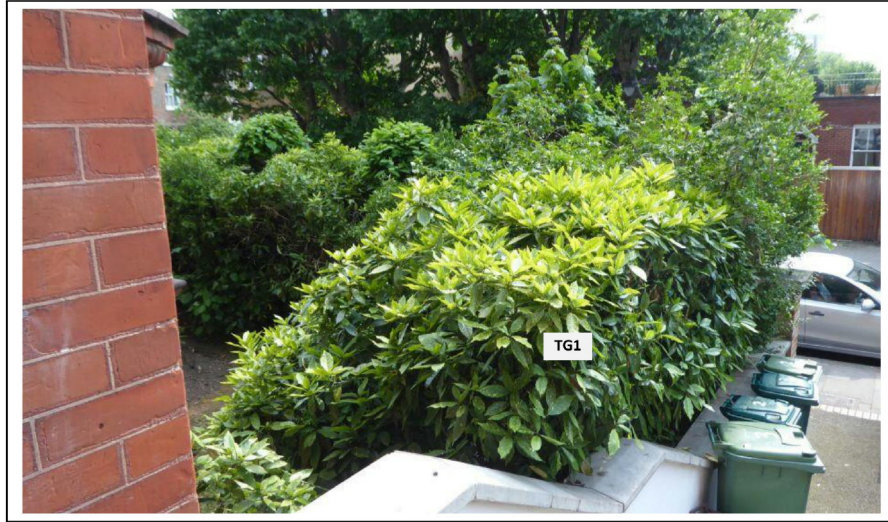
Irrespective of the identification of recovered root samples, our survey has identified vegetation within influencing distance of the building with a current potential to influence soil volumes below foundation level; the most significant in relation to the current damage is the vegetation of TG1 group directly adjacent to the right-hand side of the steps.

View from porch of TG1 group adjacent to right-hand flank of steps

If an arboricultural solution is to be implemented to mitigate the influence of the implicated trees/vegetation we recommend that the nearby elements of TG1 group are removed, combined with re-pollarding of the limes of TG2 group.

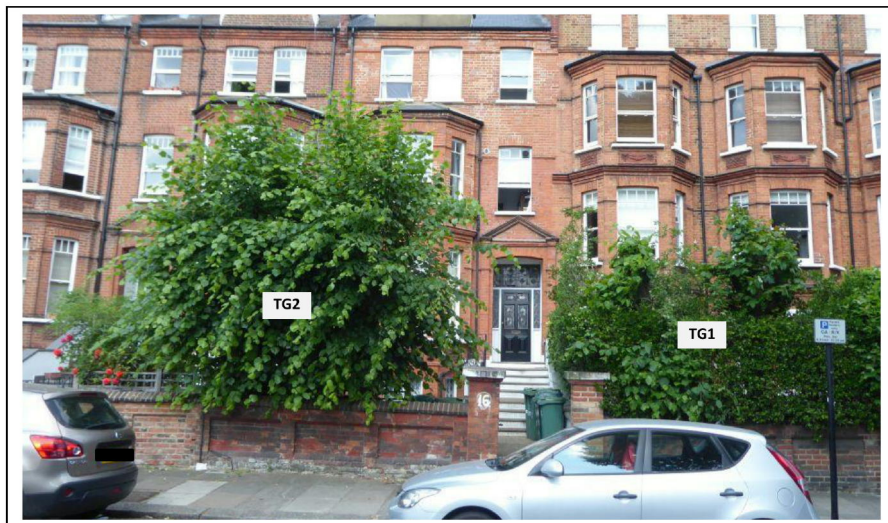
Roots were observed to a depth of 1.45m bgl in TP/BH1 and recovered samples have been positively identified (using anatomical analysis) as *Tilia* spp.; the origin of which will likely be the Limes of TG2 group.

View from property frontage of TG1 and TG2 groups
