Site Investigation Report

Job Information	
Client	Crawford & Co
Client ref	[Redacted]
Visit date	21/02/2023
Report date	05/04/2023

Auger were commissioned by Crawford & Co to undertake a site investigation and CCTV inspection of the underground drainage within the area of concern (AOC) at the property.

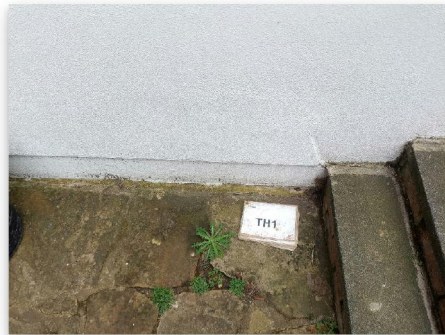
Fig 1.1: Trial Hole 1 Location

Within TH1 we revealed the footing and augered to the required depth (3m) in the proposed location. We took soil and root samples. These measurements are shown in Trial Hole Log 1 below.

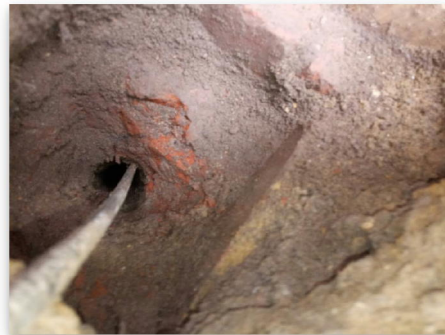
Fig 1.2: Trial Hole 1 Footing

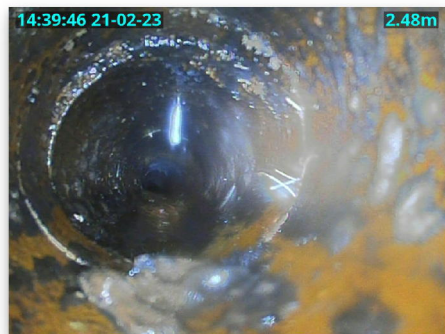
Our survey of these lines revealed joint displacements and fractures at multiple points throughout the line.

The above mentioned defects to the below ground drainage system have been caused by ground movement.

Fig 2.1: 75mm pipework joint displacement and fracturing

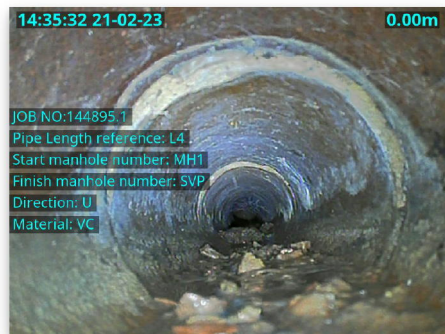
Fig 2.2: pipework defects

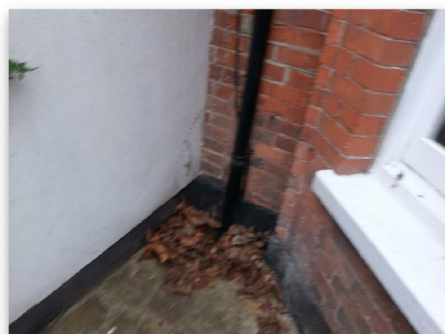
Fig 3.1: Gully to be excavated

Excavate and replace WG1 and 2m of 100mm pipework at a depth no greater than 1.0m through crazy paving.
