Project Name: TOTTENHAM MEWS - LONDON

Project Description: WinCan Import in Standard

Project Date: 27/09/2023

Town or Village:	London	Inspection Direction:	Downstream	Upstream Node:	MH02
Road:	14-19 Tottenham Mews	Inspected Length:	3.50 m	Upstream Pipe Depth:	0.000 m
Location:	Other (state in comments)	Total Length:	3.50 m	Downstream Node:	MH01
Surface Type:		Joint Length:		Downstream Pipe Depth:	0.000 m
Use:	Foul	Pipe Shape:	Circular		
Type of Pipe:	Gravity drain/sewer	Dia/Height:	150 mm		
Flow Control:		Pipe Material:	Vitrified clay pipe (i.e. all clayware)		
Year Constructed:	Not Specified	Lining Type:	Other		
Inspection Purpose:	Pre-adoption survey prior to vesting as public sewer	Lining Material:	No Lining

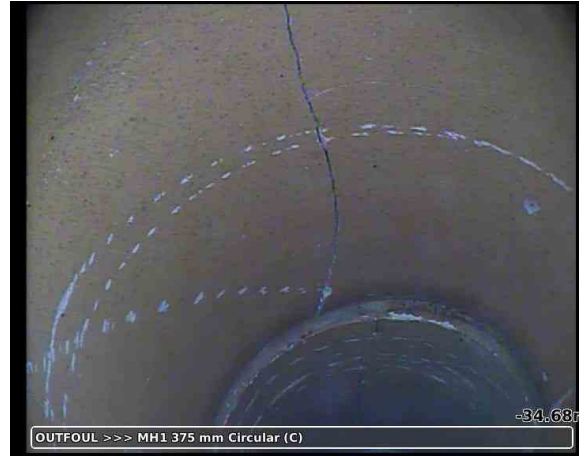
OUTFOUL >>> MH1 375 mm Circular (C)
20230927-163711-snap0020.jpg, 00:03:42, -34.64 m
Crack, longitudinal at 12 o'clock, start

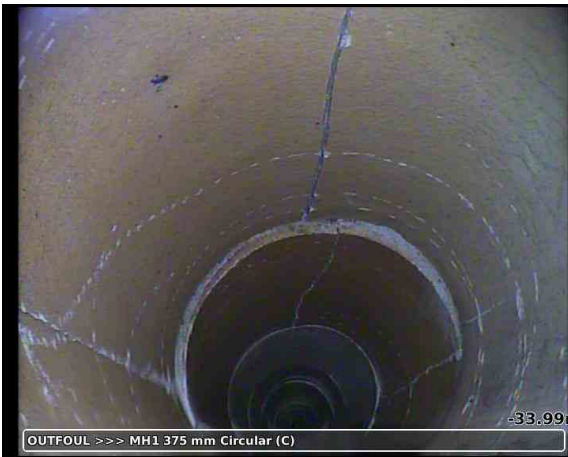
OUTFOUL >>> MH1 375 mm Circular (C)
20230927-163711-snap0019.jpg, 00:03:37, -33.99 m
Crack, longitudinal at 12 o'clock, start

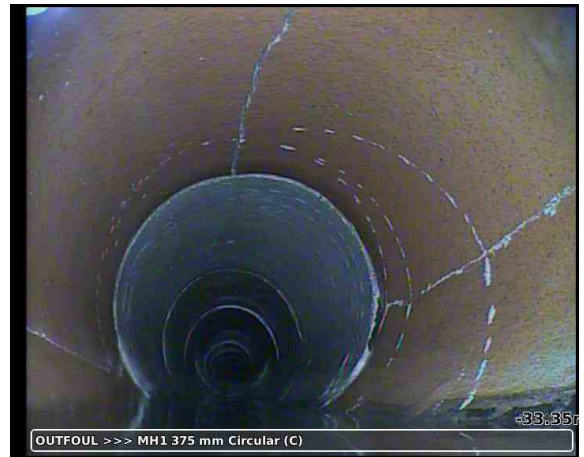
OUTFOUL >>> MH1 375 mm Circular (C)
20230927-163711-snap0018.jpg, 00:03:33, -33.35 m
Crack, longitudinal at 12 o'clock, start

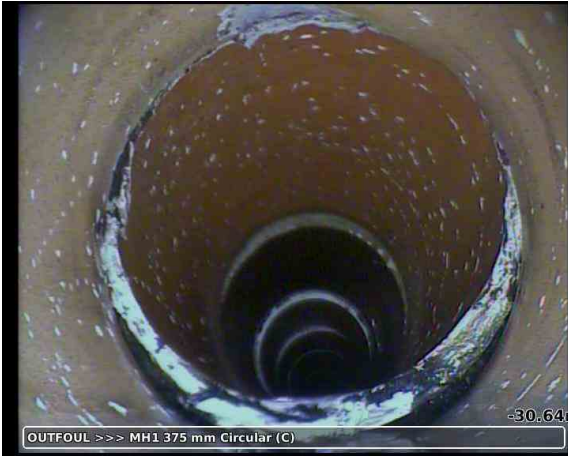
20230927-163711-snap0017.jpg, 00:03:20, -30.64 m
 Connection defective, position incorrect at 3 o'clock, diameter: 9mm

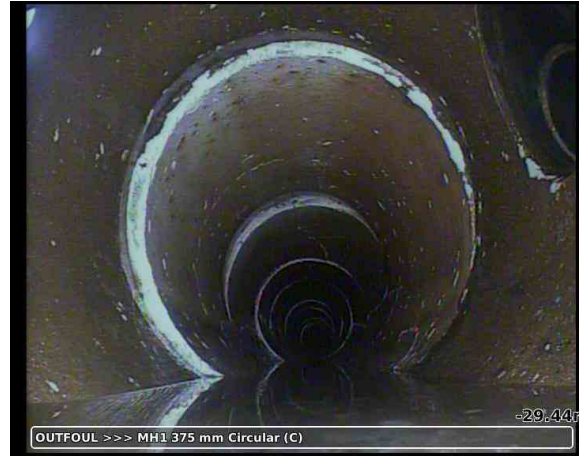
20230927-163711-snap0016.jpg, 00:03:09, -29.44 m
 Connection defective, position incorrect at 7 o'clock, diameter: 3mm

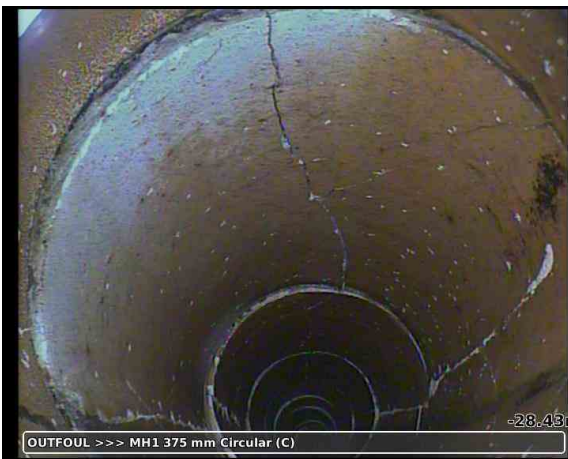
20230927-163711-snap0015.jpg, 00:03:04, -28.43 m
 Crack, longitudinal at 12 o'clock, start

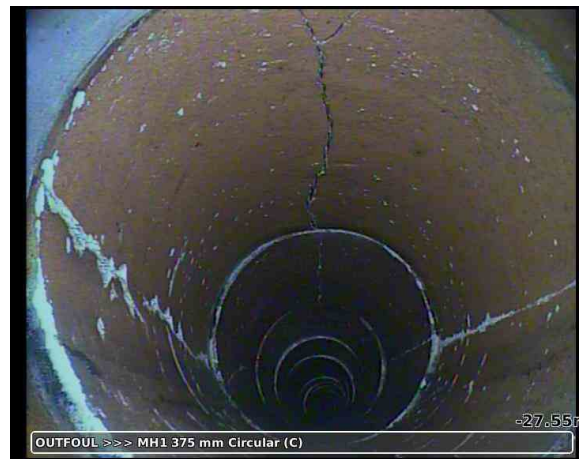
20230927-163711-snap0014.jpg, 00:03:00, -27.55 m
 Crack, longitudinal at 12 o'clock, start

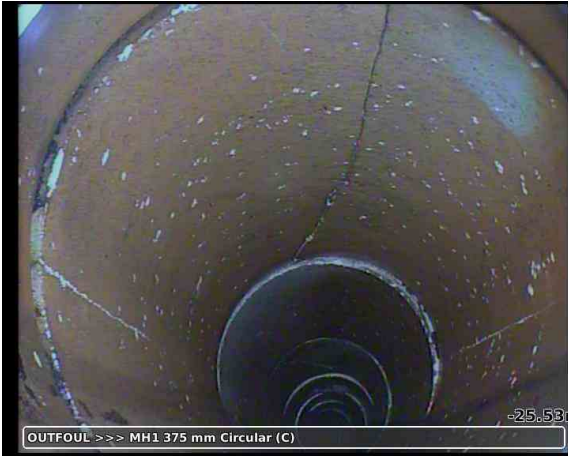
20230927-163711-snap0013.jpg, 00:02:50, -25.53 m
Crack, longitudinal at 12 o'clock, start

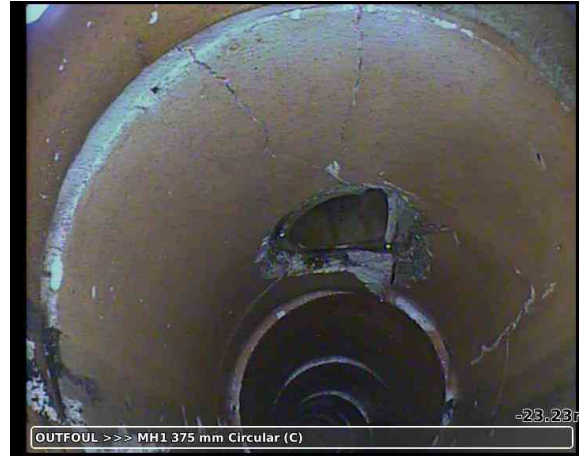
20230927-163711-snap0012.jpg, 00:02:40, -23.28 m
Cracks, multiple from 12 o'clock to 4 o'clock, start

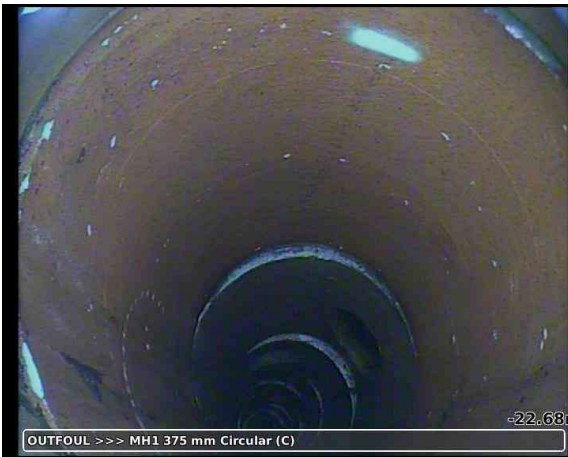
20230927-163711-snap0011.jpg, 00:02:35, -22.68 m
Connection defective, position incorrect at 10 o'clock, diameter: 3mm

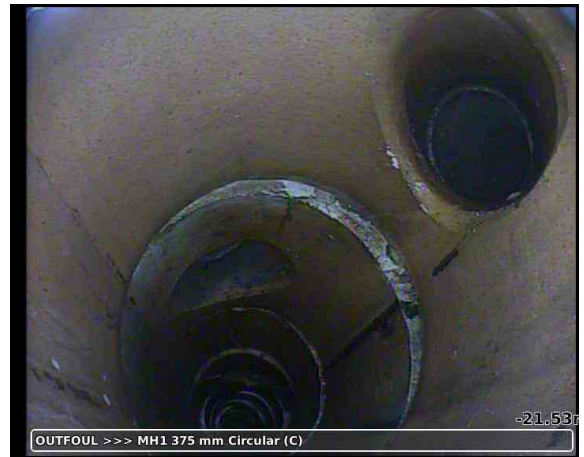
20230927-163711-snap0010.jpg, 00:02:30, -21.53 m
Connection defective, position incorrect at 11 o'clock, diameter: 5mm

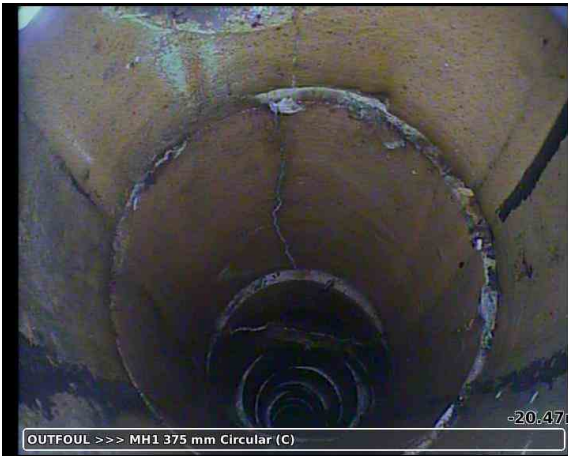
20230927-163711-snap0009.jpg, 00:02:21, -20.47 m
Crack, longitudinal at 12 o'clock, start

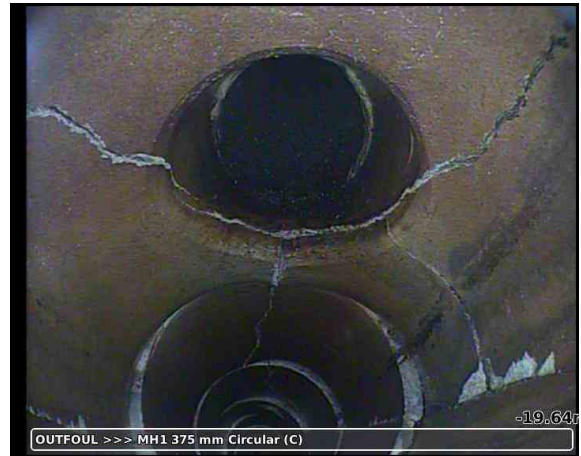
20230927-163711-snap0008.jpg, 00:02:16, -19.64 m
Cracks, multiple from 9 o'clock to 4 o'clock, start

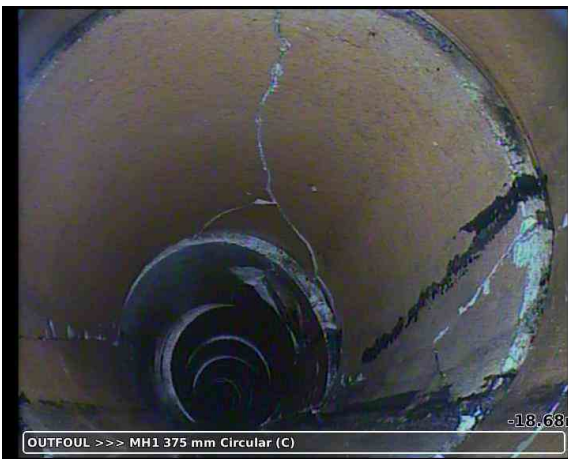
20230927-163711-snap0007.jpg, 00:02:10, -18.68 m
Crack, longitudinal at 12 o'clock, start

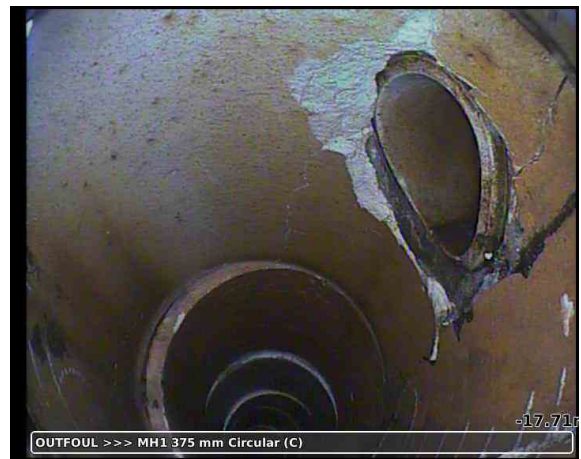
20230927-163711-snap0006.jpg, 00:02:03, -17.76 m
Cracks, multiple at joint from 3 o'clock to 6 o'clock, start

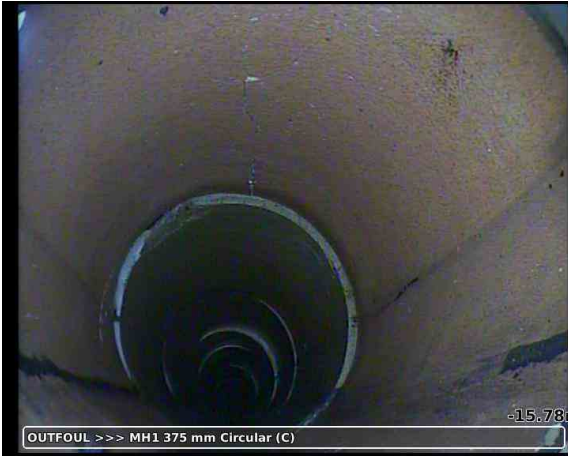
20230927-163711-snap0005.jpg, 00:01:47, -15.78 m
Crack, longitudinal at 12 o'clock, start

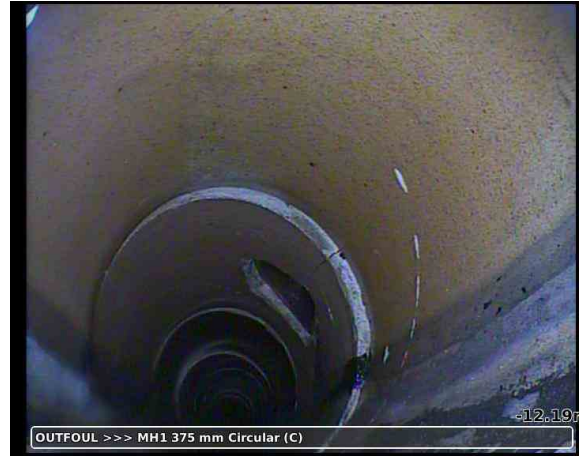
20230927-163711-snap0004.jpg, 00:01:25, -12.19 m
Connection defective, position incorrect at 11 o'clock, diameter: 5mm

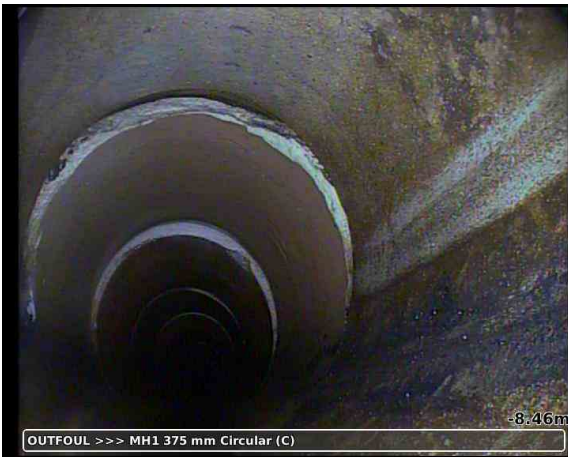
20230927-163711-snap0003.jpg, 00:00:58, -8.46 m
Connection defective, position incorrect at 3 o'clock, diameter: 6mm

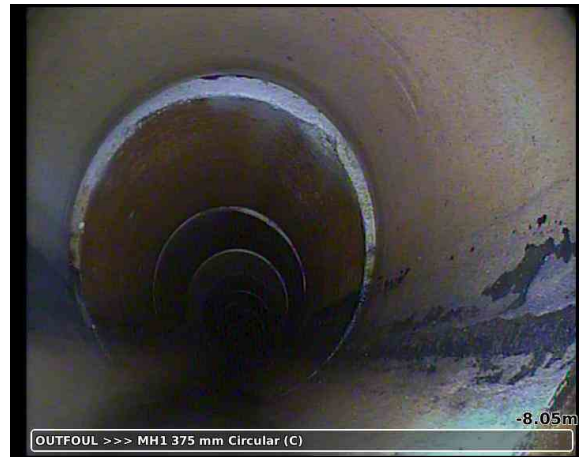
20230927-163711-snap0002.jpg, 00:00:55, -8.05 m
Connection defective, position incorrect at 9 o'clock, diameter: 3mm
