Enforcement Delegated Report

EN22/0113

31-39 Argyle Street, London,

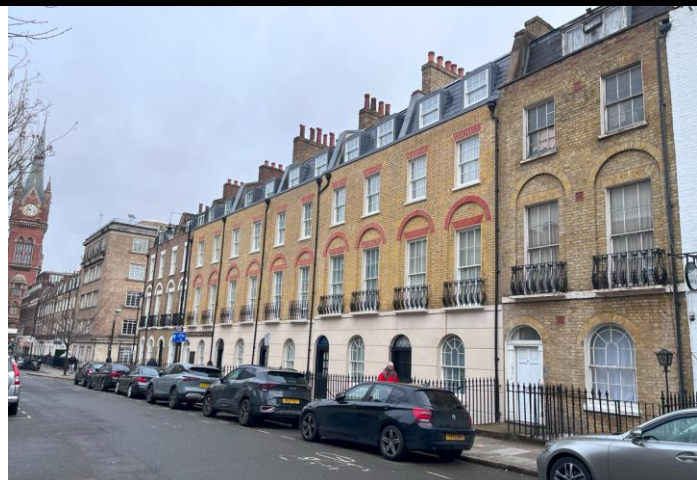
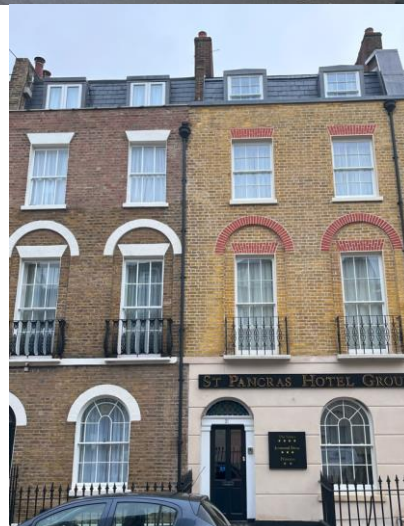
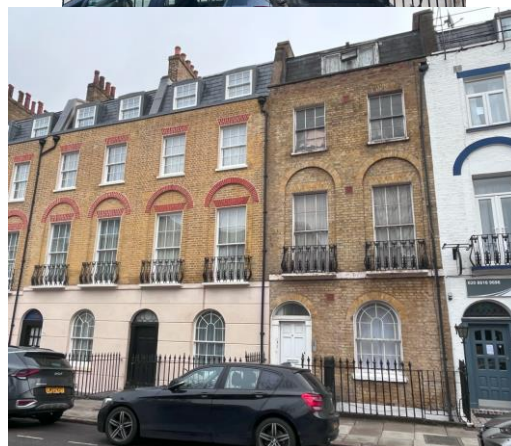
1. Excessive cleaning of all the brickwork at first and second floor front elevations of Nos 31-39;
2. Dying of the round-headed recesses and the gauged flat arches in bright red dye at the first and second floor front elevations of Nos 31-39;
3. Repointing of all the brickwork with bright lime-based mortar at first and second floor front elevations of Nos 31-39;
4. At No 37, the rendering of the brickwork at ground floor front elevation in painted stucco.

5. At No 39, the rendering of the brickwork at ground floor front elevation in painted stucco.

1.6 The first part of the works comprises the extensive cleaning and repointing (with bright lime-based mortar) of the site's brickwork at first and second floor front elevations without the benefit of Listed Building Consent. As a result, the site's facade has been substantially and unequivocally brightened, where part of the historical character of the buildings have been materially altered and lost. When compared to the surrounding buildings, the magnitude of the works' effect is amplified and appears out of character with the setting of the area. Accordingly, the works have implemented a dominant and incongruous addition to the terrace, thus do not relate well to the immediate and wider Conservation Area. Additionally, as the brickwork's prior appearance cannot be recreated in today's cleaner environment, such undertaken works pose an unfortunate and undesirable effect on the appearance of the host buildings and may have already led to long term decorative damage and may be extremely difficult (if not impossible) to reverse/reinstate its original appearance once completed. As such, whilst the Council welcomes the maintenance of Camden's listed buildings, in this particular case, this part of the unauthorised works are considered as unnecessary and excessive, thus inappropriate.

1.7 The second part of the works comprise the recent rendering of No 39's historic brickwork at ground floor to match the painted stucco ground floors of No 31-37. In investigating these breaches it became clear that ground floor front elevation of No 37 had been rendered post listing. The listing description notes the ground floor was painted brickwork, thus has been rendered in painted stucco without consent. However, it appears these works were undertaken over 15 years ago, the Council acknowledges that due to the passage of time the removal of the stucco would cause damage to the underlying brickwork. Accordingly, its removal would not mitigate the overall harm caused. Nonetheless, the unauthorised render at No 37 is considered to detract from the character and appearance of the host building and area as it replaces the listed brick facade with a visually brighter and solid one. This unsympathetic addition contributes to the erosion of the exposed brickwork appearance at the site and the wider conservation area. The Council aims where possible to protect the special historic appearance of buildings (designated and non-designated heritage assets). Accordingly, we consider the rendering of No 39 to be excessive and inappropriate as it further adds to the harmful and undesirable cumulative effect of the unauthorised No 37 ground floor render. As the works at No 39 have been recently undertaken and the render is lime-based, the Council believes the underlying brickwork (whilst it still may be difficult) should be salvaged and restored.

1.9 The third part of the works comprise the dying of the yellow bricks of the gauged flat arch windows and round-headed recesses of No 39 with bright red dye without the benefit of Listed Building Consent. As a result, No 39 has radically departed from its original appearance in a harmful manner and contribute to the harmful appearance of the excessive brightening of the No 31-39 facades. The Council considers that the dye not only pose an unfortunate and undesirable effect on the appearance of the host building but pose a serious risk to the health of it and again may have already led to long term decorative damage and may be extremely difficult (if not impossible) to reverse/reinstate its original appearance once completed. As such, this part of the unauthorised works are also considered inappropriate and will require special attention.

1. Apply a light soot wash to the brickwork and jointing at first and second floor front elevations, to match their previous appearance of No 31-39.
2. Completely remove the painted stucco render from No 39's front elevation at ground floor level (making good and reinstating the appearance of the underlying brickwork to match its previous appearance).
3. Remove the bright red dye from the yellow bricks of No 39's round-headed recesses and gauged flat arches, then apply a light soot wash to reinstate their previous appearance.
4. Make good all damages as a result of the above operations.
