Greencroft Gardens

Structural Condition Report

02018-ENG-XX-RP-XXX-0001

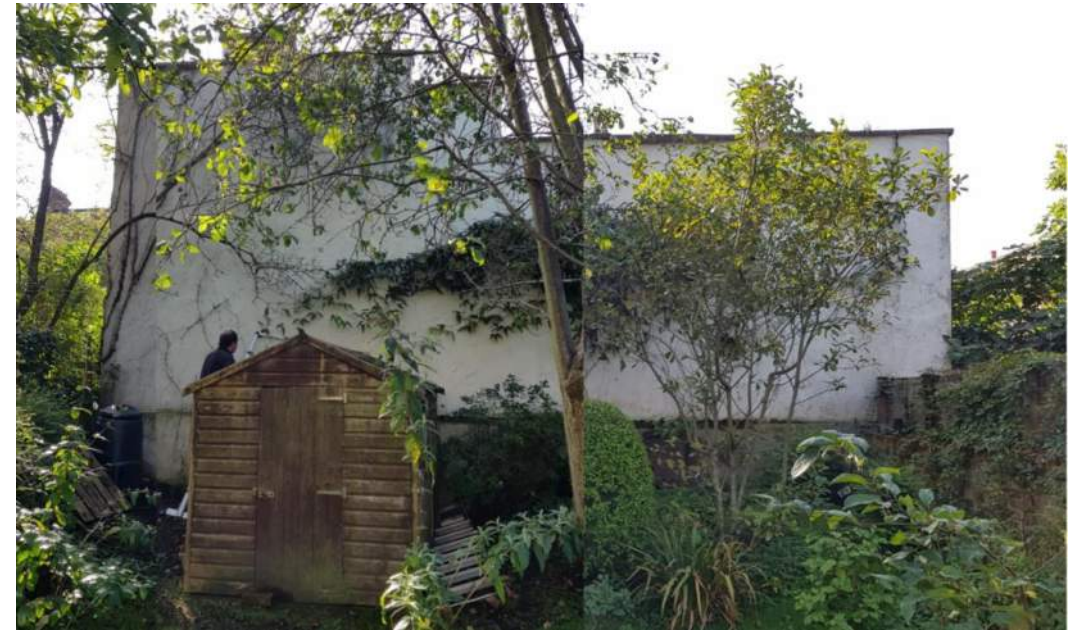
North Elevation

Extensive cracks are visible in the render along the external wall, with cracks running through the brickwork in several areas. Vertical cracking from ground level to roof is visible at two of the steps in roof level, with diagonal cracking visible at two of the steps in roof level as well. One of the longer vertical cracks appears to have been previously patched, however it is still visible from ground level to the step in then brickwork. It is unknown when this crack was patched. A horizontal crack is visible along over half of the façade, across the top of an existing vent. Much of the cracking is visible on the LHS of the façade, in a mix of vertical, horizontal, and diagonal hairline and larger cracks. Two sections of intrusive investigative works were undertaken to remove the external render of the facade, both revealing that the cracking extended to the brickwork behind and was not just superficial in the render. It is unknown how far into the wall this cracking extends, or how much of the cracking in the render over the facade extends into the brickwork. Refer to Appendix B for a sketch markup of the extent of the cracking in the façade.

The finding that cracking is extending through the brickwork strongly suggests that the cracks are caused by structural movement, and not say by shrinkage/thermal movement within the render.

Due to the ground conditions, it is likely that the cracking in the façade is due to clay heave. Clay heave is when a clay-based soil expands, or contracts, depending on its moisture content. There can seasonal variation resulting from changing moisture levels within the soil, similarly trees can take moisture out of a soil causing it to shrink locally, and subsequently causing a building founded on the same soil to move. Potential causes for clay heave in the area could be the existing trees in the ground adjacent to the wall, the removal of the trees next to the external wall and the installation of the garden shed against the wall. The tree stumps are thought to date from 1993, although this cannot be definitively confirmed. Similarly, it is not known when the shed was constructed. The cracking in this area was found to go through to the brickwork behind the render and was min. 1mm wide in areas.

An existing plum tree and three tree stumps sit to the centre and East of the garden on this façade, which are likely to be the cause of the cracking to this side of the wall, due to the re-saturation of the soil following the removal of the trees.

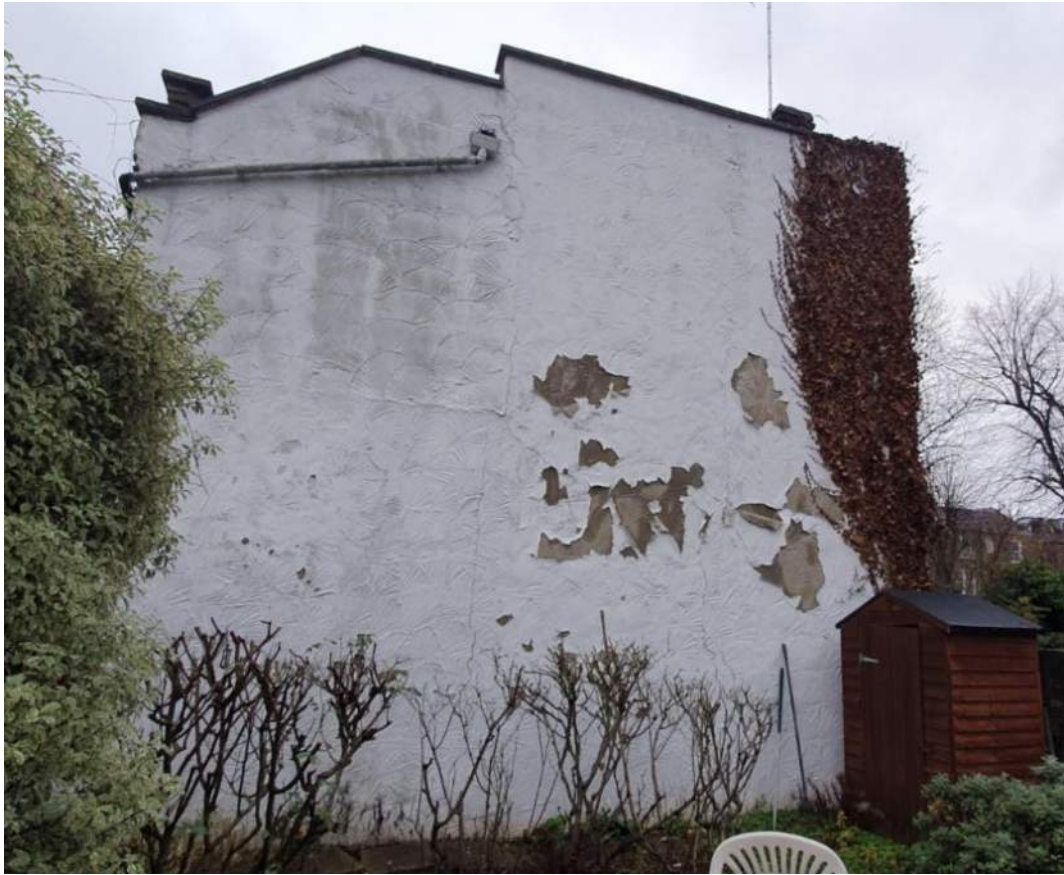
South Elevation

Extensive cracks are visible in the render along the external wall, with cracks running through the brickwork in several areas. There are two main vertical cracks from ground level up to the top of the wall, one in line with a previous extension to the property, reaching the step in the façade at the top. From visual inspection, the cracks appear to increase in width towards the top of the wall. Horizontal cracking is visible at first floor level to the West, along the assumed line of a previous extension to the property. It is unknown if this crack extends through to the brickwork. Refer to Appendix C for a sketch markup of the extent of the cracking in the façade.

Whilst the cracks to the East correlate with previous building alterations, the cause of the vertical cracks to the West and associated cracks at lower levels are unclear. It is likely that the vegetation within the garden has caused shrinking from change in moisture content, or that there has been previously removed larger planting that has allowed for re-saturation of the ground below, causing swelling of the clay soil. From visual inspection of the East elevation, it appears that the base of the climbing plant has been removed, although it is unknown when this was done. This is likely to have caused the re-saturation of the soil below, and therefore has potential to be the cause for the vertical cracking to the East.

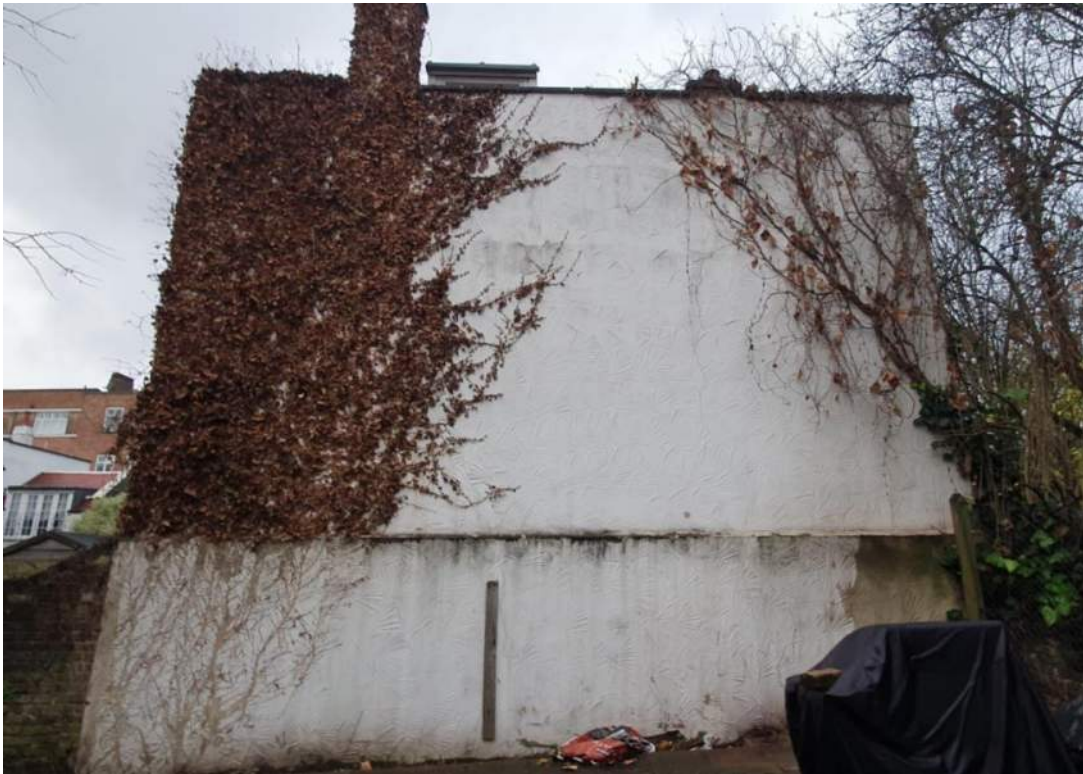
East Elevation

From visual inspection of photographs and previous investigative works carried out, the East elevation has a large visible vertical crack to the North. As discussed in the 2020 report in Appendix F, visible cracking was seen internally on this face and to the North-East corner, correlating with the external cracks seen here. The crack was measured to be around 1mm side at ground level, but increased in width higher up, appearing to exceed 2mm in places. It is unknown whether this cracking extends into the brickwork, however it can be reasonably assumed that due to the internal and external cracking in the same region, it may also be affecting the brickwork. There are also at least 2 other vertical cracks in the wall, as seen in photographs. Refer to Appendix D for a sketch markup of the extent of the cracking in the façade.

It is likely that the removal of the climbing plant to the South, and the growth of the existing tree to the North are the cause of the vertical cracking seen in this façade. The removal of the climbing plant would cause swelling of the soil below due to re-saturation of the soil, whereas the growth of the existing tree would cause shrinkage of the soil.

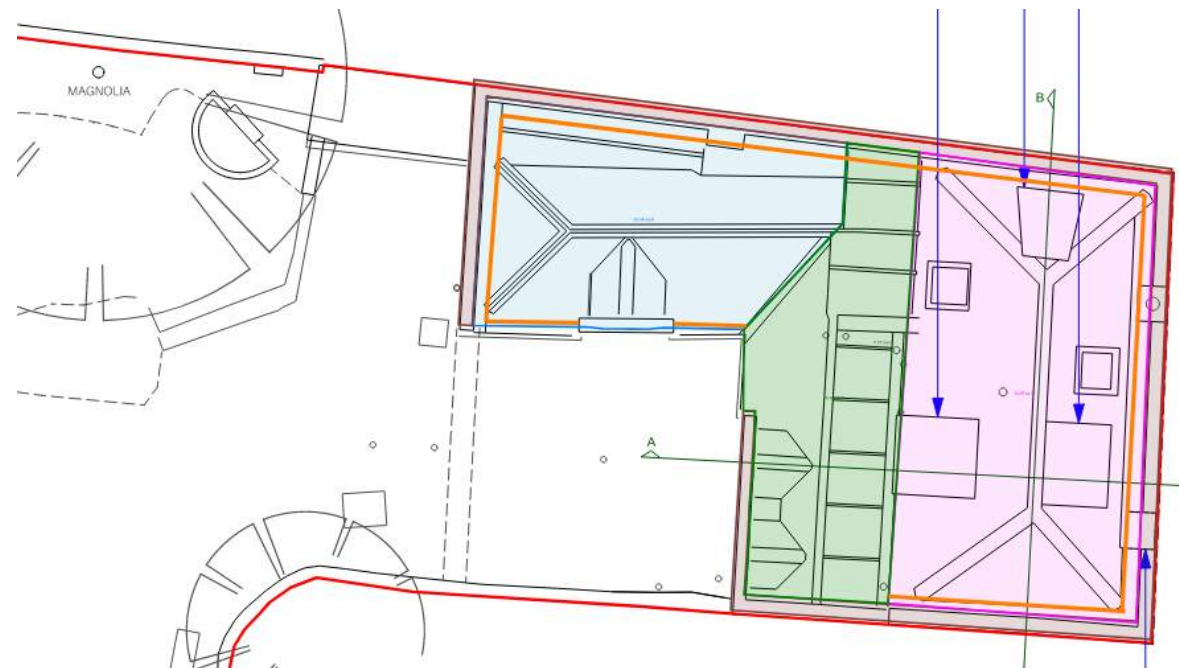
Roof Type Layout

Roof Type 1, highlighted in blue, comprises 95 x 47 timber rafters at 400c/c with 145 x 47 timber ties between rafters at high level, with a total timber volume of 0.49m³.

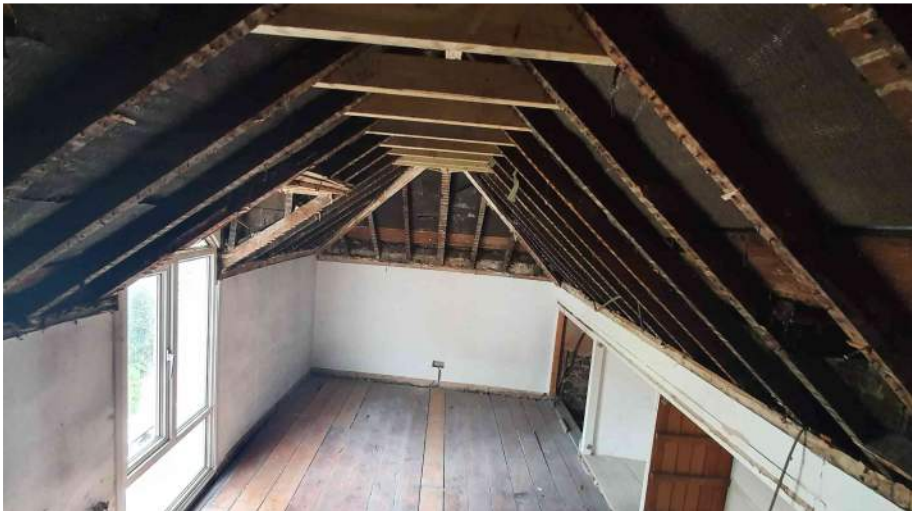
The roof build-up comprises slate tiles supported off timber rafters and purlins. A perimeter gutter is formed by a masonry parapet at the roof edge, which is capped with stone/concrete coping stones. The exact structural arrangement of the roof build-up differs throughout the property, due to previous extensions and refurbishments carried out. All roof types are constructed in timber rafters, with additional structural elements dependent on roof type. Most of the roof timbers appear to be in good condition, with no photographic evidence of water ingress or rot. There are signs of limited localised water ingress to roof type 1, with water staining to the ceiling.

Given the age of the structure it is likely that the gutter detail has failed in some locations resulting in water ingress and subsequent rotting of rafters, it should be expected that some rafter ends will need replacement.

View B: Roof Type 1

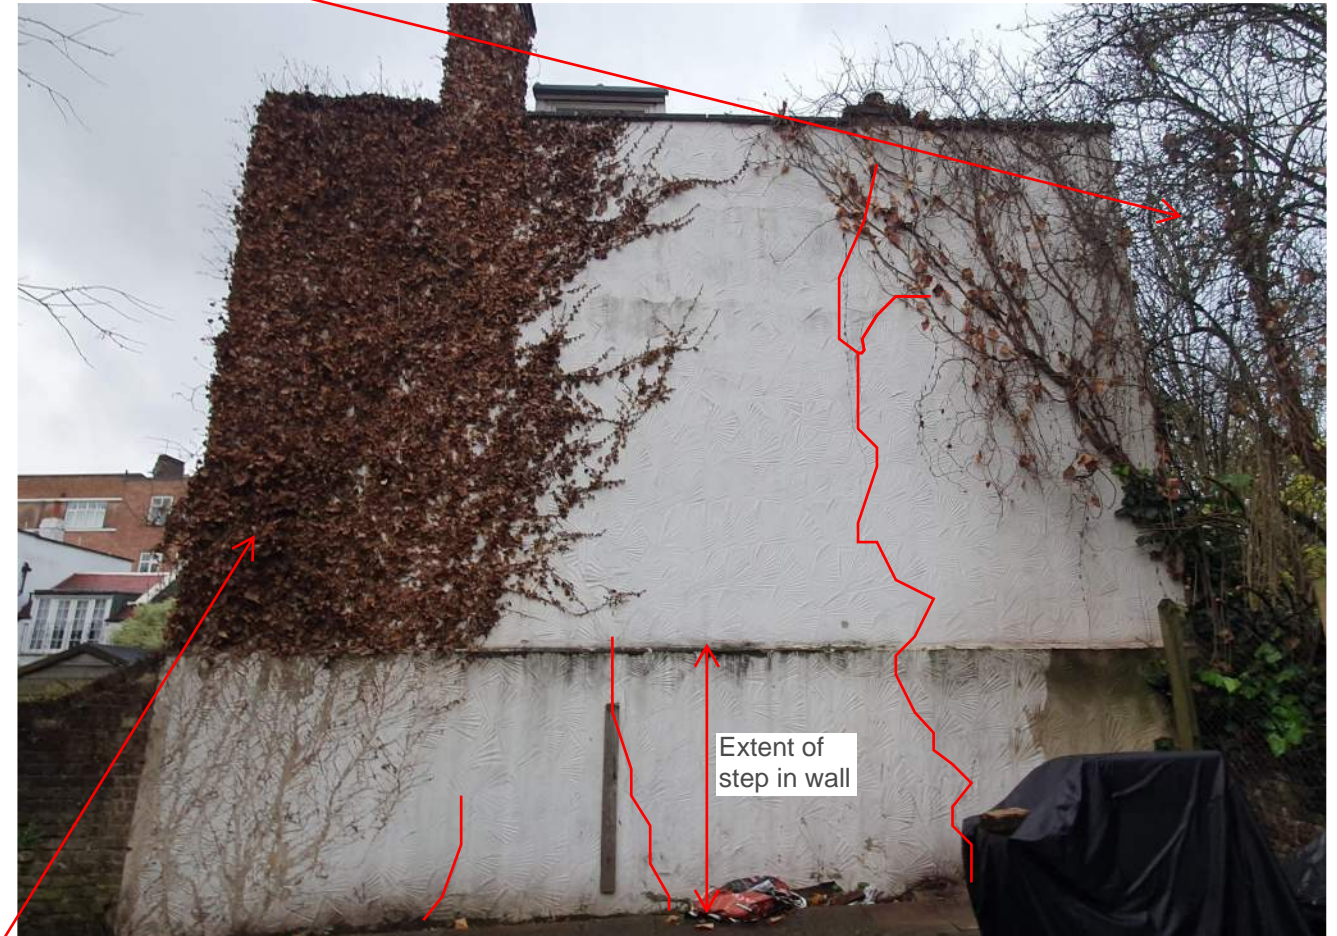
Crack Location Elevation Sketch

Note: East wall was not accessible, therefore cracks shown indicatively from photographic evidence provided.

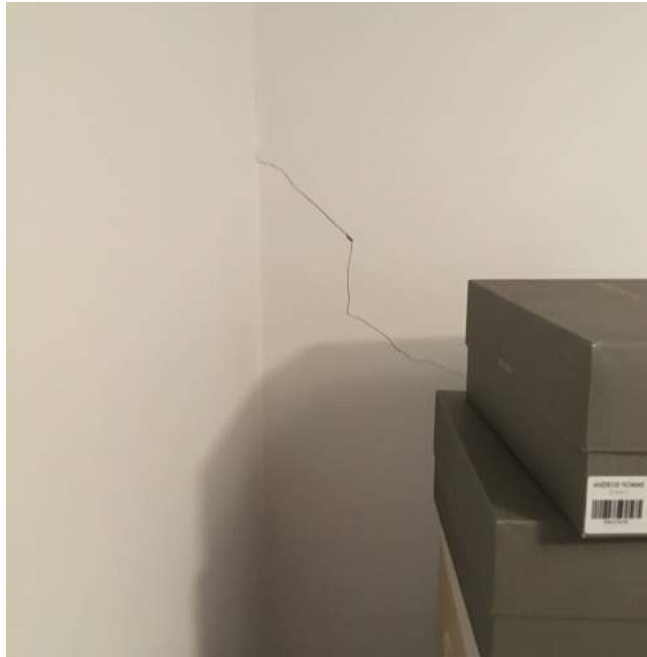
Figure 05:- Ground Floor North-East corner, facing East

On the east wall there was a larger crack, measured as 1mm wide, extending diagonally down from mid-height at the corner (Figure 05).

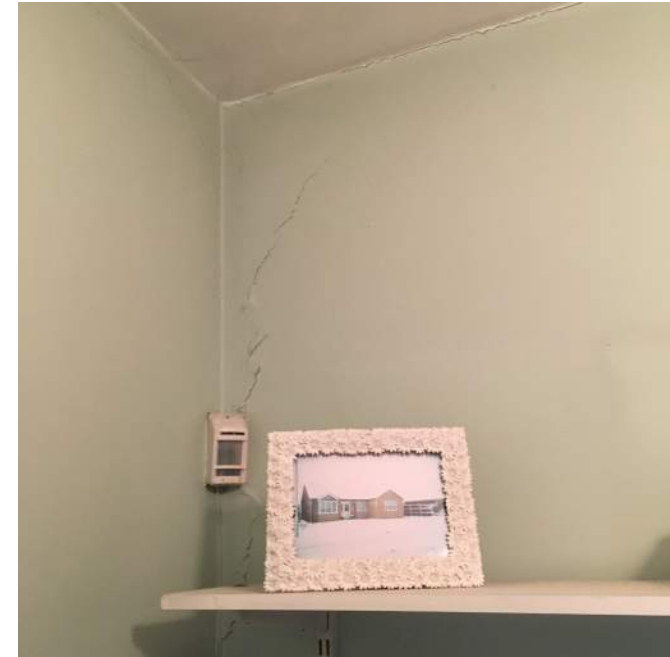
Figure 06:- First Floor North Elevation approximately a third of the way along the elevation from the North-East corner

Cracking was noted at the first floor within the north-east corner bedroom approximately a third of the way along the North Elevation. Vertical cracks had formed close to the return wall. The cracks were measured as approximately 0.5mm in width.

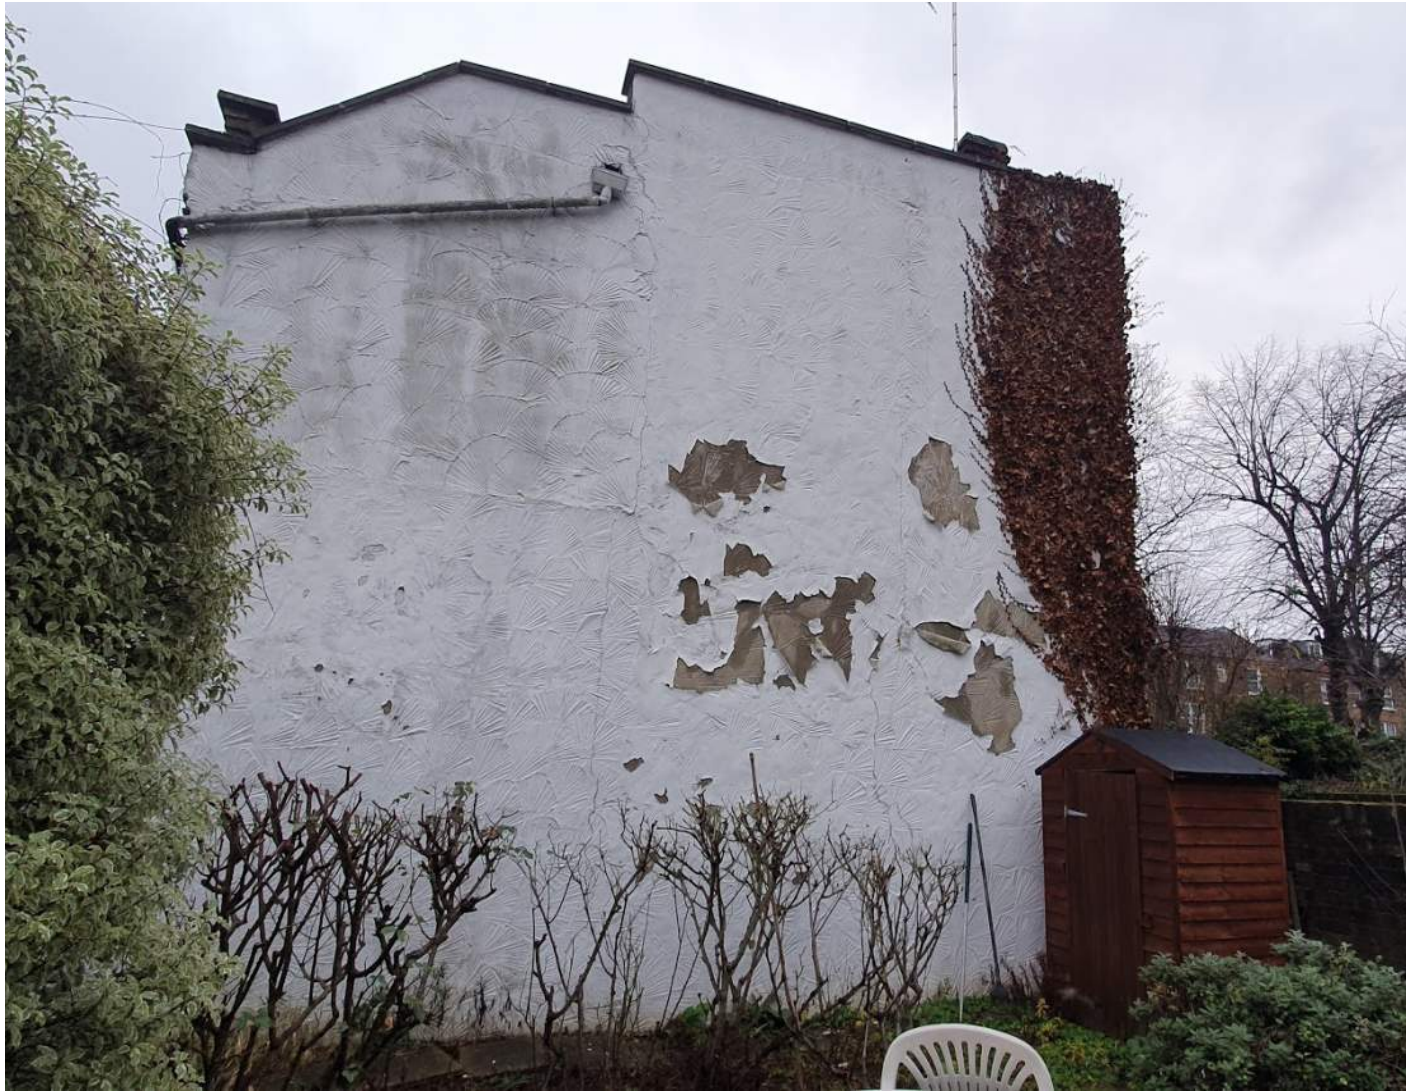
Figure 08:- South Elevation

Cracks less than 1mm wide were observed on the South Elevation at the mid-point extending from the valley line at roof level to ground approximately vertically. Vertical cracking was also visible at the three quarters point which was more pronounced at ground level suggesting that it is propagating vertically upwards. Some horizontal cracking was also observed (Figure 09).

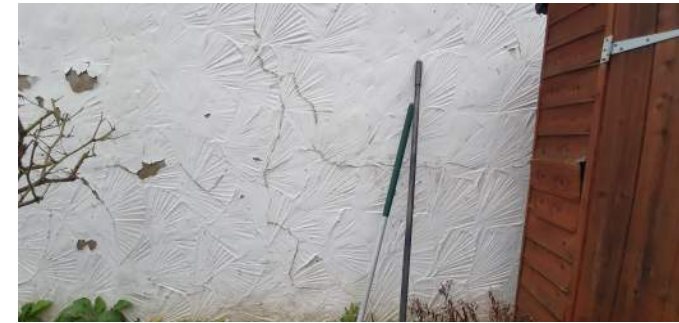
Figure 09:- Bottom Right-Hand Side Detail of South Elevation

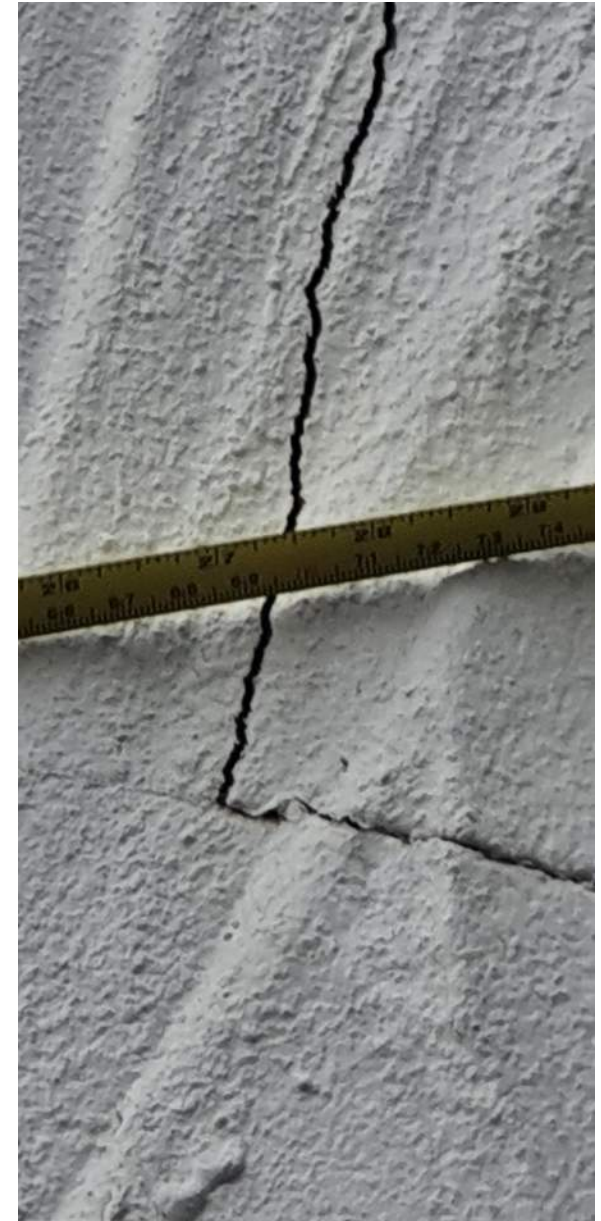
The external crack is vertical and was measured at ground level as 1mm wide but appeared to be more pronounced at height and is thought to exceed 2mm in places.

Figure 11:- East Elevation detail of crack
