Project Name: 29 INGLEWOOD ROAD
Project Description: WinCan Import in Miraculix Standard
Project Number: 4745
Project Status: Complete
Project Date: 21/09/2023

Project Information	P-1
Project Pictures	P-5
Section Item 1: SVP > MH1 BRANCHA (SVPX)	1
Section Item 2: RWG > MH1 BRANCHB (RWGX)	4
Section Item 3: CAPPED > MH1 BRANCHC (CAPPEDX)	6
Section Item 4: BURIEDMH > MH1 (BURIEDMHX)	8
Section Item 5: OC > MH1 BRANCHD (OCX)	11

A CCTV survey was carried out to ascertain condition and connectivity

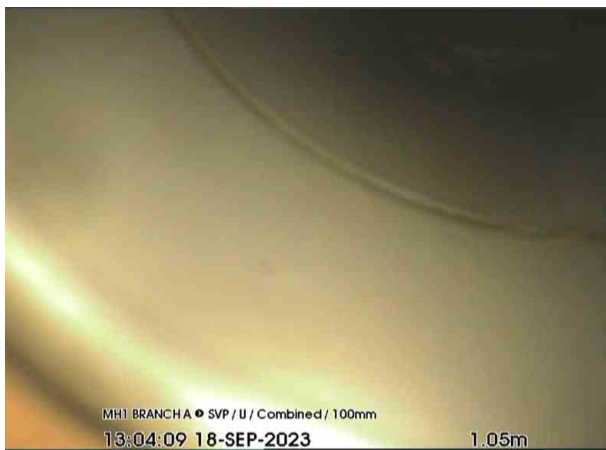
SVPX_d22d88ea-ddc7-43ae-ba32-71806bb7859f_20230921_150142_131.jpg, 00:00:31, 1.05 m
Pipe material changes to polyvinyl chloride at this point

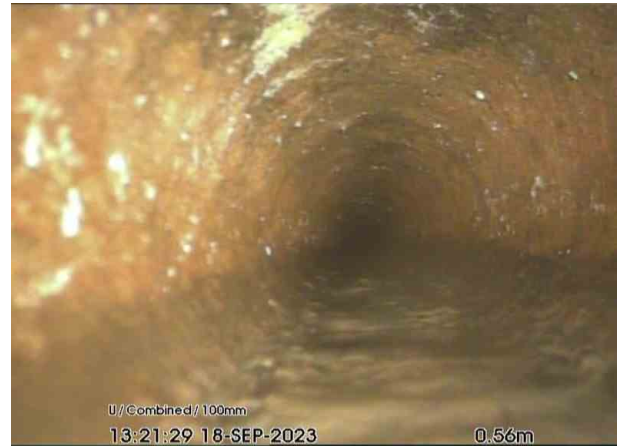
Town or Village:	Nw6	Inspection Direction:	Upstream	Upstream Node:	BURIED MH
Road:	29 Inglewood Road	Inspected Length:	14.36 m	Upstream Pipe Depth:	
Location:	Property or buildings	Total Length:	14.36 m	Downstream Node:	MH1
Surface Type:		Joint Length:		Downstream Pipe Depth:	0.550 m
Use:	Combined	Pipe Shape:	Circular		
Type of Pipe:	Gravity drain/sewer	Dia/Height:	100 mm		
Flow Control:	No flow control	Material:	Vitrified clay		
Year Constructed:	Not Specified	Lining Type:	No Lining		
Inspection Purpose:		Lining Material:	No Lining		
Comments:	Encrustation throughout the line				
Recommendations:	Descale using picote to clean pipework

<table><tr> <td style="width: 10%;">0.00</td> <td style="width: 10%;">MH</td> <td style="width: 40%;">Start node, manhole, reference: MH1</td> <td style="width: 10%;">00:00:00</td> <td style="width: 10%;">4_0-00m_132100.jpg</td> <td style="width: 10%;"></td> </tr><tr> <td style="color: green;">0.56</td> <td style="color: green;">S01 DEE</td> <td style="color: green;">Attached deposits, encrustation from 12 o'clock to 12 o'clock, 10% cross-sectional area loss, start</td> <td style="color: green;">00:00:19</td> <td style="color: green;">SVPX_eb52a971-7362-471b-afd</td> <td></td> </tr></table>

SVPX_eb52a971-7362-471b-afde-9110ca26785b_20230921_150843_929.jpg, 00:00:19, 0.56 m
Attached deposits, encrustation from 12 o'clock to 12 o'clock, 10% cross-sectional area loss, start

Section 4 - Jet/Picote clean to remove encrustation from the line.

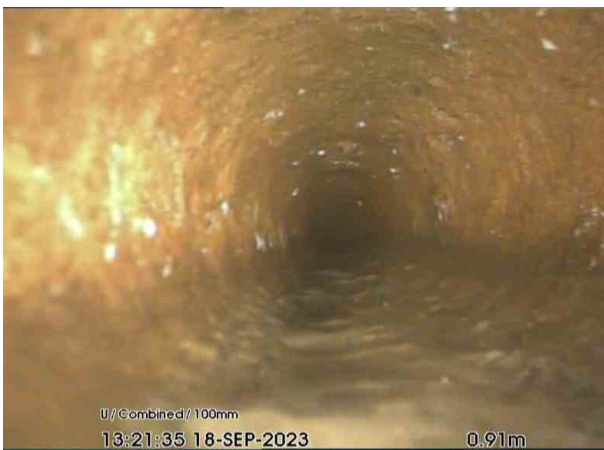
SVPX_deb1f473-a967-4add-ae6d-8fca9d25ea2b_20230921_150847_966.jpg, 00:00:19, 0.56 m
Attached deposits, encrustation from 12 o'clock to 12 o'clock, 10% cross-sectional area loss, start

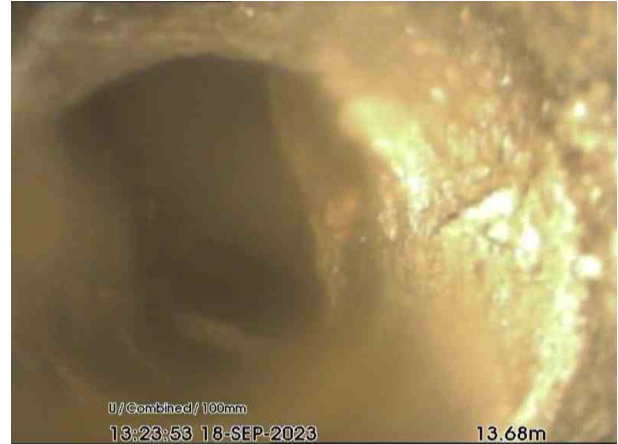
<table><tr> <td style="width: 10%;">0.00</td> <td style="width: 10%;">MH</td> <td style="width: 40%;">Start node, manhole, reference: MH1</td> <td style="width: 10%;">00:00:00</td> <td style="width: 10%;">4_0-00m_132100.jpg</td> <td style="width: 10%;"></td> </tr><tr> <td style="color: green;">13.68</td> <td style="color: green;">F01 DEE</td> <td style="color: green;">Attached deposits, encrustation from 12 o'clock to 12 o'clock, 10% cross-sectional area loss, finish</td> <td style="color: green;">00:02:42</td> <td style="color: green;">SVPX_5dd9993d-6e49-4d4e-ac</td> <td style="color: green;">3</td> </tr></table>

SVPX_5dd9993d-6e49-4d4e-ac08-df64fb90a7a2_20230921_151231_814.jpg, 00:02:42, 13.68 m
Attached deposits, encrustation from 12 o'clock to 12 o'clock, 10% cross-sectional area loss, finish
