Phase 3E - Fire Door Condition Assessment Report

<u>Rev.2</u>

Date: 01/08/2023

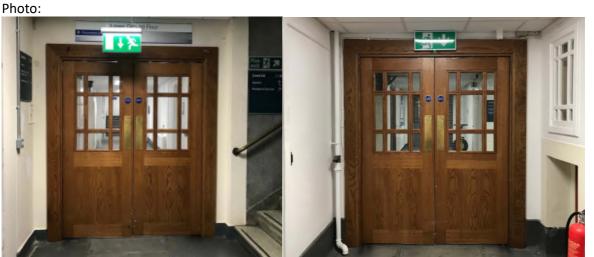
Door Code: D.LG.1

- Good condition •
- Integrated door closer will require new lipping on door •
- Infill required on door frame following removal of door closer

Floor pivot hinge plates •

• Single leaf effective clear width: 720mm

• Double leaf effective clear width: 1450mm

- 0-30: 47.5N
- 30-60: 37.5N

Non-compliant under Part M

- New cold, hot and drop seals •
- Replacement of Georgian glass
- Casing of windows require repair, and assessment of integrity, daylight visible through casing.

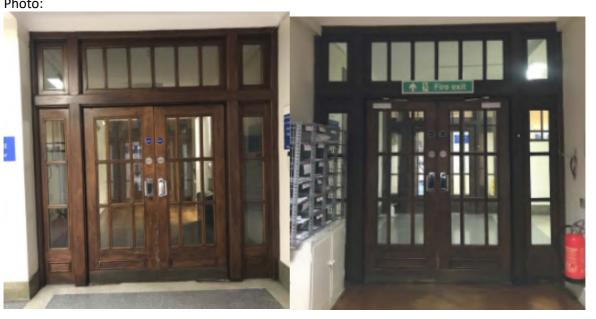
Door Code: D.1.2

- Fair condition •
- Georgian glass •
- Misalignment of door set •
- Floor pivot hinge plates

Single leaf effective clear width: 740mm •

Double leaf effective clear width: 1480mm •

- 0-30: 80N •
- 30-60: 55N •

Non-compliant under Part M

- New cold, hot and drop seals •
- Replace Georgian glass
- Re-adjustment of set to fix misalignment
- Timber infills
- Light touch decorative works •

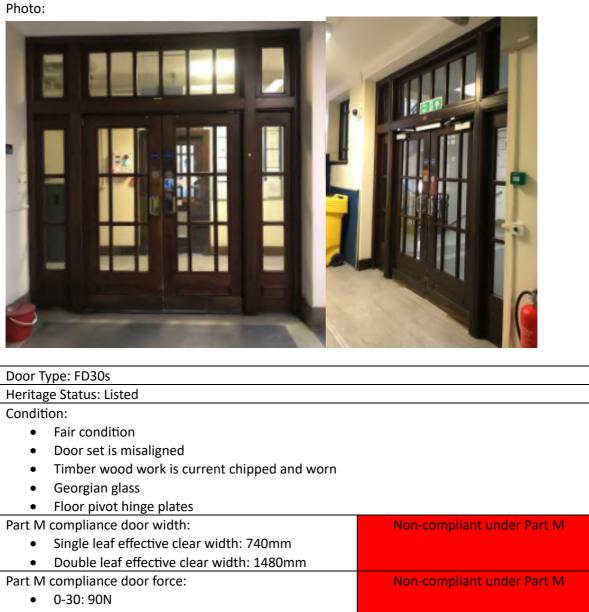
Door Code: D.3.1

• 30-60: 82.5N

- Re-adjustment of timber door set to fix misalignment •
- Reparation works to the leading edge of the timber door set •
- New cold, hot and drop seals •
- Replacement of Georgian glass •

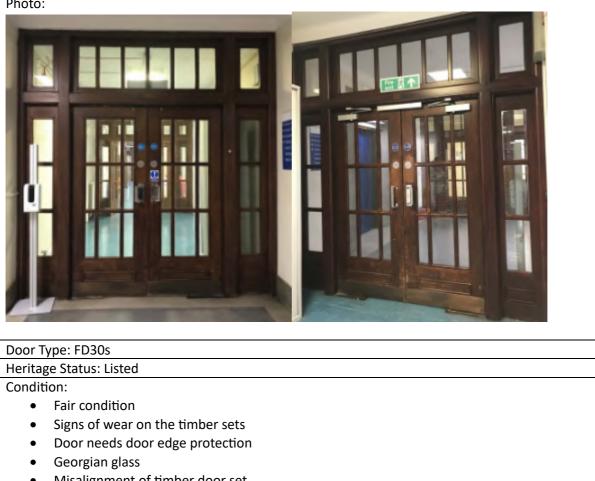
Door Code: D.3.2

Non-compliant under Part M

- Misalignment of timber door set •
- Floor pivot hinge plates •

- Single leaf effective clear width: 740mm
- Double leaf effective pinch width: 1480mm •

- 0-30: 97.5N
- 30-60: 62.5N •

- Re-adjustment of timber door sets to fix misalignment •
- Reparation works to the timber
- Replacement of the Georgian glass
- New cold, hot and drop seals
- New part M compliant closer

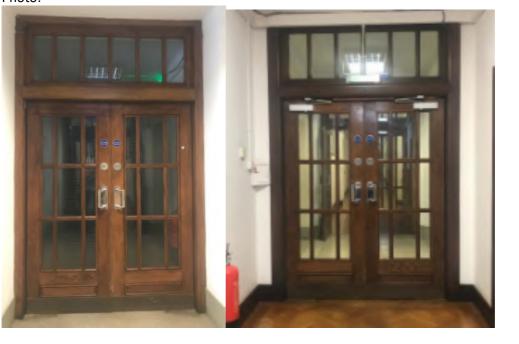
Door Code: D.G.5

Non-compliant under Part M

- Good condition
- Georgian glass
- Floor pivot hinge plates

- Single leaf effective clear width: 730mm
- Double leaf effective clear width: 1470mm

- 0-30: 77.5N
- 30-60: 62.5N

- Re-adjustment of timber door set to fix misalignment
- New cold, hot and drop seals
- Replacement of Georgian glass
- Infill of timber where existing closer has been fixed
- Installation of part M compliant closer

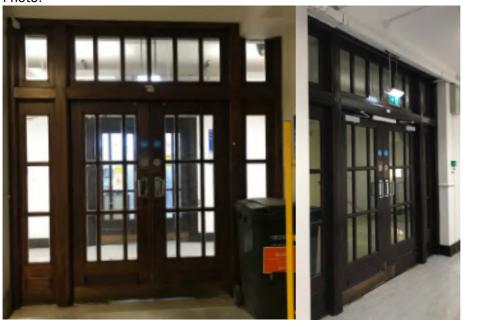
Door Code: D.3.4

Non-compliant under Part M

- Fair condition
- Georgian glass
- Floor pivot hinge plates
- Part M compliance door width:
 - Single leaf effective clear width: 740mm
 - Double leaf effective clear width: 1480mm

- 0-30: 87.5N
- 30-60: 60N

- Slight reparation works to the timber door set
- Replacement of Georgian glass
- New hot, cold and drop seals
- Infill of timber where existing closer is fixed
- New part M compliant closer

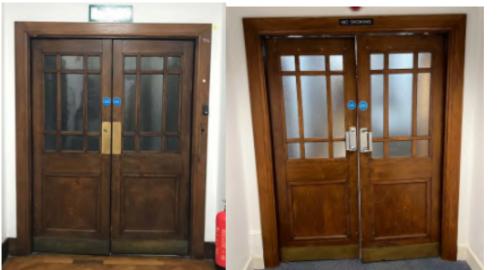
Door Code: D.G.10

Non-compliant under Part M

- Good condition
- Damage to the top edge of the door set
- Integrity of glass questionable
- Floor pivot hinge plates

- Single leaf effective clear width: 680mm
- Double leaf effective clear width: 1360mm

- 0-30: 60N
- 30-60: 60N
- Fire Door?: Yes

- Replace glass with fire resistant glass
- Re-adjustment of door to fix misalignment
- New hot, cold and drop seals
- Infill timber with intumescent packing
- Light reparations to timber door set
- New part M compliant door closer

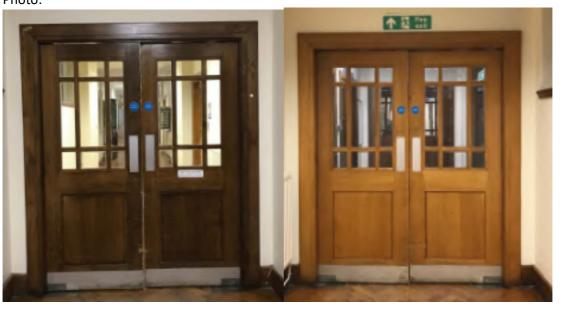
Door Code: D.1.6

Door T	ype: FD30s		
Herita	ge Status: Listed (unknown if reproduction)		
Condit	ion:		
•	Good condition		
•	 Very slight signs of wear to the timber 		
•	Floor pivot hinge plates		
Part M	compliance door width:	Compliant under Part M	
•	Single leaf effective clear width: 760mm		
•	Double leaf effective clear width: 1520mm		
Part M compliance door force:		Non-compliant under Part M	
•	0-30: 47.5N		
•	30-60: 47.5N		
Fire Do	Fire Door?: Yes		
Fire re	quirements:		
•	Light reparation works to the timber door set		
•	New hot, cold and drop seals		
•	 Infill timber where existing closer is installed 		
•	New part M compliant closer

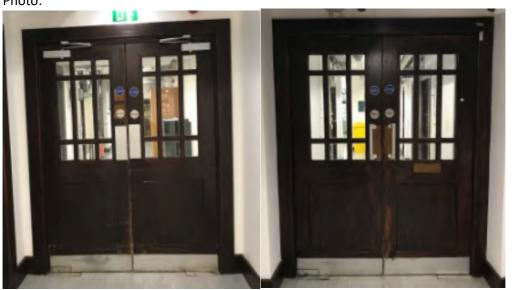
Door Code: D.3.7

Non-compliant under Part M

- Fair condition •
- Georgian glass •
- Slight signs of wear to the timber sets
- Floor pivot hinge plates

- Single leaf effective clear width: 700mm •
- Double leaf effective clear width: 1400mm

- 0-30: 62.5N •
- 30-60: 62.5N

- Light reparations to the timber sets
- Re-adjustment of timber door sets to fix misalignment •
- **Replace Georgian glass**
- New hot, cold and drop seals
- New part M compliant door closer •
