TECHNICAL REPORT ON A SUBSIDENCE CLAIM

16 Fairhazel Gardens
London
NW6 3SJ

SUBSIDENCE CLAIM

DATE 17 November 2023

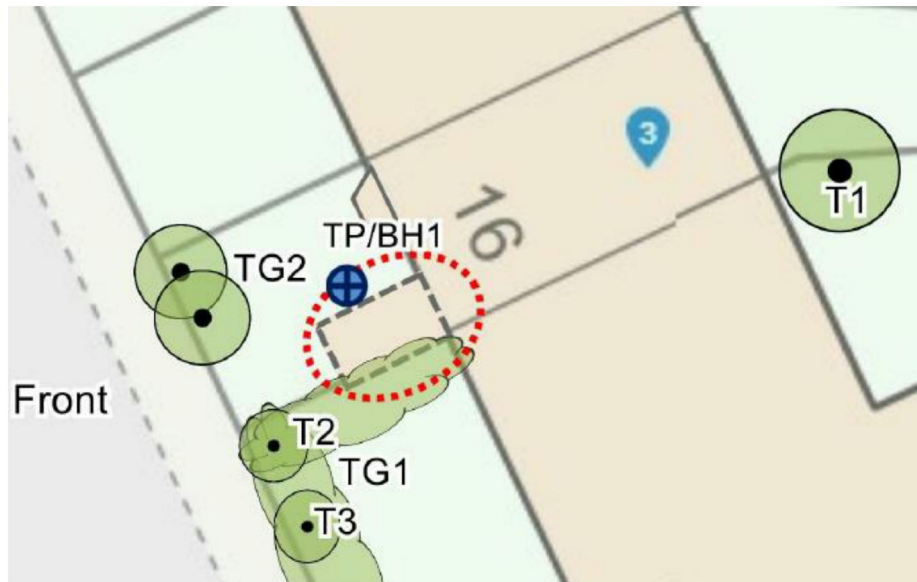
See sketch.

There are several trees and shrubs nearby, some with roots that may extend beneath the house foundations. The following are of particular interest:-

Irrespective of the identification of recovered root samples, our survey has identified vegetation within influencing distance of the building with a current potential to influence soil volumes below foundation level; the most significant in relation to the current damage is the vegetation of TG1 group directly adjacent to the right-hand side of the steps.

If an arboricultural solution is to be implemented to mitigate the influence of the implicated trees/vegetation we recommend that the nearby elements of TG1 group are removed, combined with re-pollarding of the limes of TG2 group.

As per the recommendations of the Arboricultural Report we recommend that the nearby elements of TG1 group are removed, combined with re-pollarding of the limes of TG2 group.

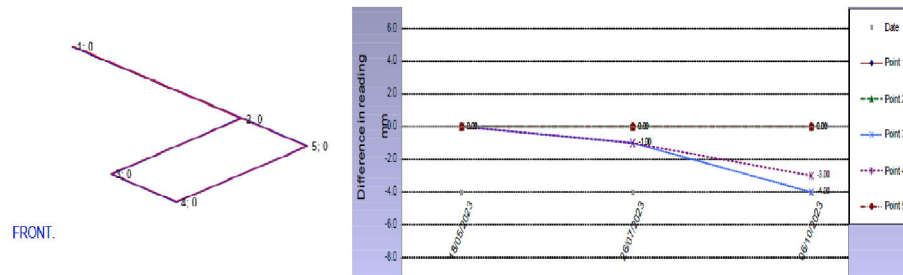
Level monitoring has been implemented to provide further evidence to support our conclusions. Initial readings have been taken and further readings will be taken on a bi monthly basis.
