## **Expert Commentary: Application of Lime Render**

**Address: 39 Argyle Street, London, WC1H 8EP**

**Date of Review: Thursday, 7<sup>th</sup> September 2023**

**Prepared by:**  
Malone Associates Ltd

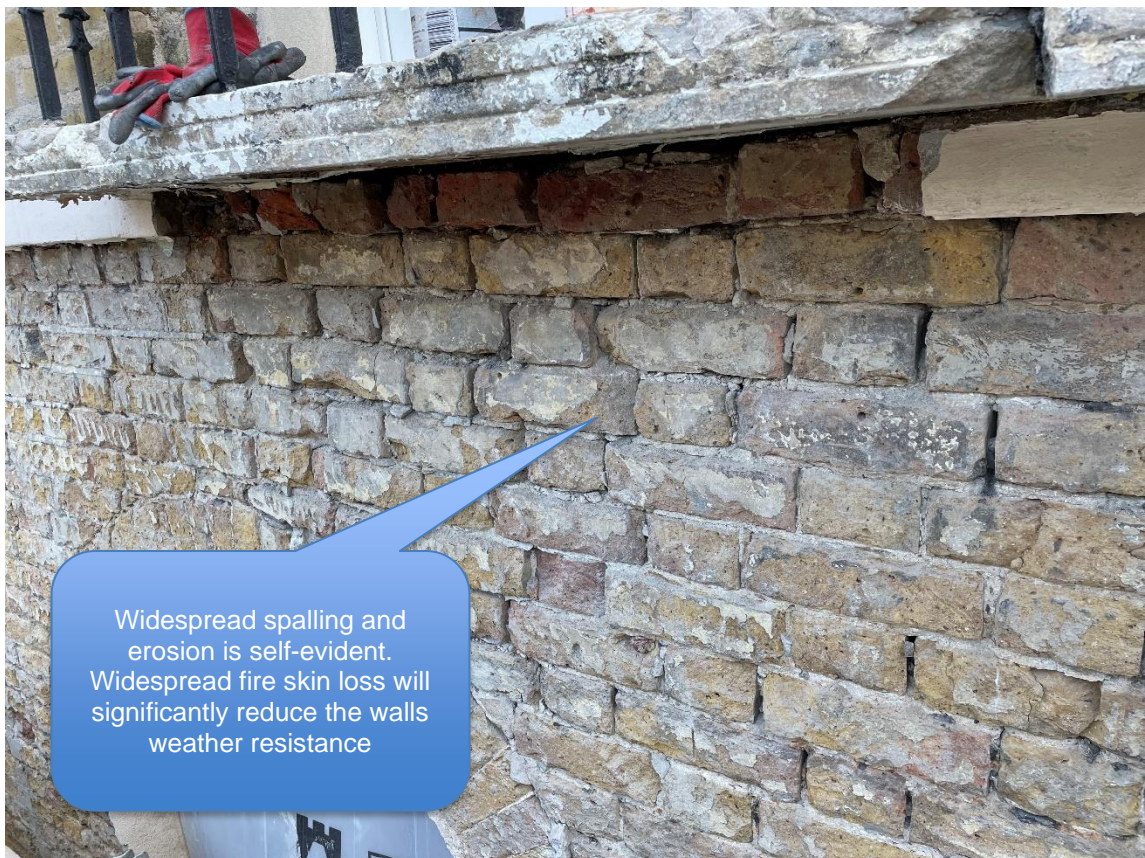
Figure 1

- 5.1 On review of the photographic evidence, it can be seen that brickwork at 31-37 is heavily spalled and the bricks have lost the sharp brick arrises. The brick face has taken on a rounded appearance which negatively affects the buildings aesthetic, as well as technical qualities.

It is inevitable that some damage will be done to the masonry as hard OPC render is removed, but also inevitable that some damage will have occurred due to the OPC render trapping moisture in the masonry. Freeze/thaw action and subsequent spalling and erosion would have been progressive and ongoing had this render not been removed.

Spalling and erosion at 31-37 was so widespread that the aesthetic appearance of the building is severely impaired but more importantly, the masonry façade has severely reduced weather resistance due to loss of the brick fire skins and as such, will be at significantly increased risk of penetrating damp and accelerated freeze/thaw action and subsequent erosion. I have no doubt that the application of lime render was the technically correct course of action to take when dealing with 31-37 Argyle Street,

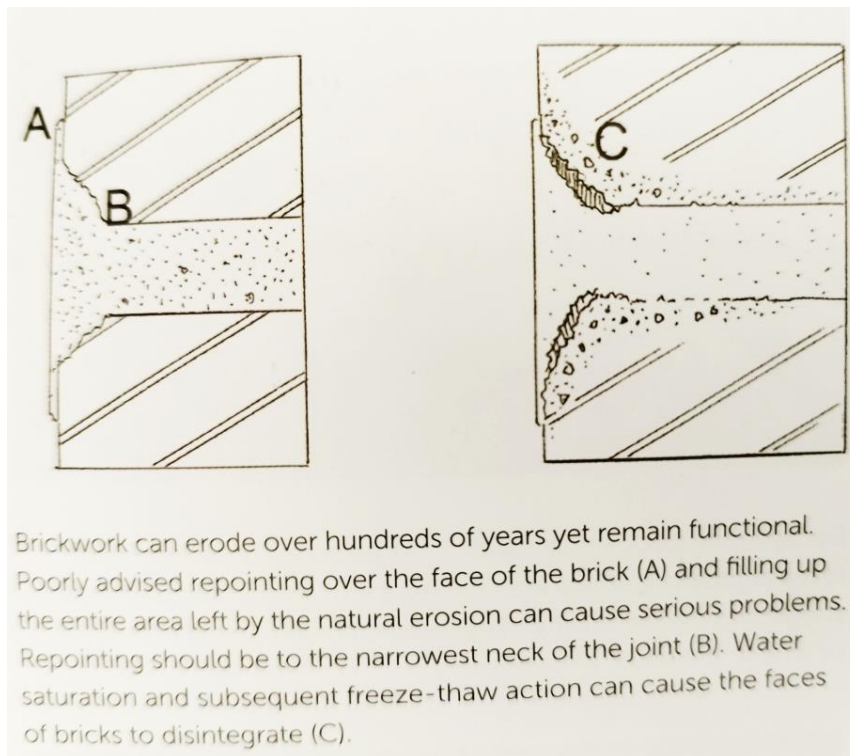
As discussed in section 4.1 of this report, when lime mortar joints lose the ability to lose salts and moisture due to the application of hard OPC pointing, then inevitably, we will see significant spalling and erosion of the brickwork, which tends to be focussed on the brick arrises. Future attempts to correctly repoint using lime mortar will result in messy smeared mortar joints due to the loss of these arrises.

Figure 2 below illustrates the damage that will be seen where lime has been substituted for OPC pointing.
