**SUBSIDENCE REPORT**

*37 Lancaster Grove, London, NW3 4HB*

**Inspection – 5<sup>th</sup> December 2022**

**Report dated – 7<sup>th</sup> December 2022**

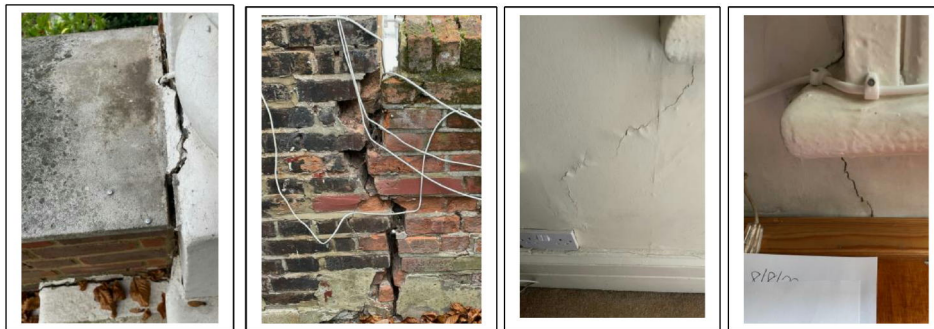
We noted several areas of cracking (internally and externally) which is commensurate with foundation movement caused by subsidence – predominately affecting the front steps and garden walls, but also to a lesser extent the main front elevation.

Damage would generally fall within category 4 - “Severe” (external works) and 2 “sight” (main house) from BRE Digest 251 - “Assessment of Damage in Low Rise Buildings”, and is indicative of subsidence to the steps, external works, and to the front elevation. It is very likely to be caused

by clay shrinkage due to roots from the aforementioned vegetation extracting moisture from the underlying clay beneath the foundations.

We advise that some more site investigations be undertaken (i.e. trial pit and borehole to the front lightwell) in order to ascertain construction of house foundations and subsoil condition. We also advise that level monitoring be reactivated and crack monitoring extended to cover all cracks (including those in the house and to the garden wall which are not currently being monitored). We are able to organise and oversee these investigations.
