TECHNICAL REPORT ON A SUBSIDENCE CLAIM

**37 Lancaster Grove Limited
37 Lancaster Grove
London
NW3 4HB**

SUBSIDENCE CLAIM

DATE 6 February 2019

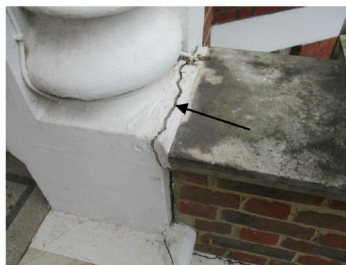
View of cracking to front steps

Front Steps - 10mm previously repaired stepped cracking to right hand wall, 5mm separation on steps right hand junction and main house continues across top step junction, 10mm separation on steps left hand junction and main house, bottom step is cracked in two places, 2nd step is cracked and right hand section has dropped resulting in rear concrete infill section de-bonding and falling into void below steps, 2nd and 4th steps are loose and rocking, unrelated damp staining and bubbling to paintwork noted to right hand wall within the right hand basement well area.

The pattern and nature of the cracking affecting the front steps and porch structure is indicative of an episode of subsidence. The cause of movement appears to be clay shrinkage.

The timing of the event, the presence of shrinkable clay beneath the foundations and the proximity of vegetation where there is damage indicates the shrinkage to be root induced. This is a commonly encountered problem and probably accounts for around 70% of subsidence claims notified to insurers.

Although the cause of the movement needs to be dealt with, we note the vegetation is subject to a Preservation Order. Unfortunately, current legislation requires certain investigations to be carried out to support an application for any tree management works.

Typically, these investigations would involve trial pit(s) to determine the depth and type of footings, boreholes to determine the nature of the subsoil/influence of any roots and monitoring to establish the rate and pattern of movement. The monitoring data provided must be sufficient to show a pattern of movement consistent with the influence of the vegetation and therefore it may be necessary to carry out the monitoring for up to a 12 month period.

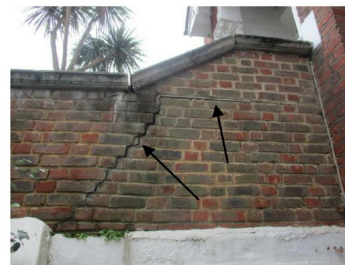
Cracking to right hand side steps wall
