## Addendum Arboricultural Report

### Subsidence Damage Investigation at:

37 Lancaster Grove  
London  
NW3 4HB

CLIENT: Crawford & Company  
 CLIENT REF: [REDACTED]  
 MWA REF: [REDACTED]  
 MWA CONSULTANT: George Peters BSc. (Hons), M.Arbor.A  
 REPORT DATE: 17/12/2020

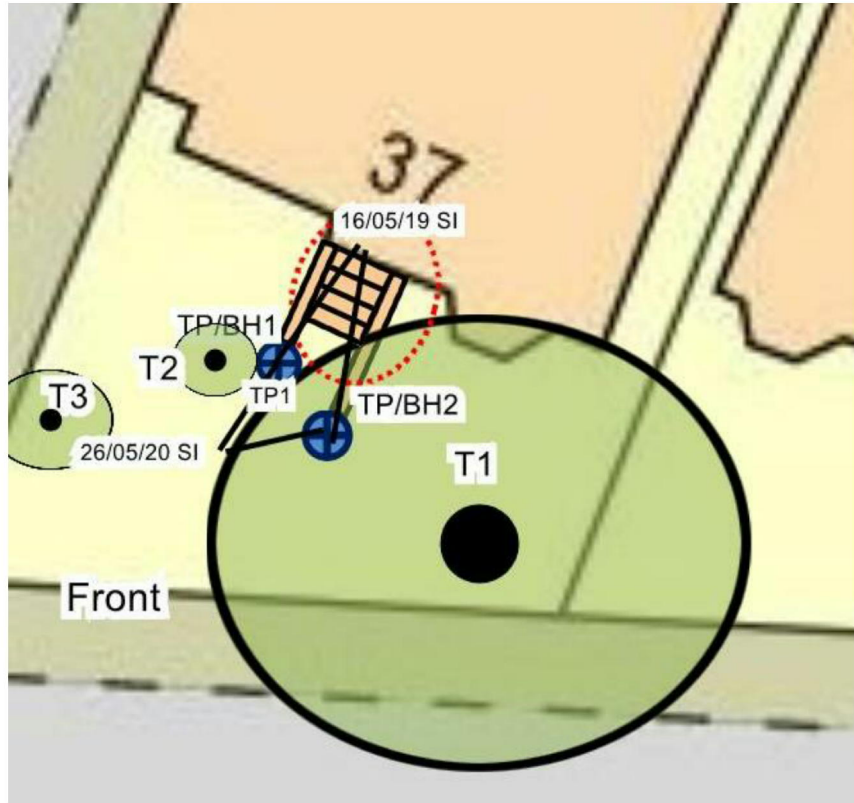
Site Plan

Approximate areas of damage

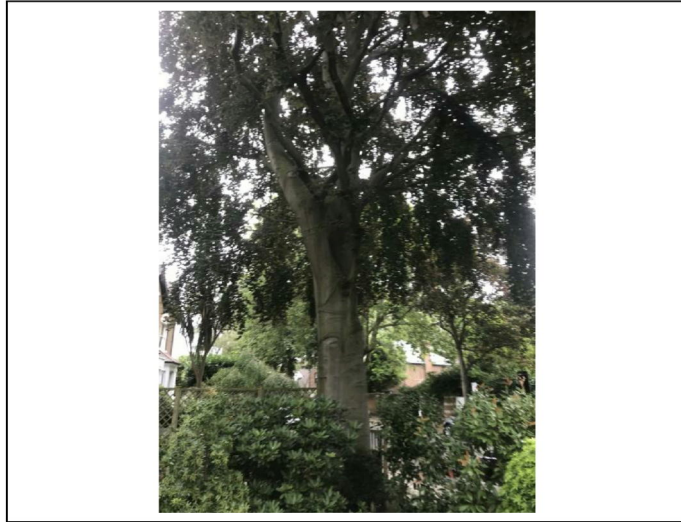
Based on the technical reports currently available, engineering opinion and our own site assessment we conclude the damage is consistent with shrinkage of the clay subsoil related to moisture abstraction by vegetation. Having considered the information currently available, it is our opinion that T1 is the principal cause of the current subsidence damage.

Tree No.	Species	Ht (m)	Dia (mm)	Crown Spread (m)	Dist. to building (m)	Age Classification	Ownership
T1	Beech	18 *	1200 *	18	5	Younger than Property	Policy Holder
Management history		No recent management noted. Ganoderma at base.					
Recommendation		Remove (fell) to near ground level and treat stump to inhibit regrowth.

View of T1 Beech

If an arboricultural solution is to be implemented to mitigate the influence of the implicated trees/vegetation we recommend that T1 is removed. Other vegetation recorded presents a potential future risk to building stability and management is therefore recommended.

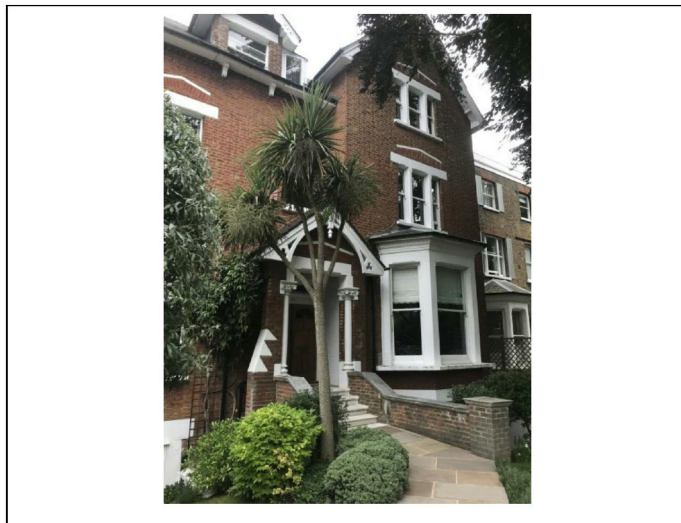
Roots recovered from 1200mm bgl in TP/BH1 also include *Monocotyledon* spp. (originating from T2 (cordyline) and *Osmanthus/Phillyrea* spp. or related shrub species (originating from non-significant vegetation). The recovery of these roots is not significant to the current claim and is not considered further.

Tree No.	Species	Ht (m)	Dia (mm)	Crown Spread (m)	Dist. to building (m)	Age Classification	Ownership
T2	Cordyline	4	150	2.5	1	Younger than Property	Policy Holder
Management history		No recent management noted.					
Recommendation		None.					
T3	Willow Leaved Pear	3	120 *	2.8	4.5	Younger than Property	Policy Holder
Management history		No recent management noted.					
Recommendation		Maintain broadly at no more than current dimensions by periodic pruning.

View of T2 Cordyline

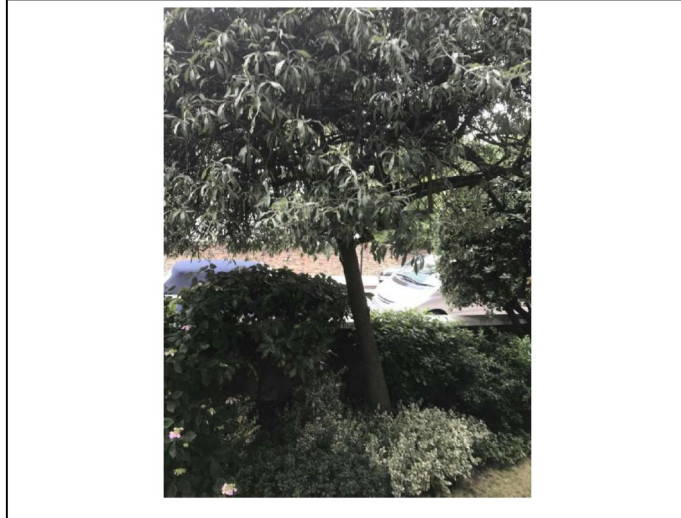
View of T2 Willow leaved pear
