Arboricultural Appraisal Report

Subsidence Damage Investigation at:

89 Arlington Road
 London
 NW1 7ES

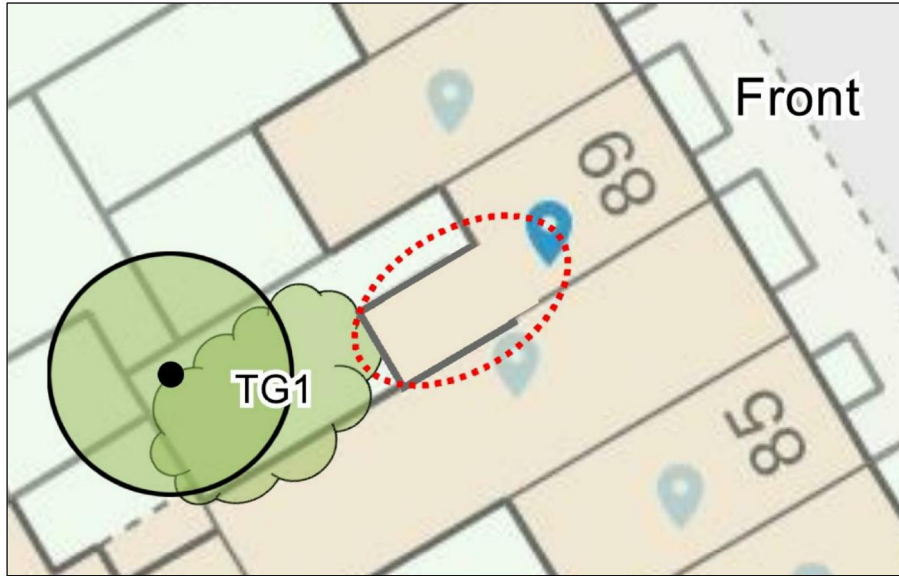
Site Plan

Approximate areas of damage

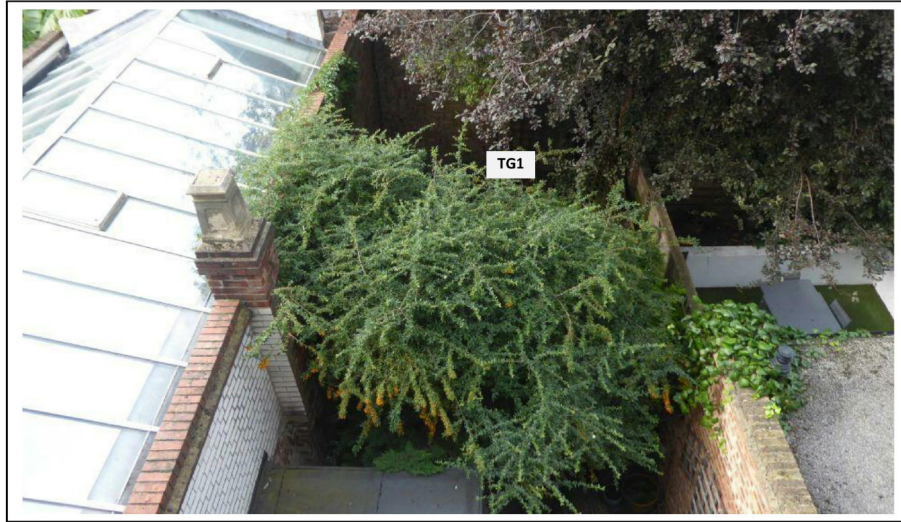
Our survey has identified vegetation within influencing distance of the building with a current potential to influence soil volumes below foundation level; the most significant of which is the TG1 group of Crab Apple with Pyracantha and Juniper understorey.

View from upper level window of TG1 group beyond rear extension

If an arboricultural solution is to be implemented to mitigate the influence of the trees/shrubs considered to be responsible for the damage we recommend that TG1 group is removed.

| Tree No. | Species | Ht (m) | Dia (mm) | Crown Spread (m) | Dist. to building (m) | Age Classification | Ownership |
|---|---|--|---|---|---|---|---|
| Recommendation | | Remove (fell) all to near ground level and treat stumps to inhibit regrowth. | | | | | |

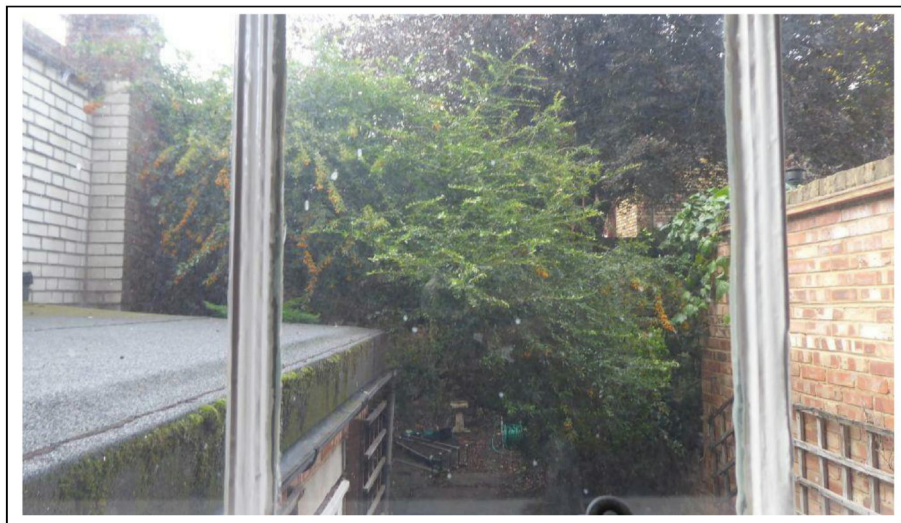
View of TG1 group
